**ALL HOURS PLUMBING**

| Project Name:<br><b>468</b> | Contract Number: | Contact:<br><b>Parchow Groundworks</b> | Date:<br><b>05/05/2026</b> |

Client: **Parchow Groundworks**  
Contact:  
Position:  
Road: **Widley Farm, New Down Lane**  
Town: **Purbrook**  
Post Code: **PO7 5SE**  
County: **Hampshire**  
Telephone:

Inspection Report

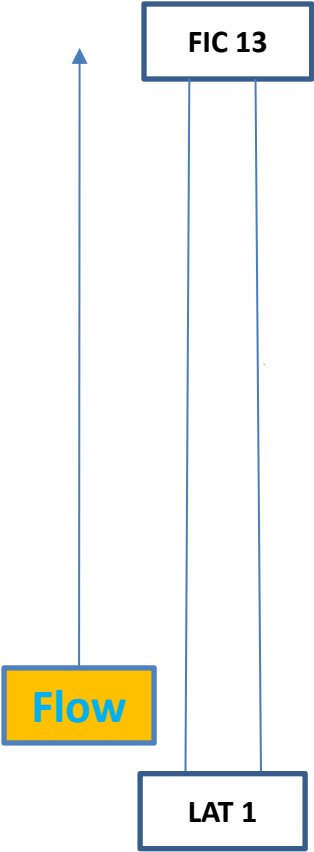
1.5M JN Line Drops In From The Right

3.3M LU Line Turns Up

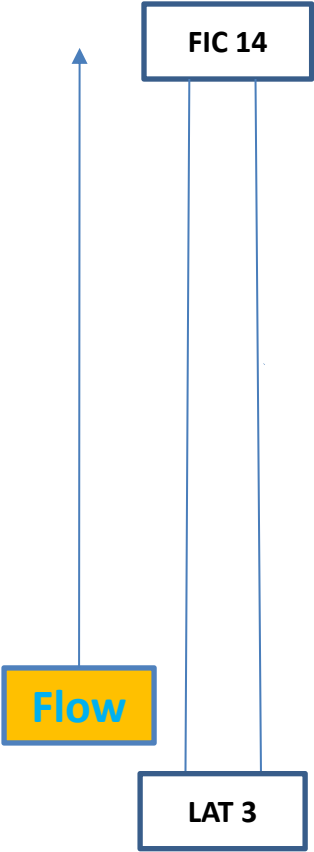
2.2M JN Line Drops In From The Right

4.0M LU Line Turns Up

REM ; THERE ARE NO MAJOR DEFECTS WITH THIS SECTION OF PIPE

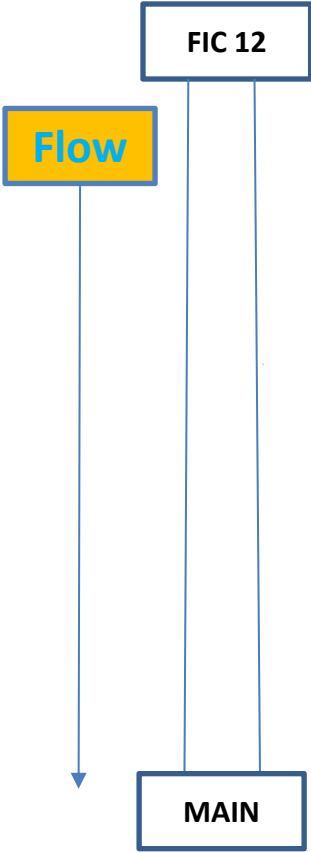
0.0M ST Start Of Survey  
0.0M WL Water Level 0 %  
0.2M MC Pipe Changes To Clay

REM ; THERE ARE NO MAJOR PROBLEMS WITH THIS SECTION OF PIPE

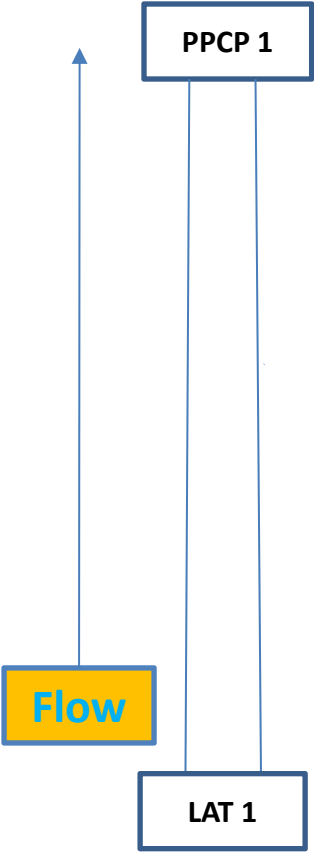
0.0M ST Start Of Survey  
0.0M WL Water Level 0 %  
1.2M JN Line Drops In From The Right

12.3M JN Line Drops In From The Right  
12.5M LU Line Turns Up To Rodding Eye

REM ; THERE ARE NO MAJOR DEFECTS WITH THIS SECTION OF PIPE

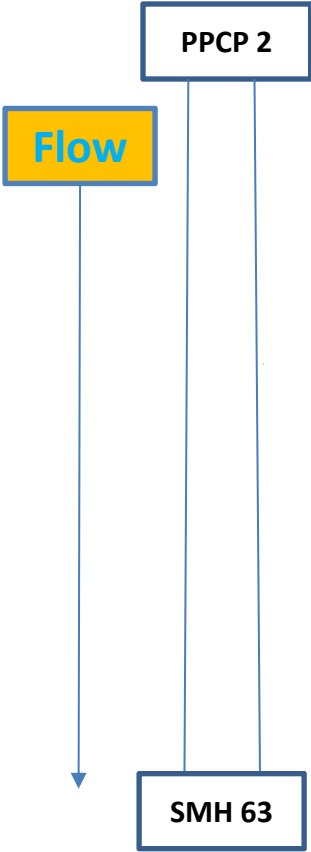
4.0M CR Cracks In Pipe

10.9M CR Cracks In Pipe

REM ; THERE ARE CRACKS IN THIS SECTION OF PIPE WHICH CAN BE REPAIRED WITH 2 PATCH LINERS

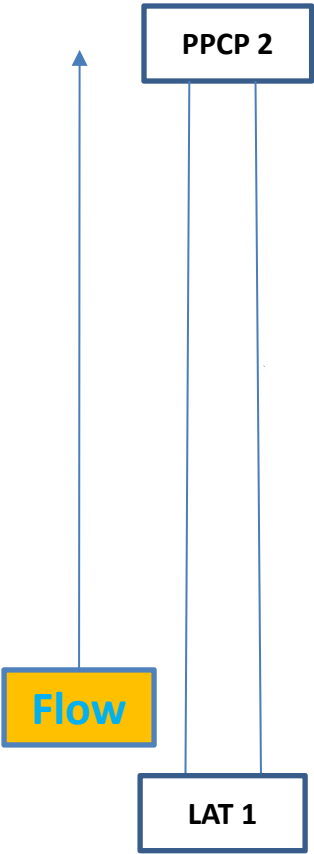
0.0M ST Start Of Survey  
0.0M WL Water Level 0 %  
0.4M JN Line Drops In From The Left  
0.5M JN Line Drops In From The Right

12.4M JN Line Drops In From The Left  
12.6M JN Line Drops In From The Left  
13.2M LU Line Turns Up To Rodding Eye

REM ; THERE ARE NO MAJOR DEFECTS WITH THIS SECTION OF PIPE

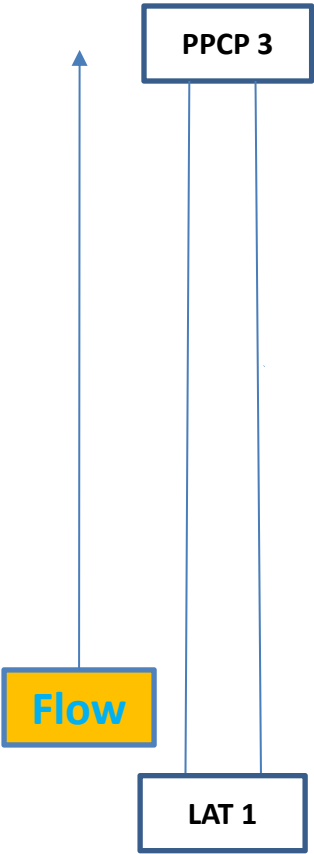
0.0M ST Start Of Survey  
0.0M WL Water Level 0 %  
0.9M JN Line Drops In From The Left

11.5M JN Line Drops In From The Left  
12.5M LU Line Turns Up To Rodding Eye

REM ; THERE ARE NO MAJOR DEFECTS WITH THIS SECTION OF PIPE

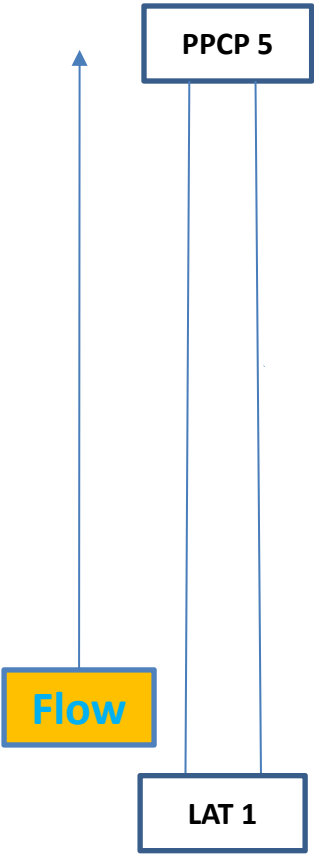
0.0M ST Start Of Survey  
0.0M WL Water Level 0 %  
0.2M JN Line Drops In From The Left  
0.4M JN Line Drops In From The Right

11.6M JN Line Drops In From The Right  
12.0M JN Line Drops In From The Left  
12.5M LU Line Turns Up To Rodding Eye

REM ; THERE ARE NO MAJOR DEFECTS WITH THIS SECTION OF PIPE

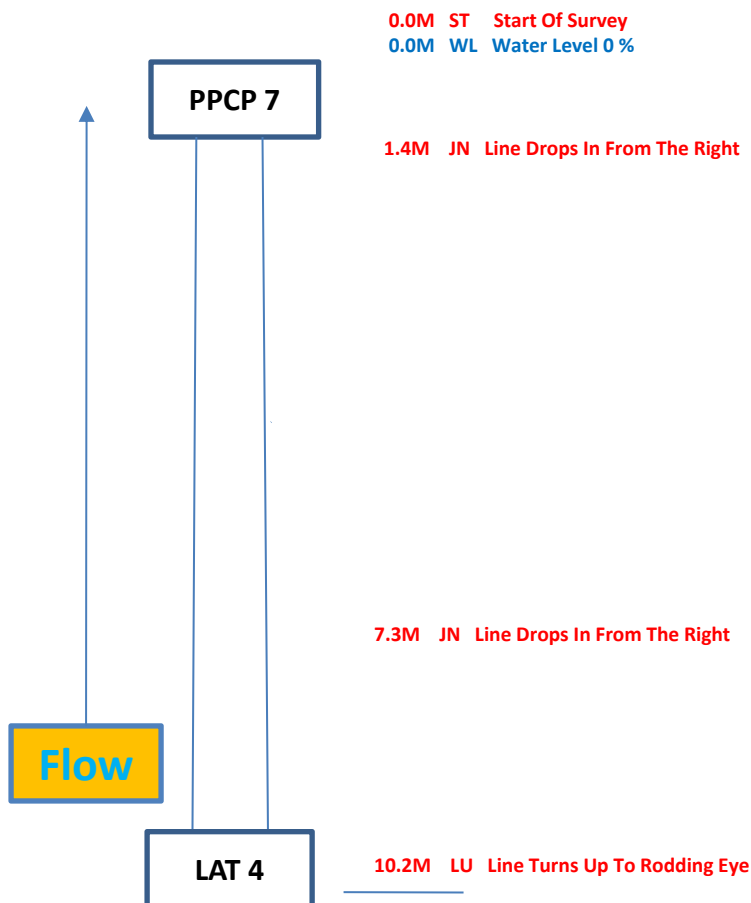
REM ; THERE ARE NO MAJOR DEFECTS WITH THIS SECTION OF PIPE

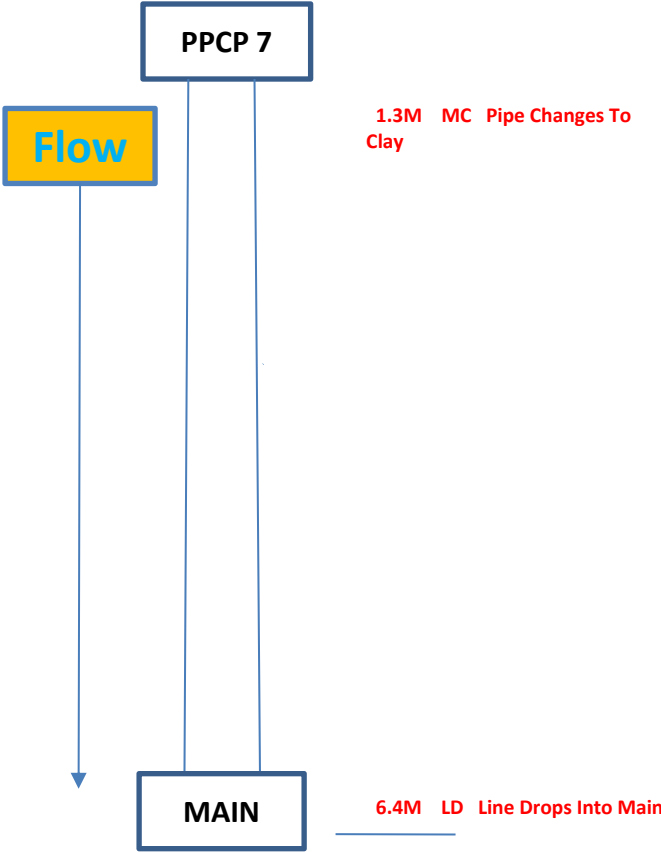
REM ; THERE ARE NO MAJOR DEFECTS WITH THIS SECTION OF PIPE

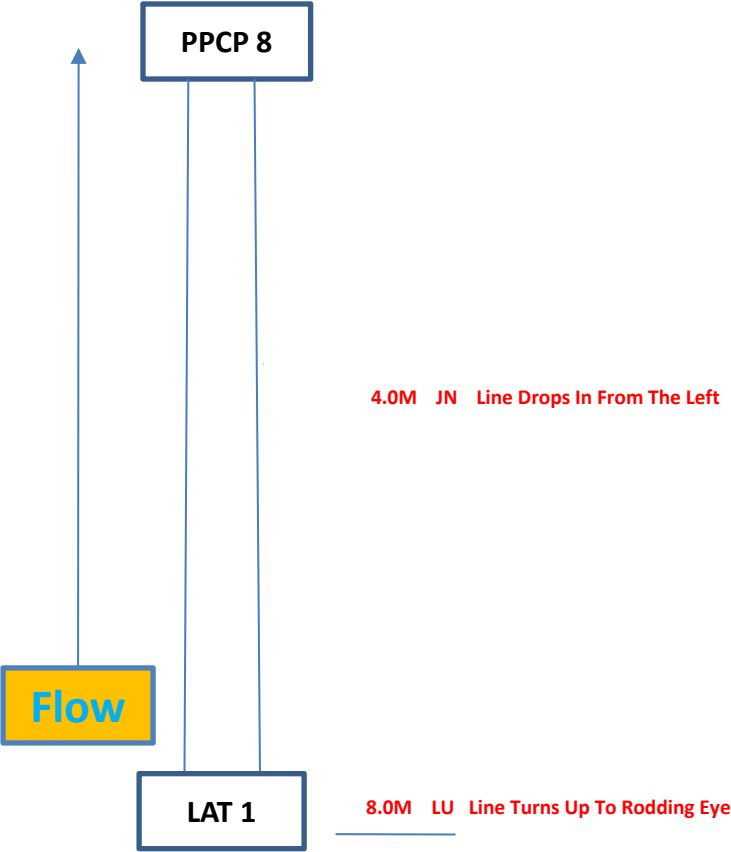
REM ; THERE ARE NO MAJOR DEFECTS WITH THIS SECTION OF PIPE

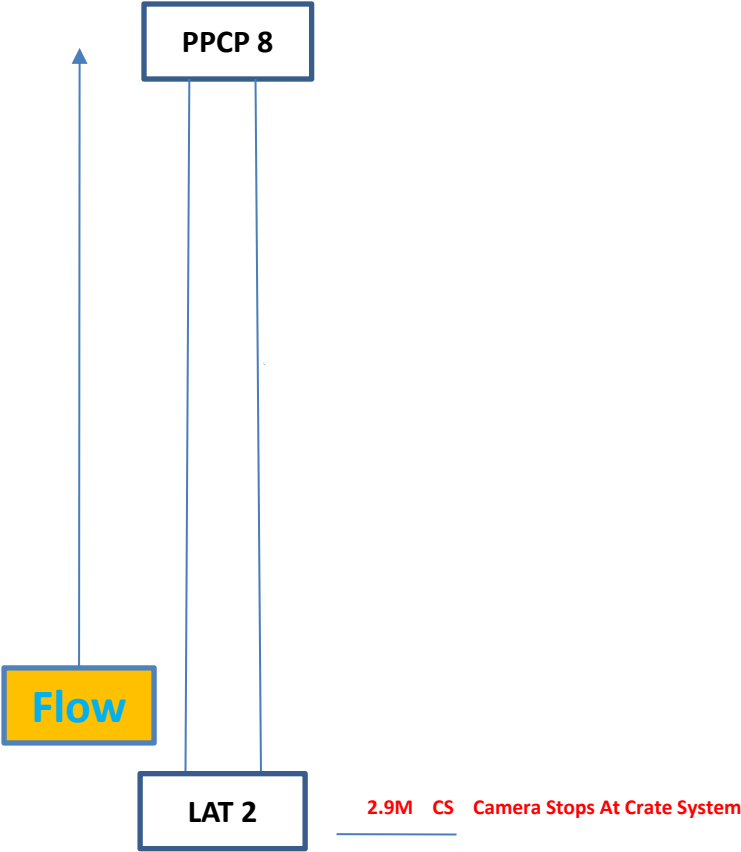
REM ; THERE ARE NO MAJOR DEFECTS WITH THIS SECTION OF PIPE

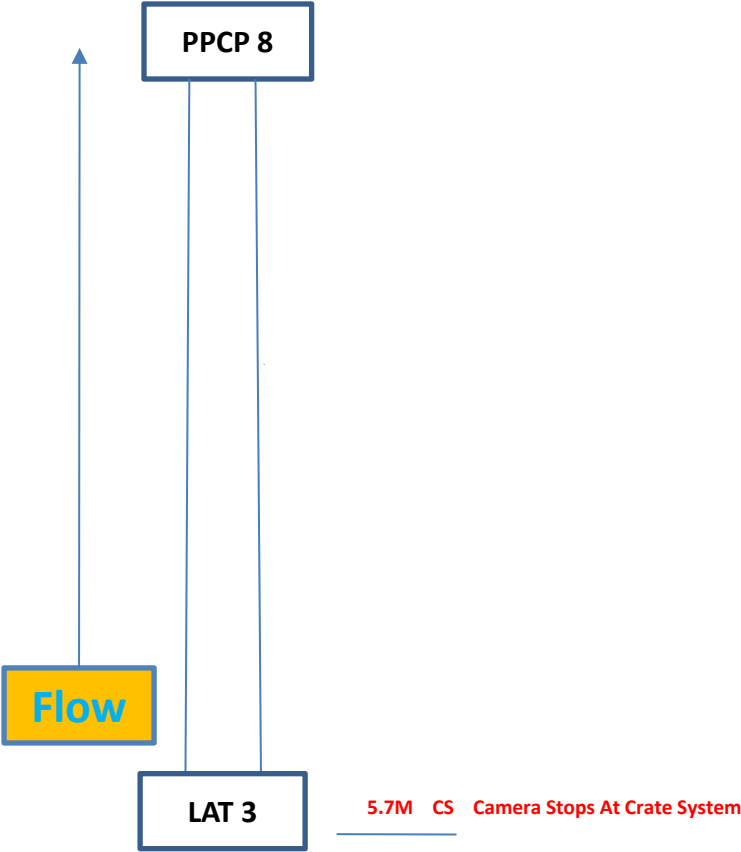
REM ; THERE ARE NO MAJOR DEFECTS WITH THIS SECTION OF PIPE

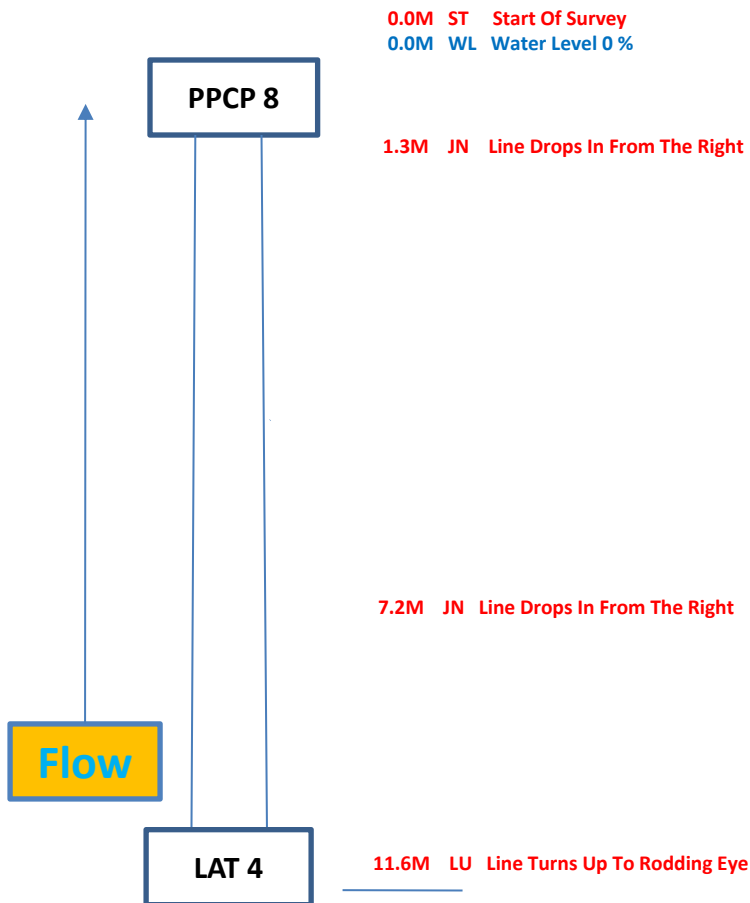
REM ; THERE ARE NO MAJOR DEFECTS WITH THIS SECTION OF PIPE

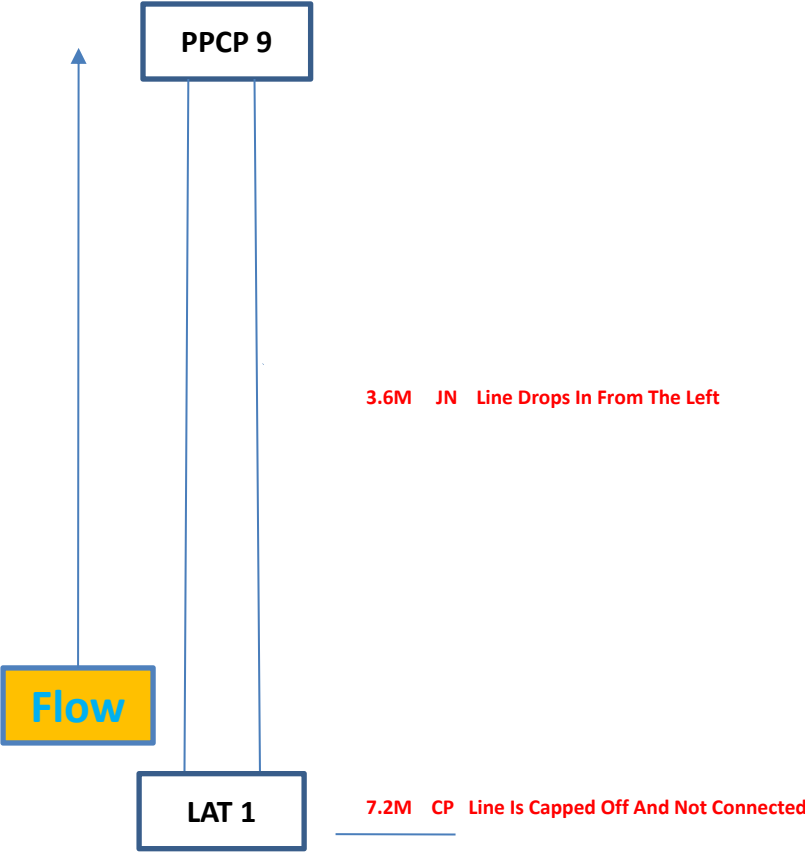
REM ; THERE ARE NO MAJOR DEFECTS WITH THIS SECTION OF PIPE

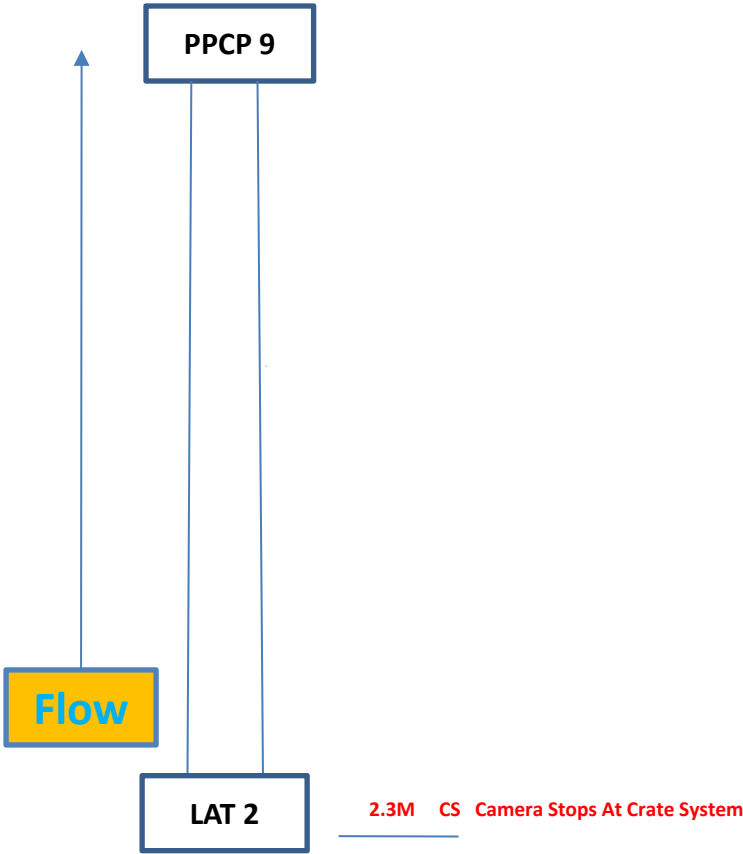
REM ; THERE ARE NO MAJOR DEFECTS WITH THIS SECTION OF PIPE

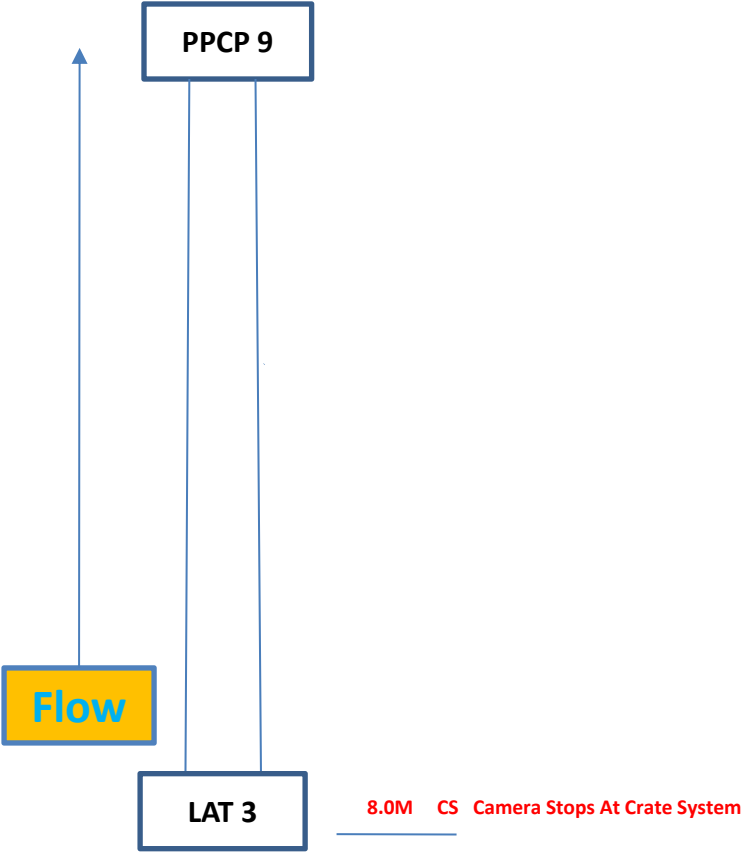
REM ; THERE ARE NO MAJOR DEFECTS WITH THIS SECTION OF PIPE

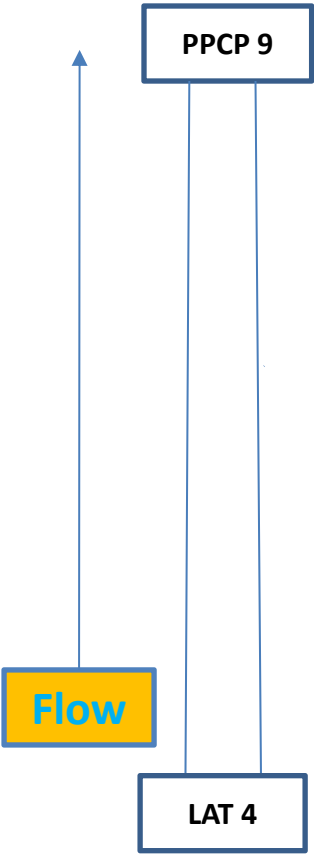
0.0M ST Start Of Survey  
0.0M WL Water Level 0 %  
0.8M JN Line Drops In From The Right

6.7M JN Line Drops In From The Right

10.8M LU Line Turns Up

REM ; THERE ARE NO MAJOR DEFECTS WITH THIS SECTION OF PIPE

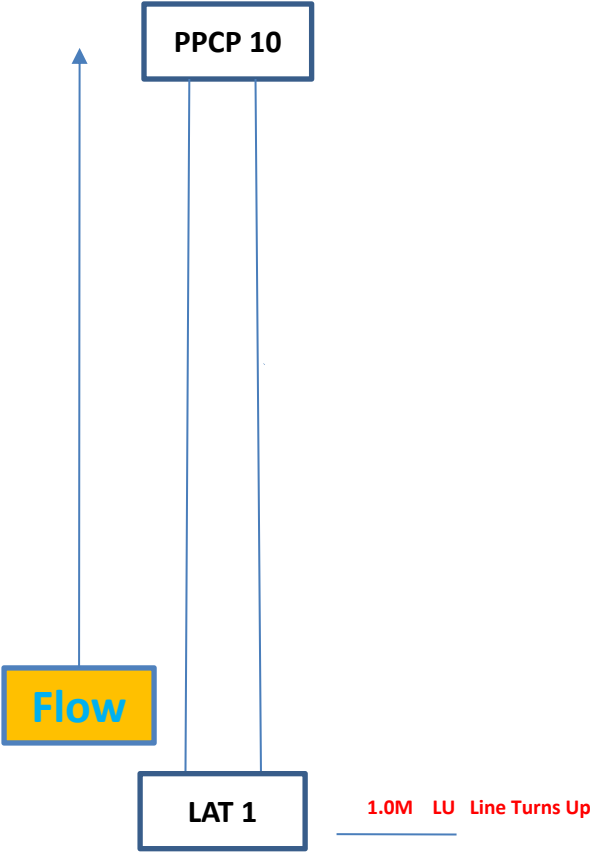
REM ; THERE ARE NO MAJOR DEFECTS WITH THIS SECTION OF PIPE

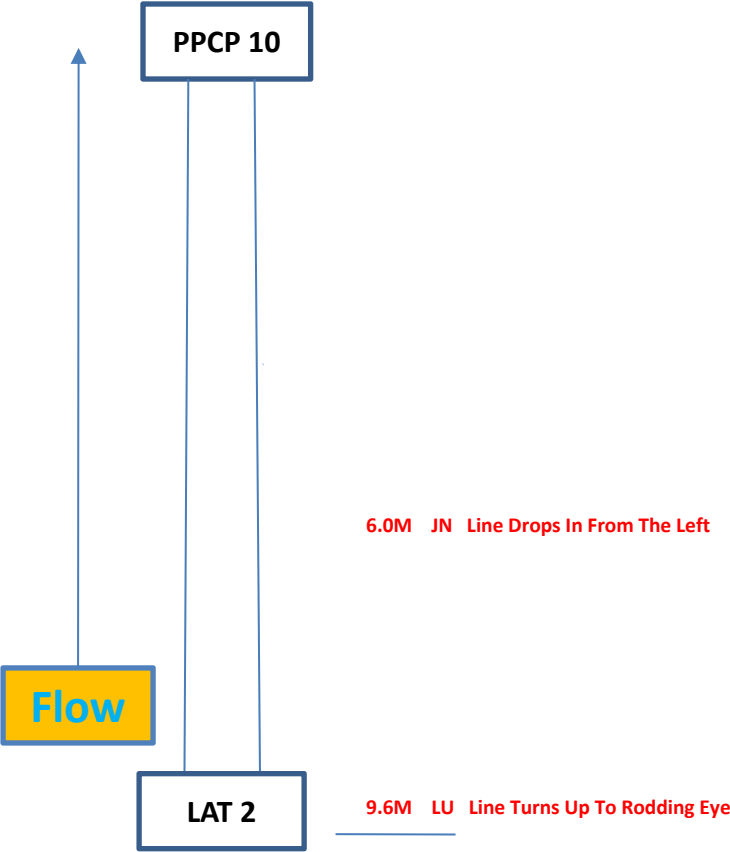
REM ; THERE ARE NO MAJOR DEFECTS WITH THIS SECTION OF PIPE

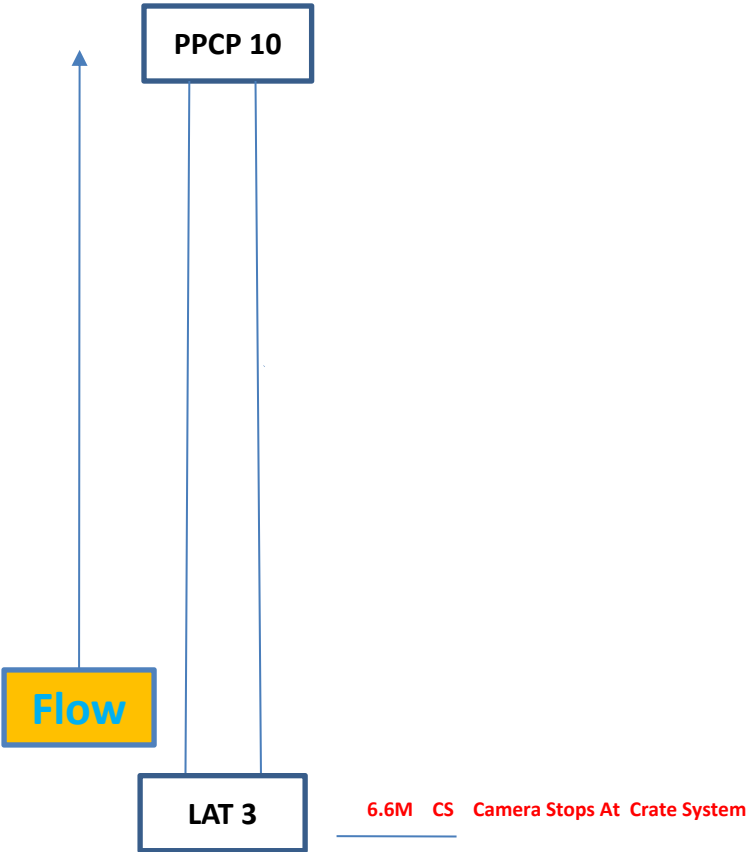
REM ; THERE ARE NO MAJOR DEFECTS WITH THIS SECTION OF PIPE

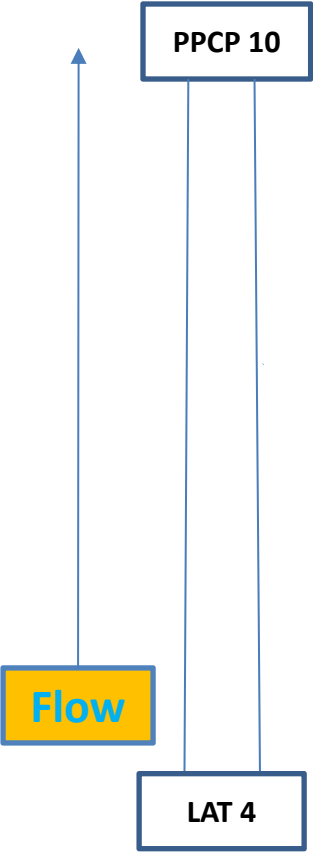
4.2M JN Line Drops In From The Left

5.7M JN Line Drops In From The Right

REM ; THERE ARE NO MAJOR DEFECTS WITH THIS SECTION OF PIPE

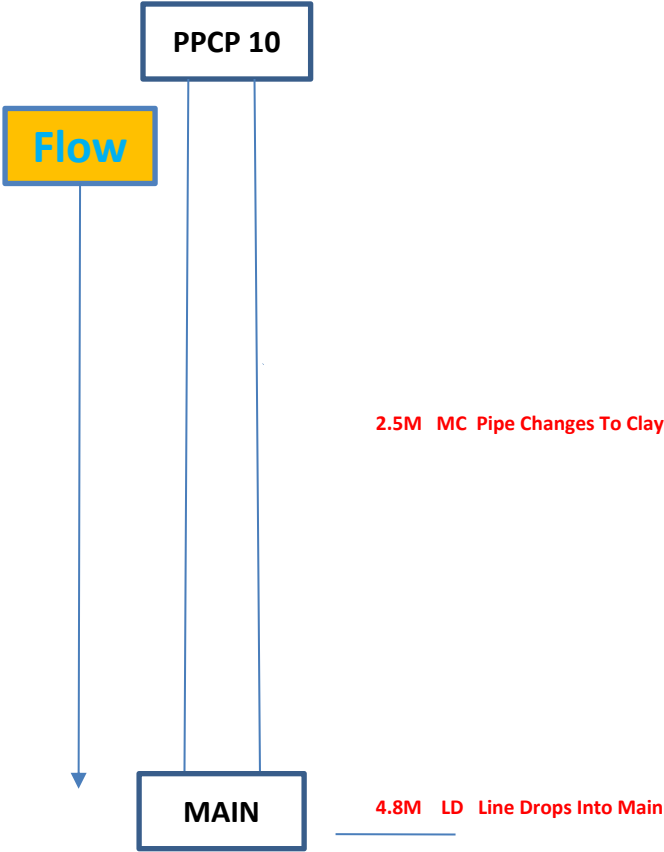
REM ; THERE ARE NO MAJOR DEFECTS WITH THIS SECTION OF PIPE

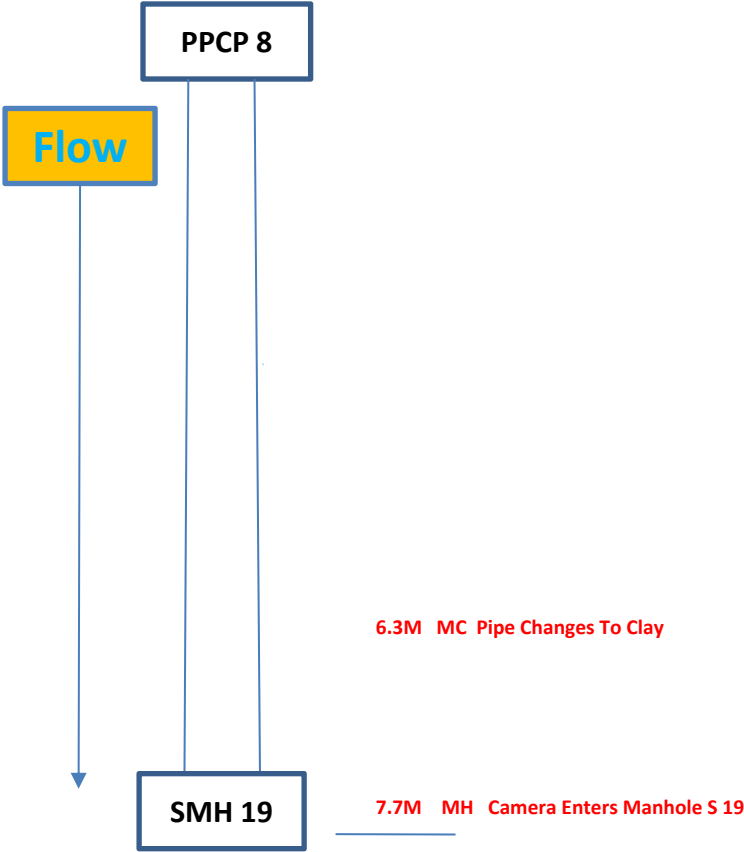
REM ; THERE ARE NO MAJOR DEFECTS WITH THIS SECTION OF PIPE

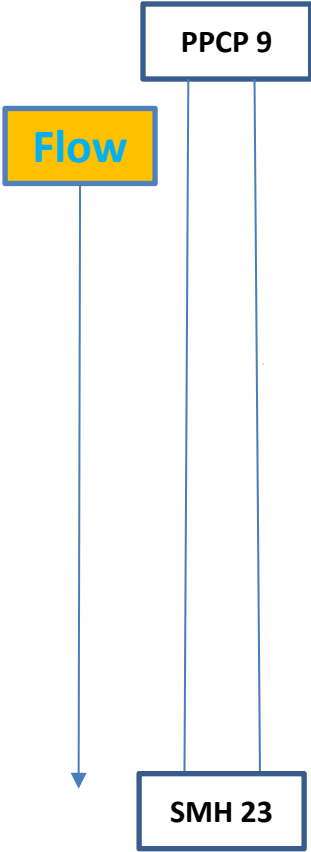
4.4M MC Pipe Changes To Clay

12.0M MH Camera Enters Manhole S 23

REM ; THERE ARE NO MAJOR DEFECTS WITH THIS SECTION OF PIPE

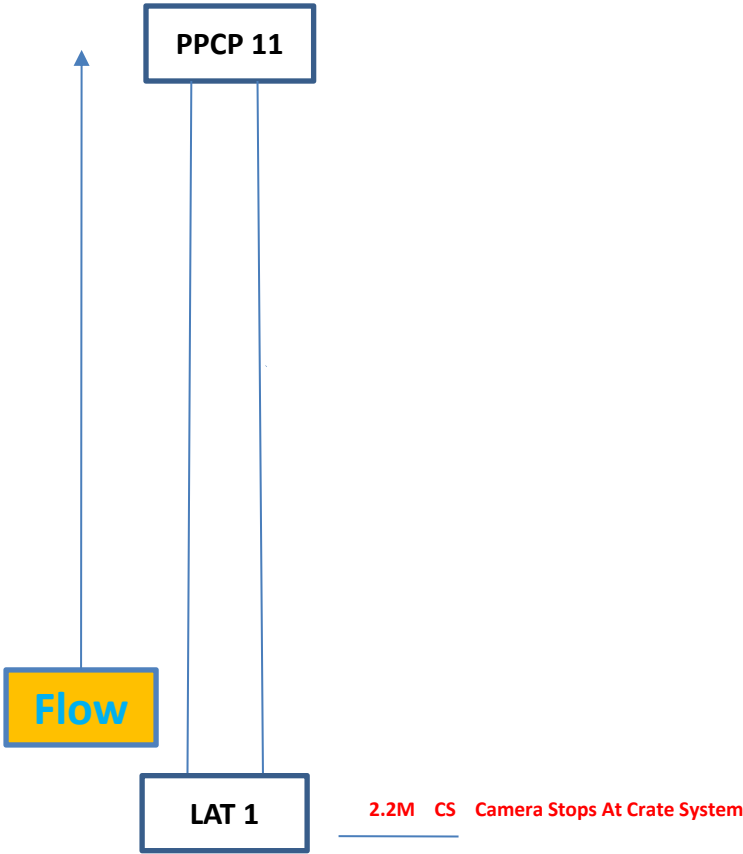
REM ; THERE ARE NO MAJOR DEFECTS WITH THIS SECTION OF PIPE

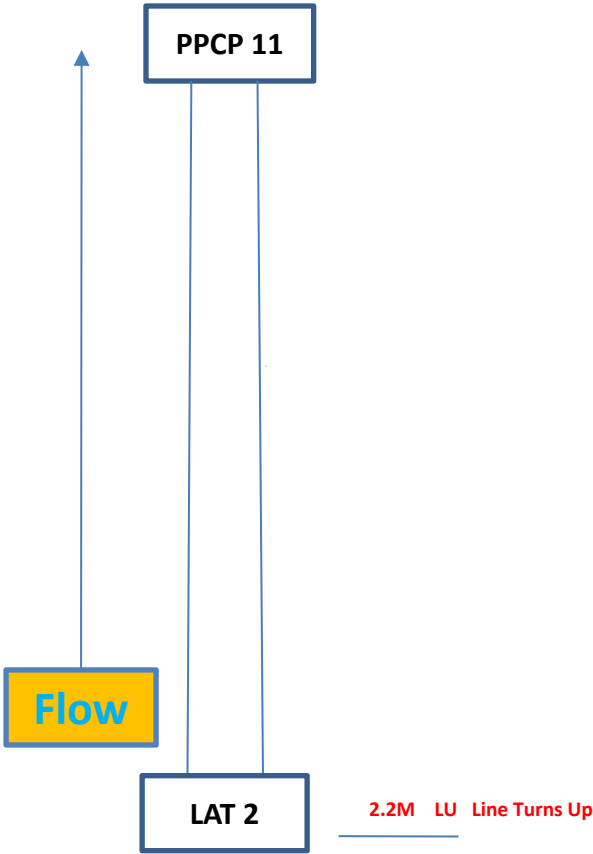
REM ; THERE ARE NO MAJOR DEFECTS WITH THIS SECTION OF PIPE

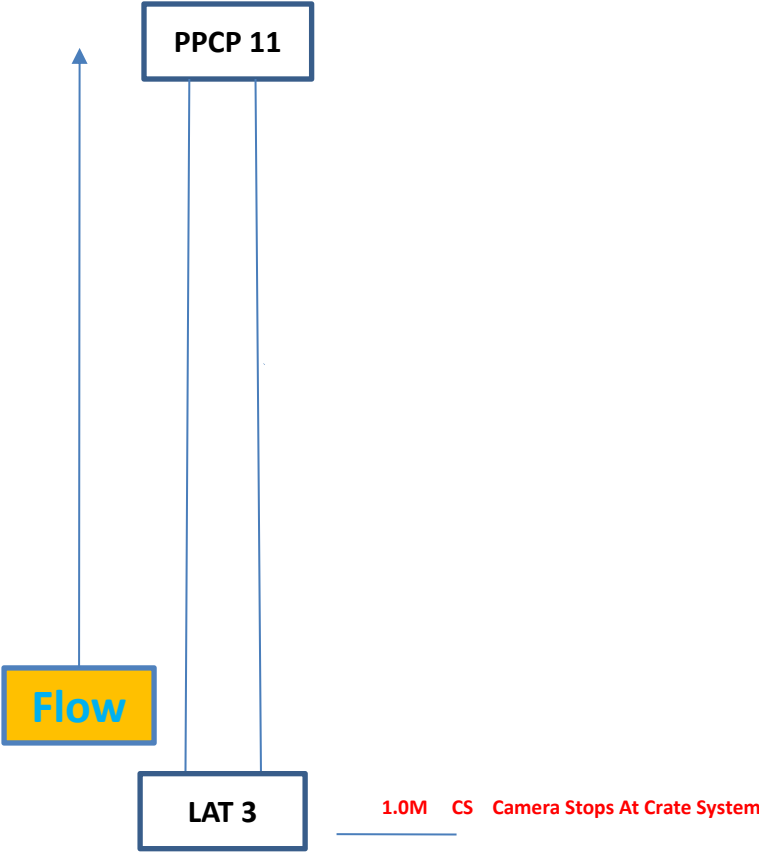
REM ; THERE ARE NO MAJOR DEFECTS WITH THIS SECTION OF PIPE

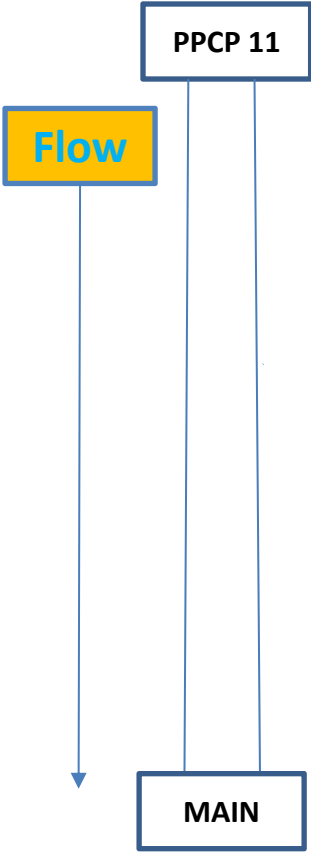
1.6M MC Pipe Changes To Clay

9.0M LD Line Drops Into Main

REM ; THERE ARE NO MAJOR DEFECTS WITH THIS SECTION OF PIPE

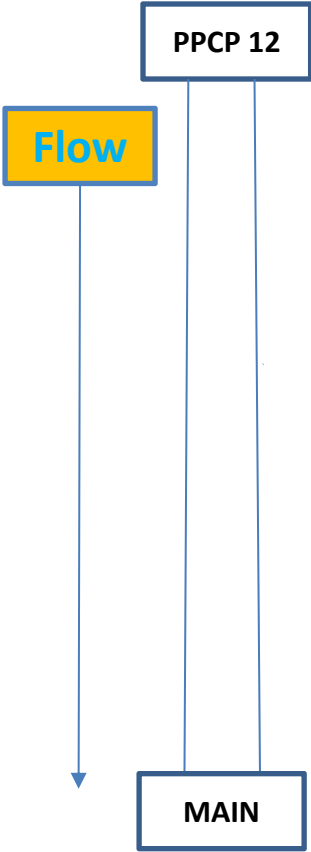
1.8M MC Pipe Changes To Clay

REM ; THERE ARE NO MAJOR DEFECTS WITH THIS SECTION OF PIPE

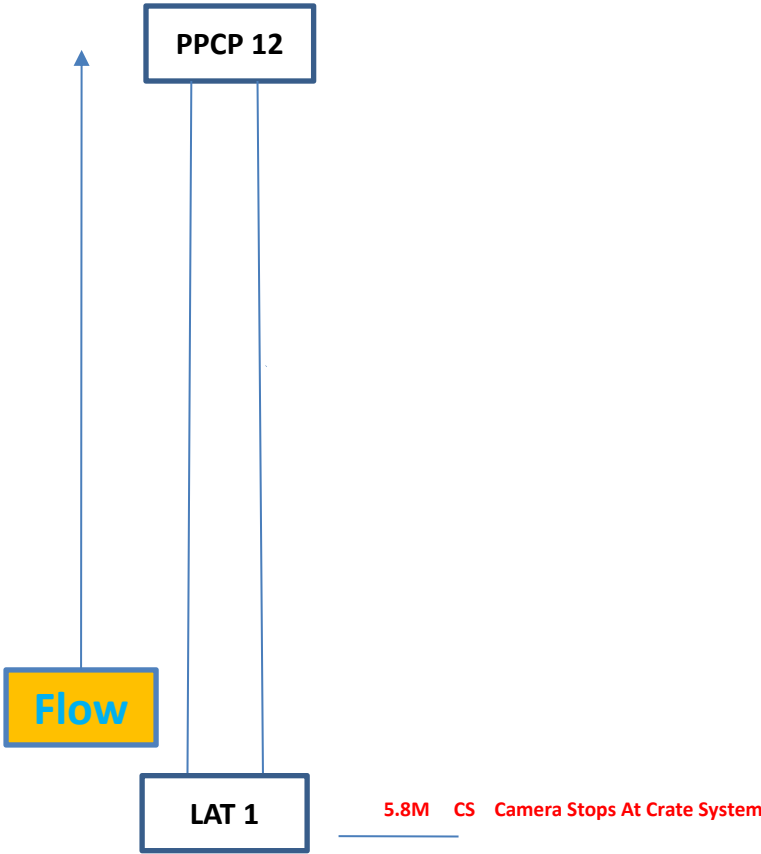
REM ; THERE ARE NO MAJOR DEFECTS WITH THIS SECTION OF PIPE

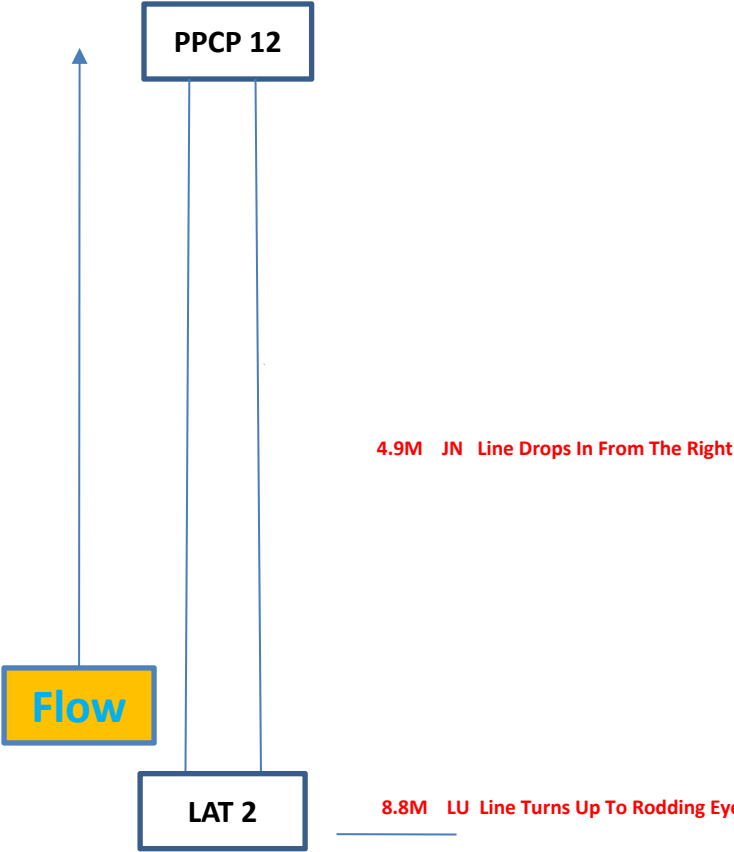
REM ; THERE ARE NO MAJOR DEFECTS WITH THIS SECTION OF PIPE

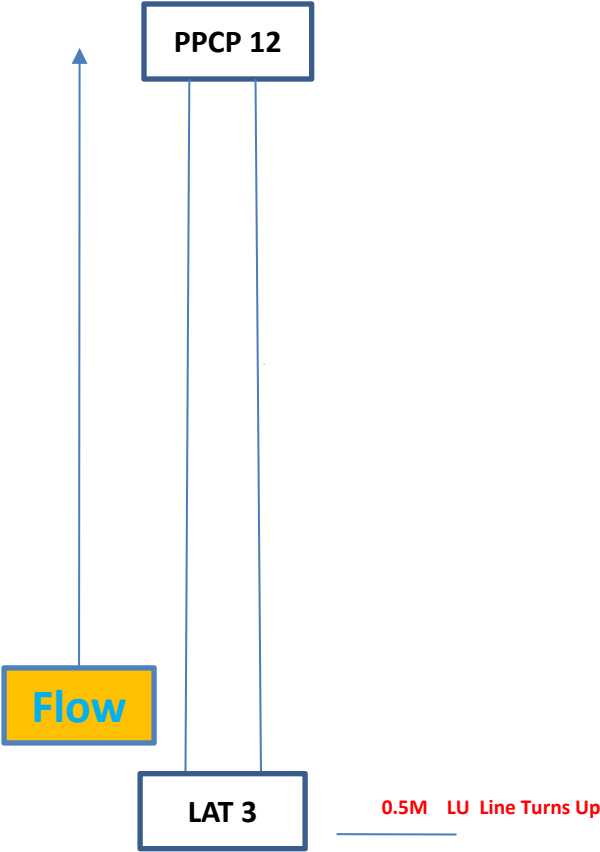
REM ; THERE ARE NO MAJOR DEFECTS WITH THIS SECTION OF PIPE

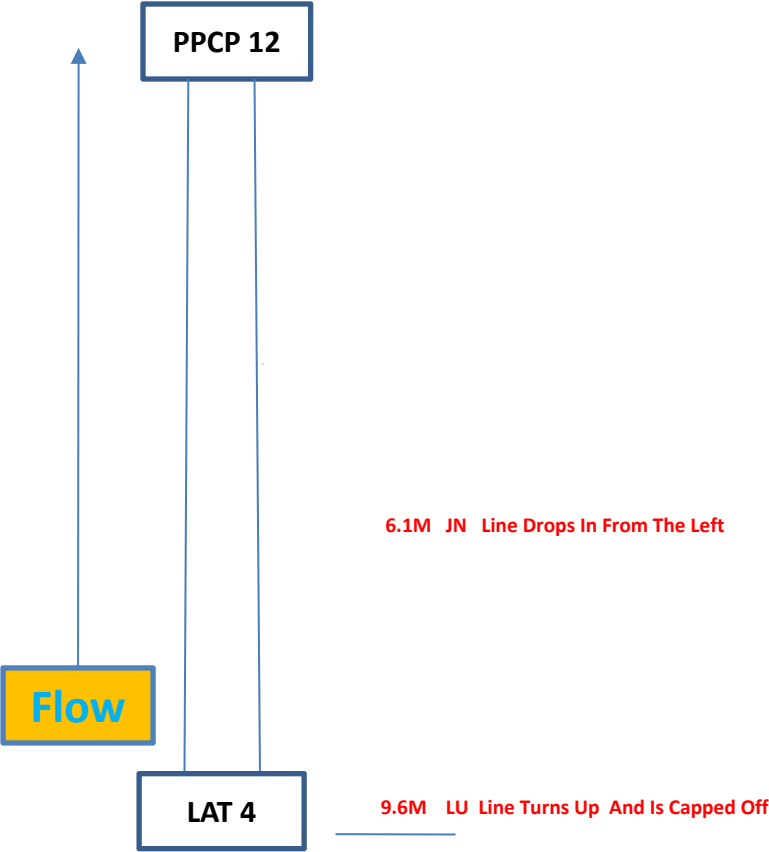
REM ; THERE ARE NO MAJOR DEFECTS WITH THIS SECTION OF PIPE

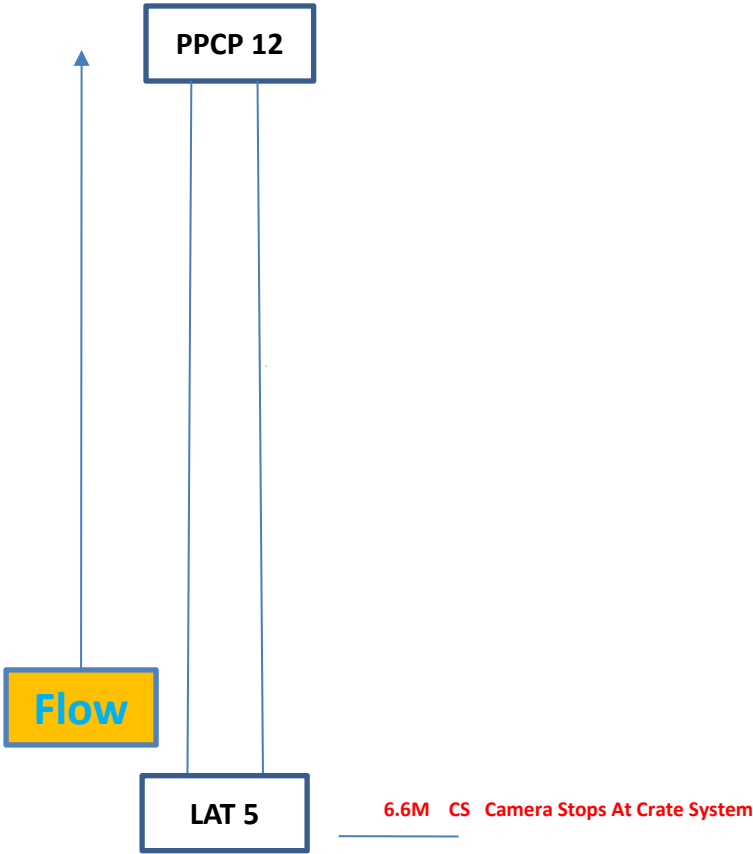
REM ; THERE ARE NO MAJOR DEFECTS WITH THIS SECTION OF PIPE

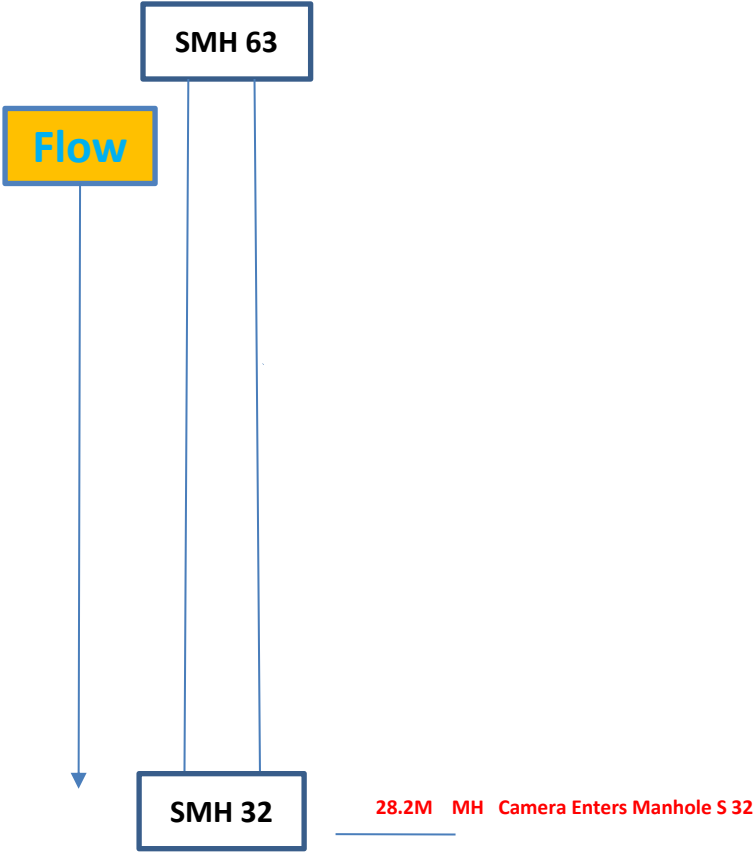
REM ; THERE ARE NO MAJOR DEFECTS WITH THIS SECTION OF PIPE

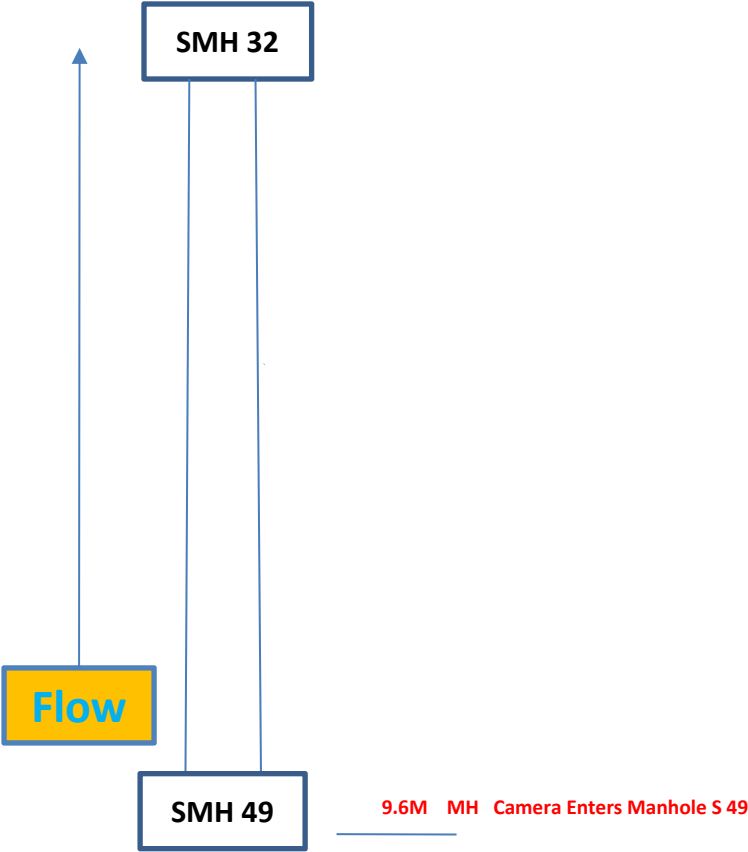
REM ; THERE ARE NO MAJOR DEFECTS WITH THIS SECTION OF PIPE

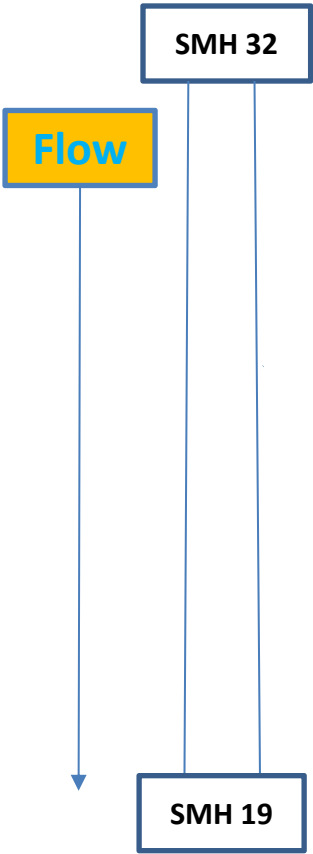
15.1M JN Line Drops In From The Right

28.2M MH Camera Enters Manhole S 19

REM ; THERE ARE NO MAJOR DEFECTS WITH THIS SECTION OF PIPE

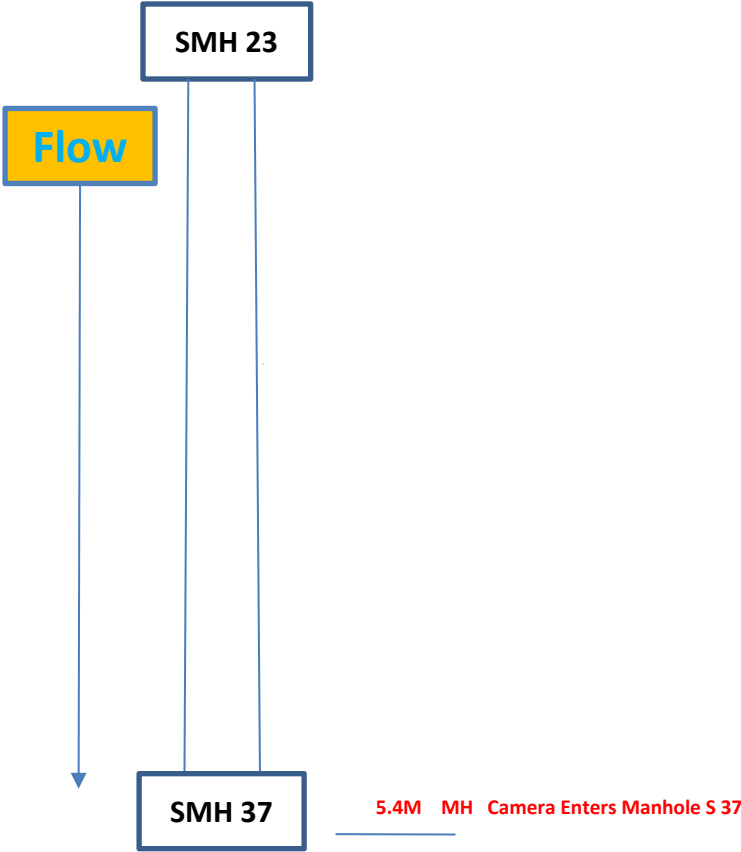
REM ; THERE ARE NO MAJOR DEFECTS WITH THIS SECTION OF PIPE

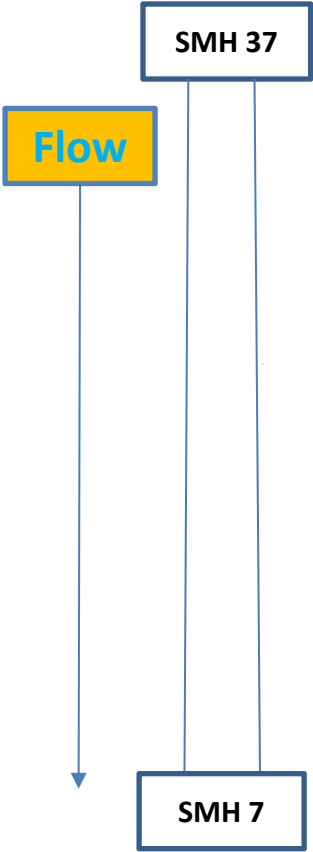
12.5M JN Line Drops In From The Left  
19.9M JN Line Drops In From The Right  
32.5M JN Line Drops In From The Left  
47.5M JN Line Drops In From The Right  
50.0M JN Line Drops In From The Left

66.1M MH Camera Enters Manhole S 7

REM ; THERE ARE NO MAJOR DEFECTS WITH THIS SECTION OF PIPE
