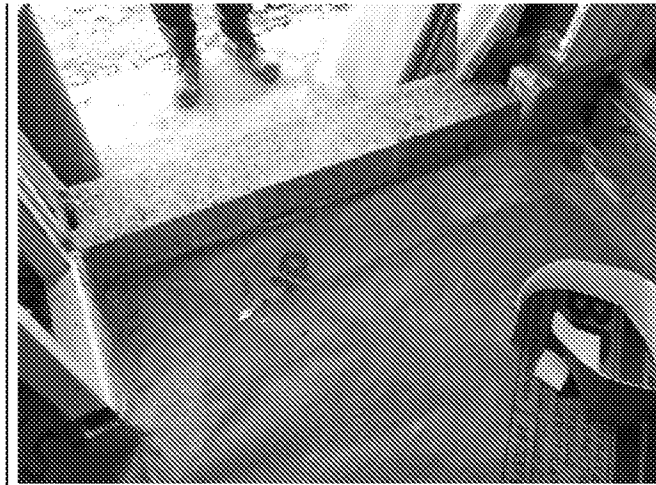
Plot 41 - Threshold

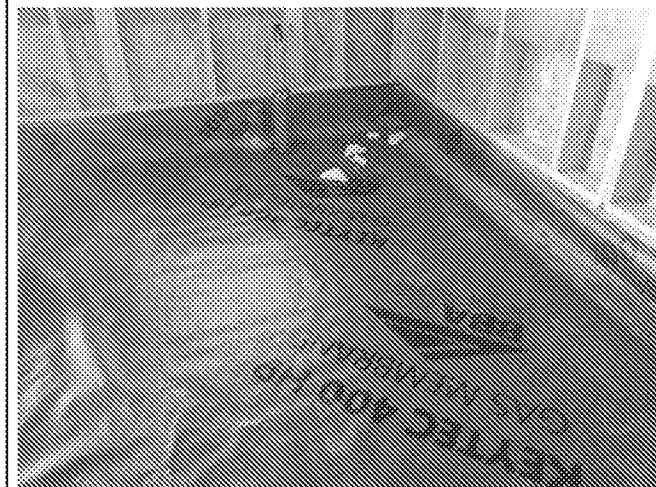
Plot 41 - Floor and services sealed

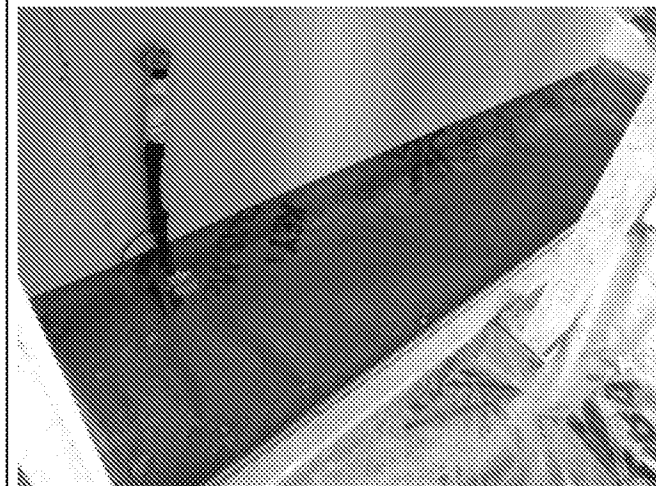
Plot 41 - under stairs sealed

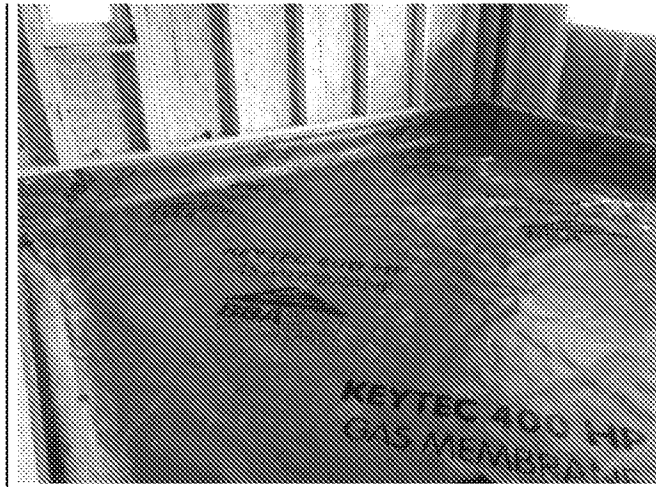
Plot 41 - floors sealed

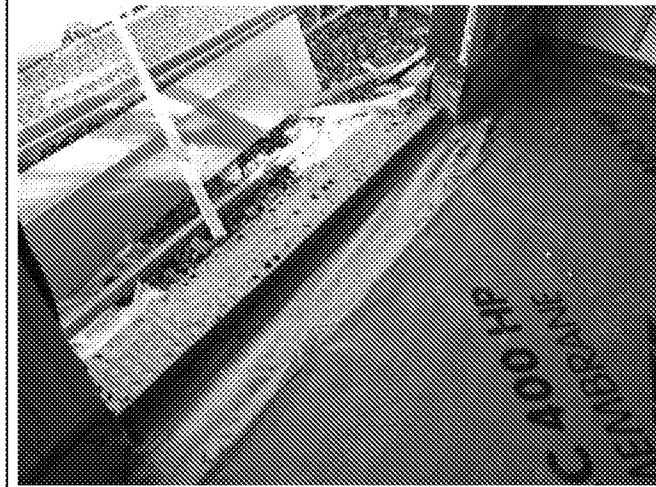
Plot 41 - Threshold

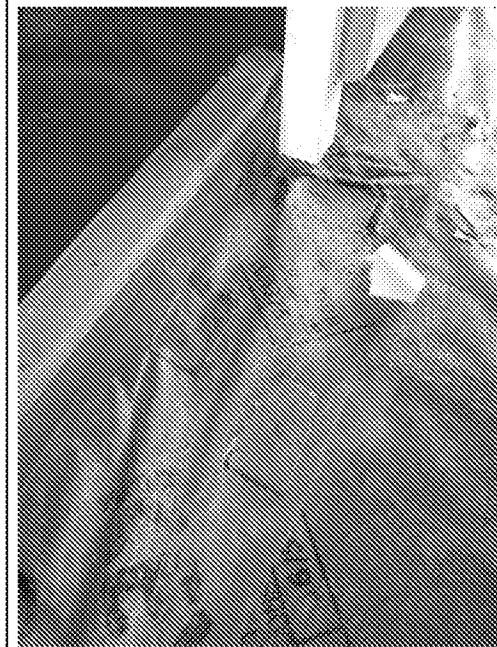
Plot 41 - Holes patched during inspection

| 1.6 Laps, welds and joints seals | All joins, welds and seals heat sealed and well sealed. A few holes/damage identified during visit, ut were repaired in the presence of the engineer. |

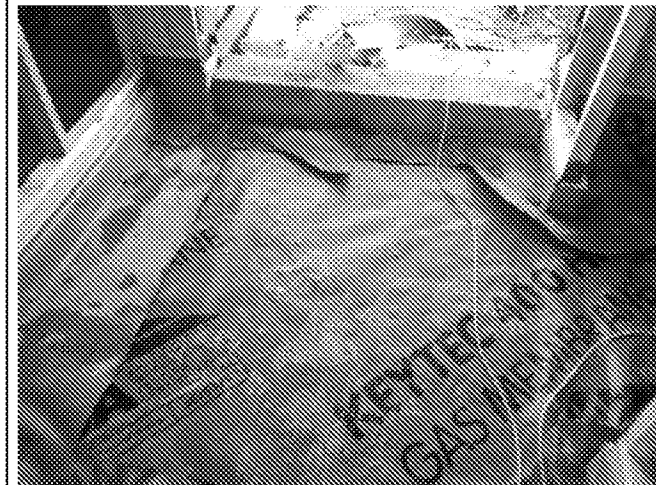
Plot 42 - Floor in progress

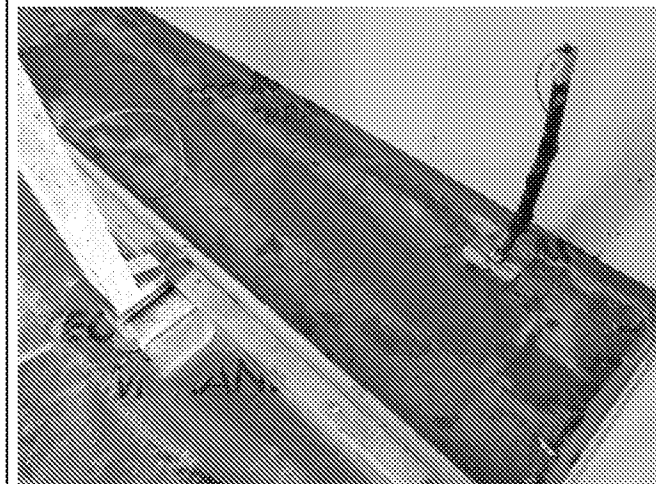
Plot 42 - under stairs sealed

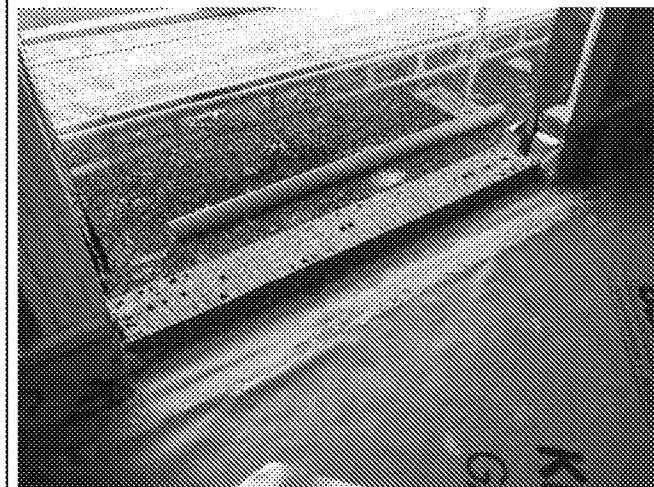
Plot 42 - Threshold sealed

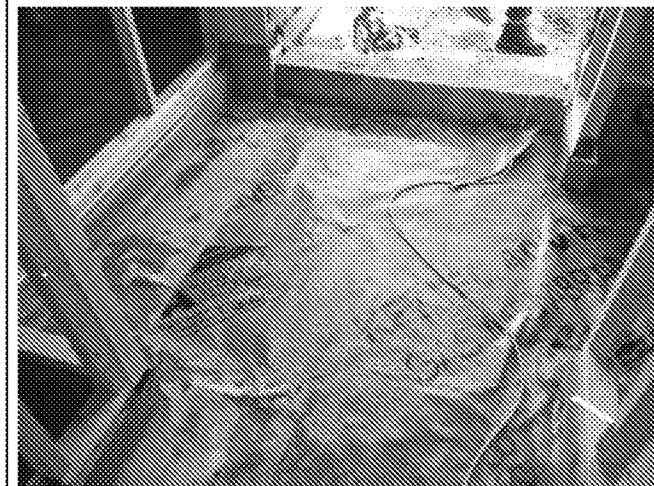
Plot 42 - Floor completed during visit

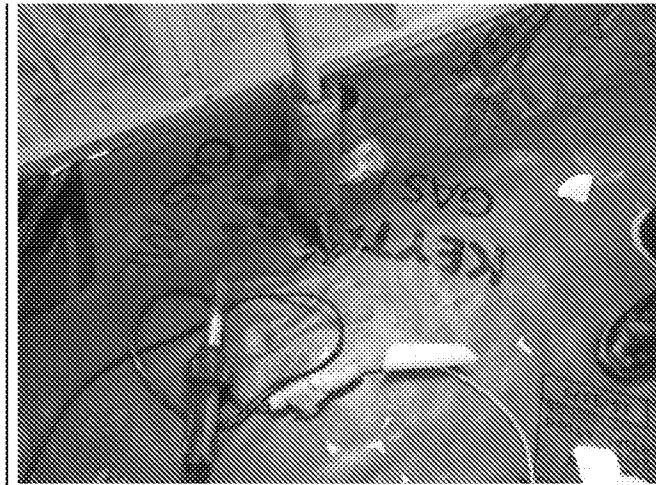
Plot 42 - service seals completed during inspection

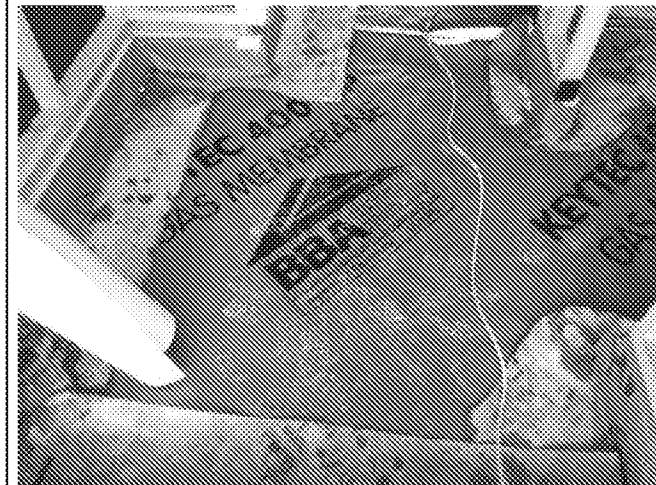
Plot 43 - in progress

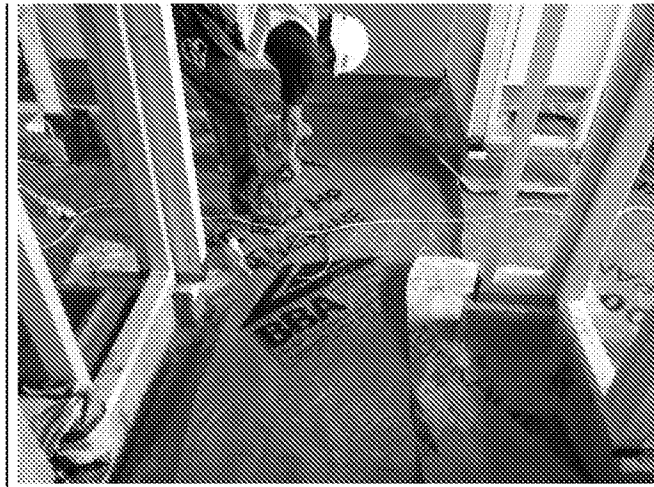
Plot 43 - in progress

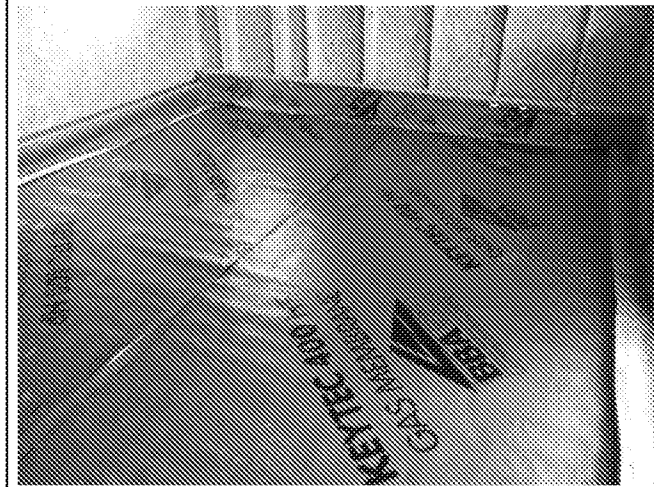
Plot 43 - in progress

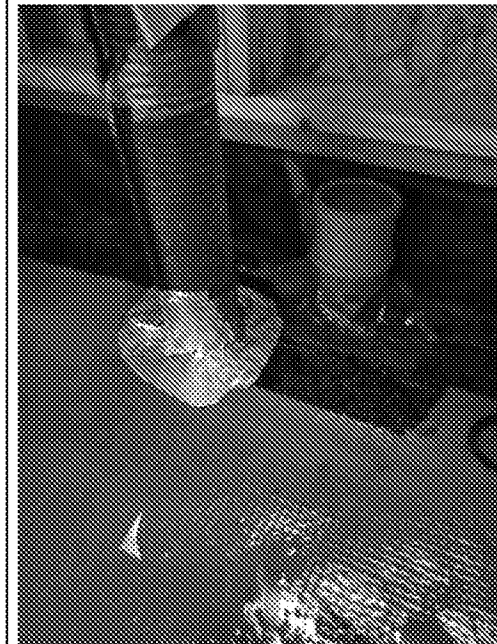
Plot 34 services

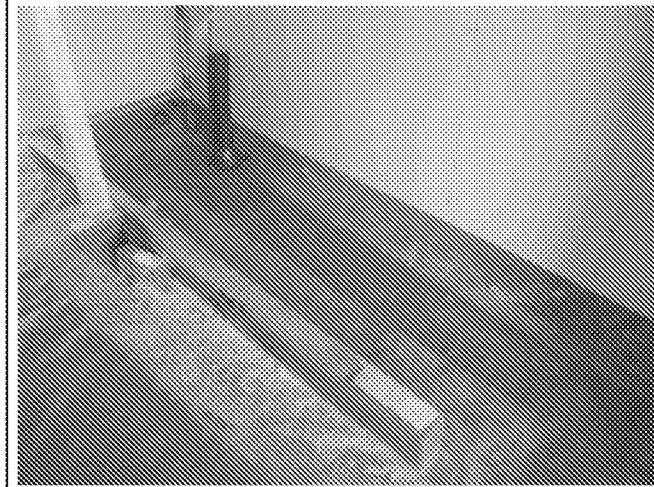
Plot 31 - Under stairs

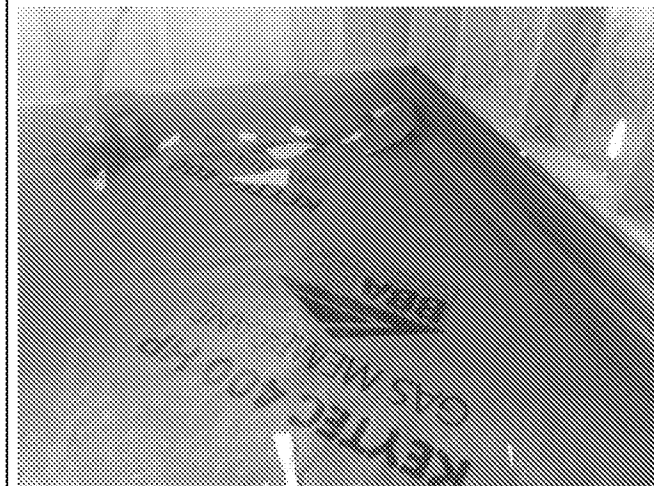
Plot 31 - Floor and service seals

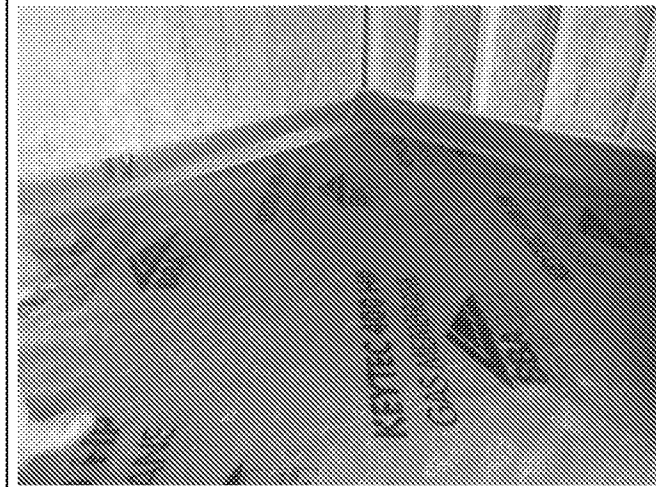
Plot 31 - Floor

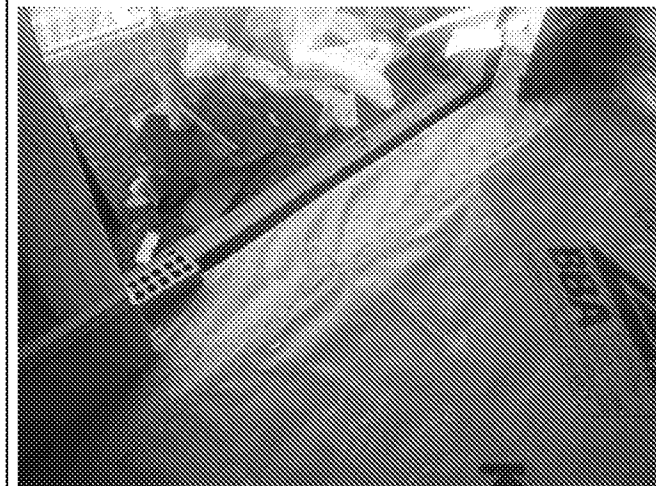
Plot 31 - Threshold

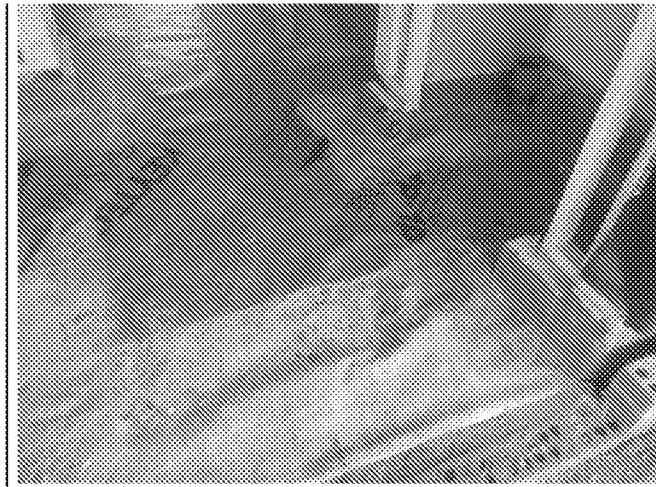
Plot 30 - Threshold

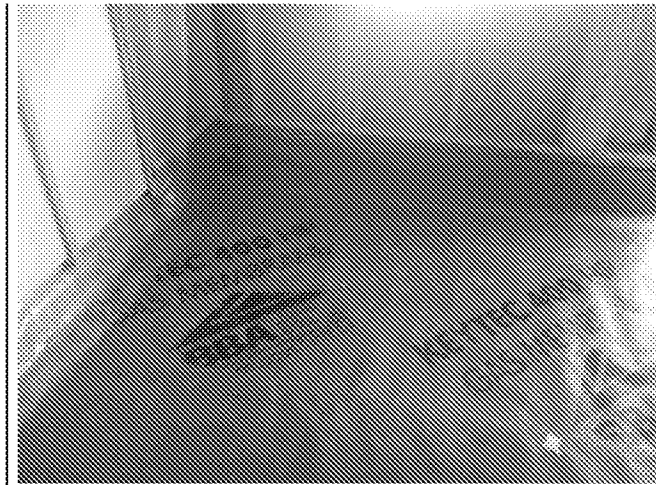
Plot 30 - Floor

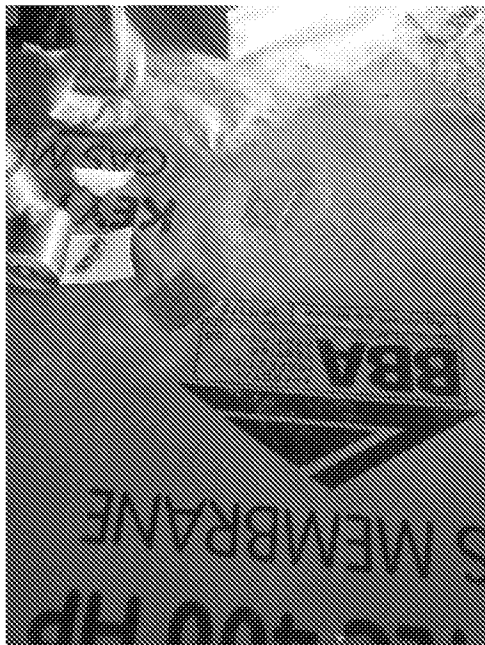
| 1.1 Condition of sub-grade and underside of membrane | Underside of membrane unable to be inspected as fully sealed. Gravel removed from some areas of subgrade and membrane subsequently patched up in Plots 28 and 30. |

Plot 30 - Patching after removal of debris under membrane

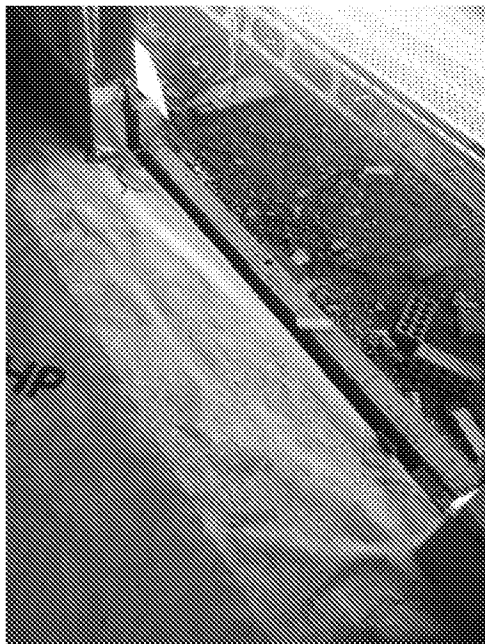
Plot 30 - Threshold

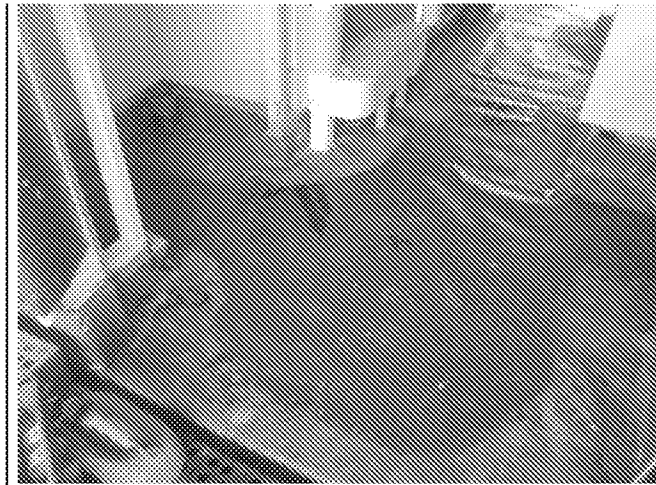
Plot 29 - Threshold and entrance hallway

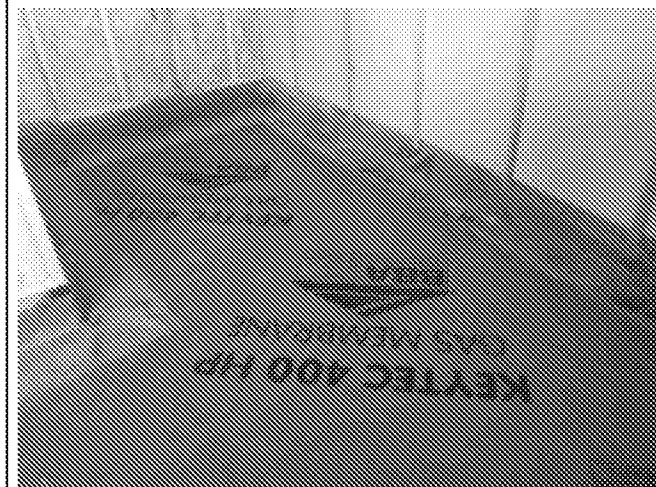
Plot 29 - Floor

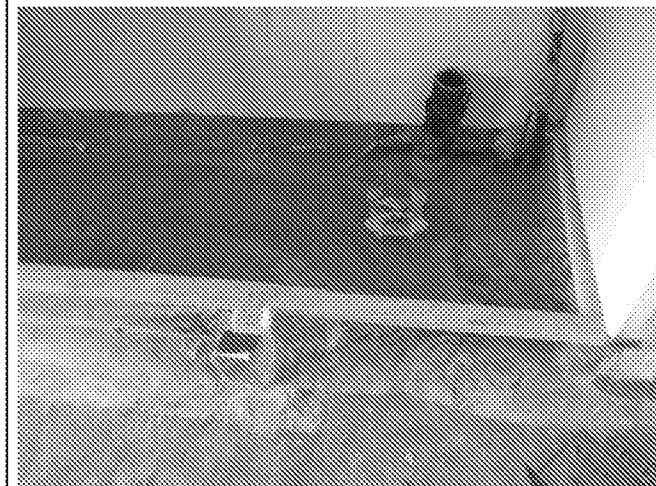
Plot 29 - Under stairs

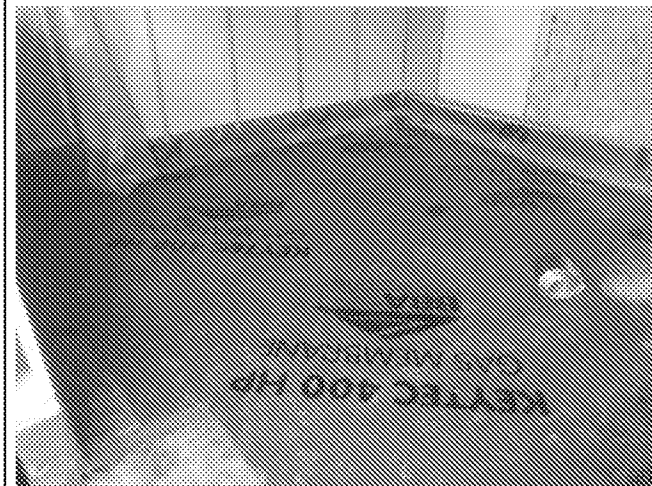
Plot 29 - Floor with some patching

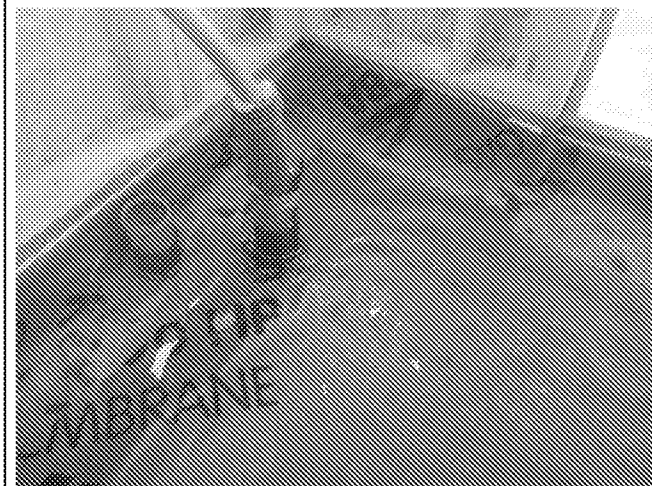
Plot 28 - Service seals

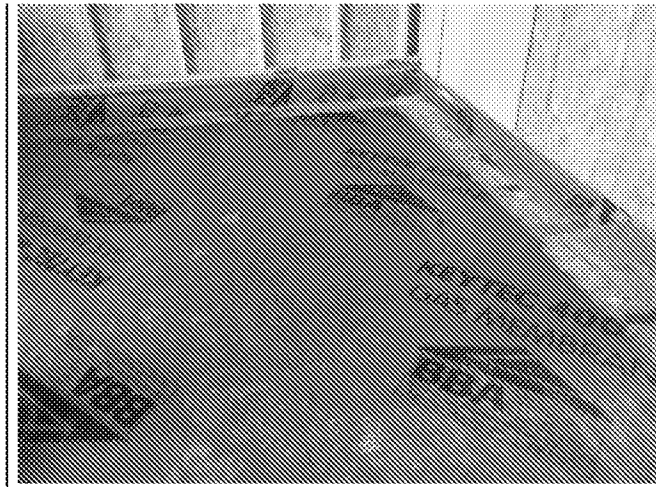
Plot 28 - Floor

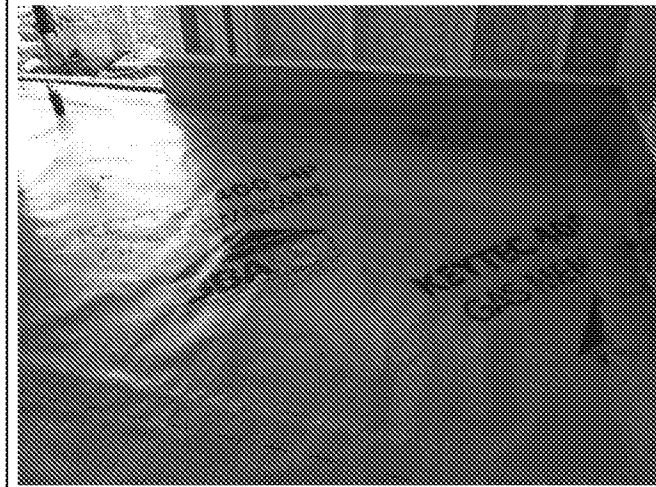
Plot 28 - Floor with patching after removal of debris from under membrane

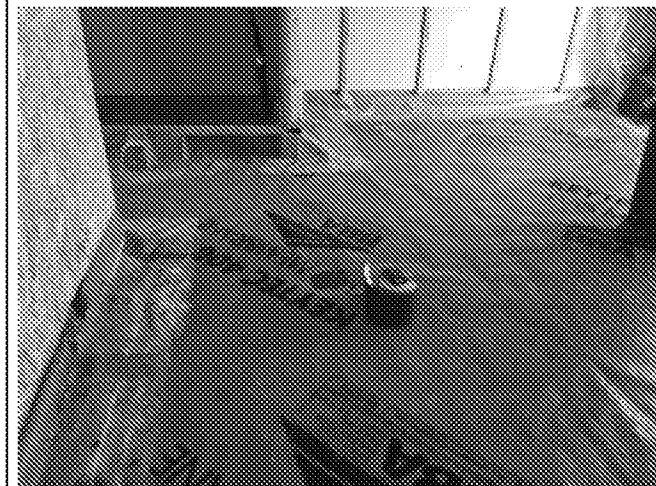
Pot 28 - Floor with some patching

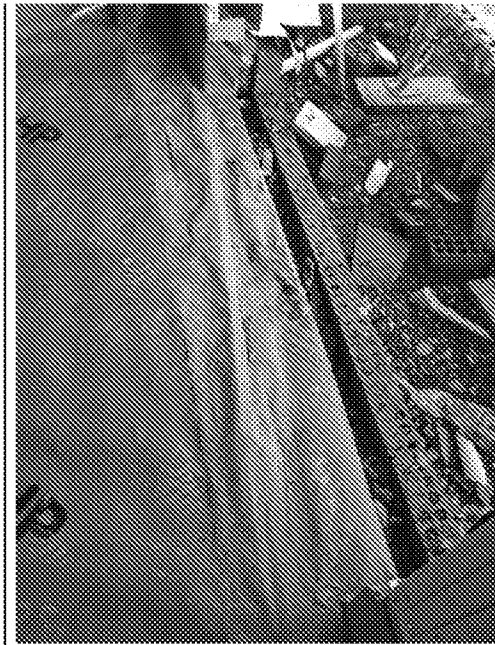
Plot 28 - Threshold with some patching

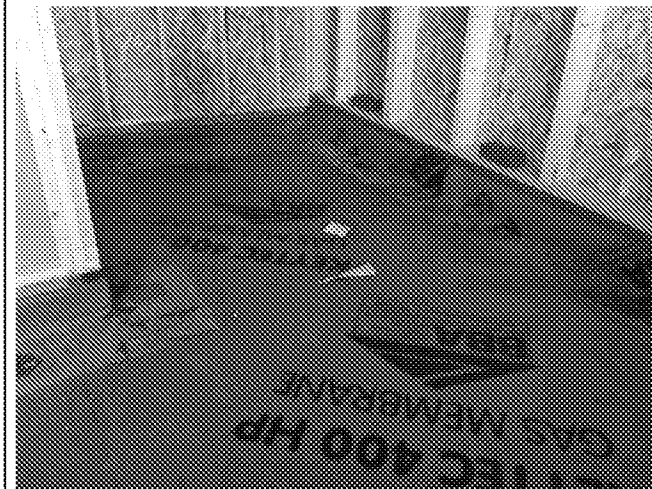
Plot 28 - Floor

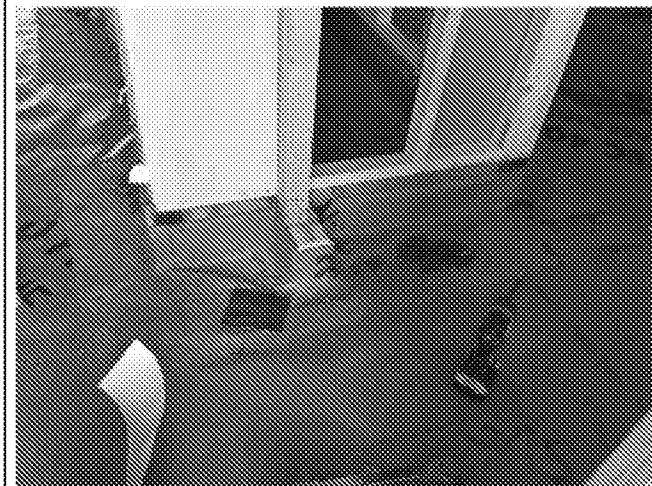
Plot 28 - Floor with patching after removal of debris from under membrane

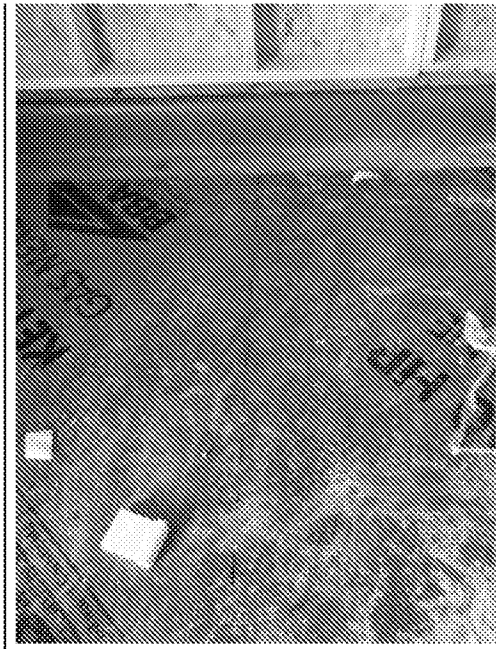
Plot 24 membrane join

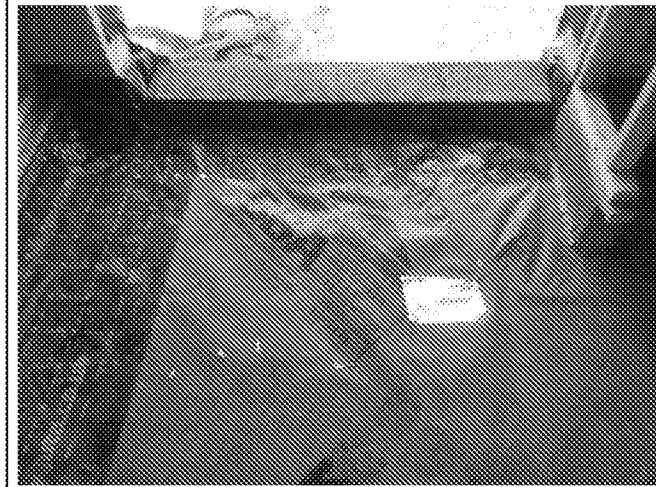
Plot 18 - Patching

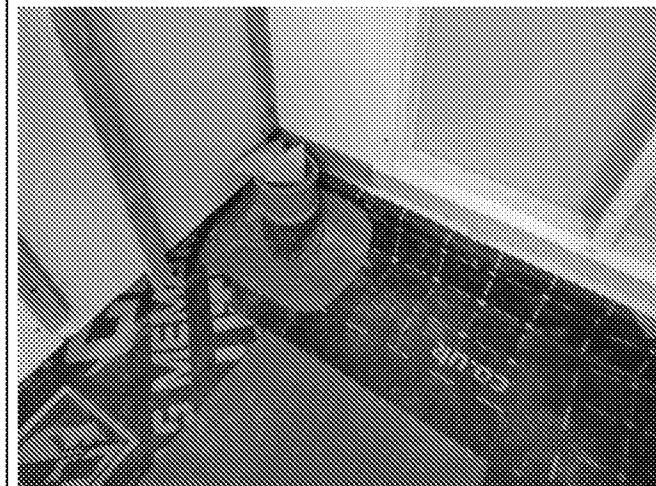
Plot 18 - service seal

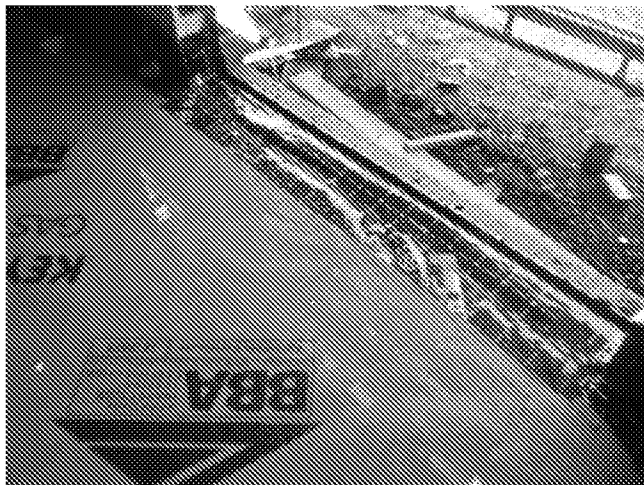
Plot 19 - Threshold

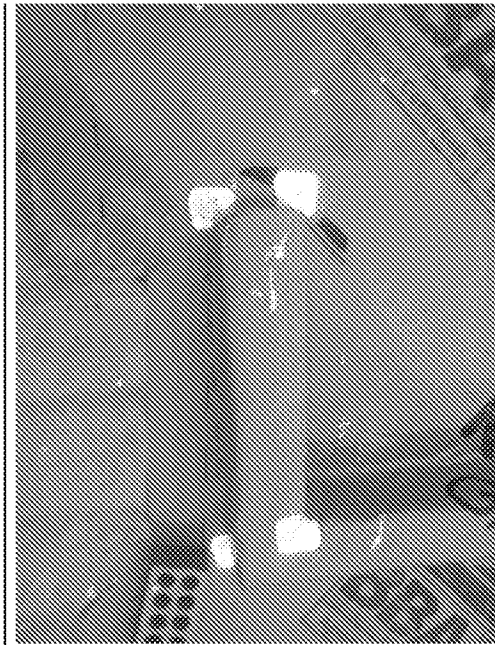
Plot 52-53 perimeter corner detail

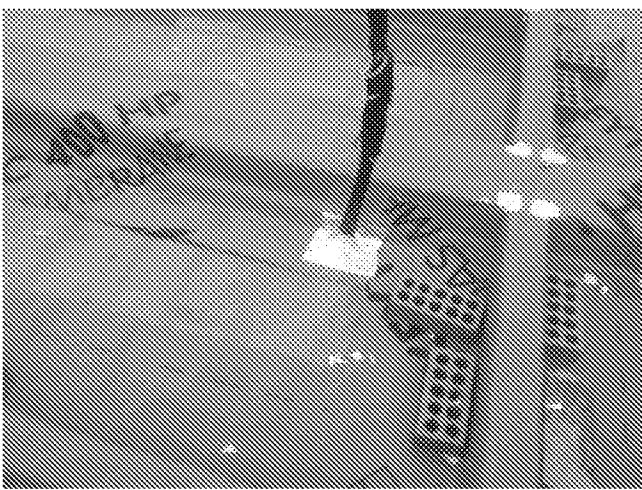
| | <p>Plot 52-53 perimeter services sealed</p> |

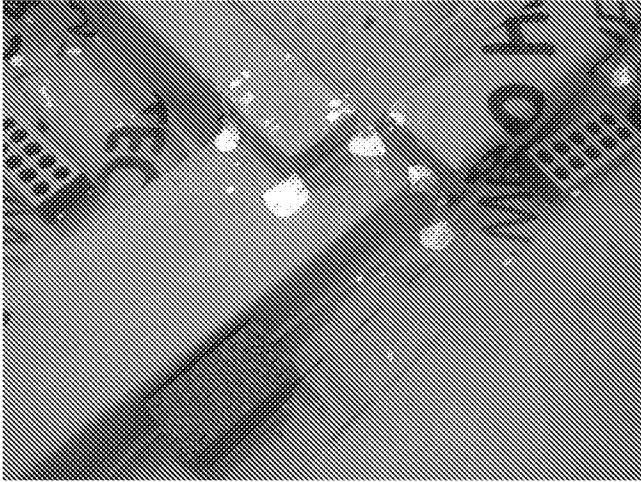
Plot 58-59 perimeter service seal

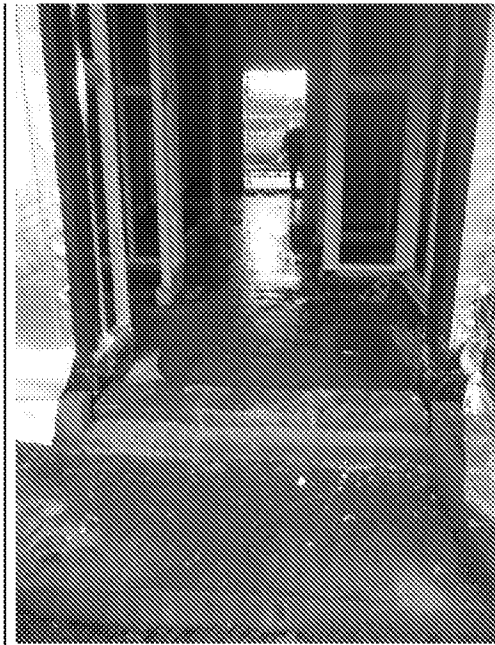
Plot 20 prior to install. Concrete slab in good condition.

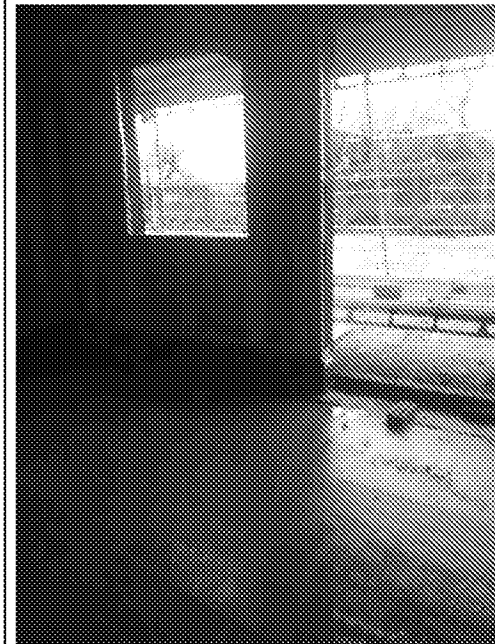
Plot 21 prior to install concrete slab in good condition.

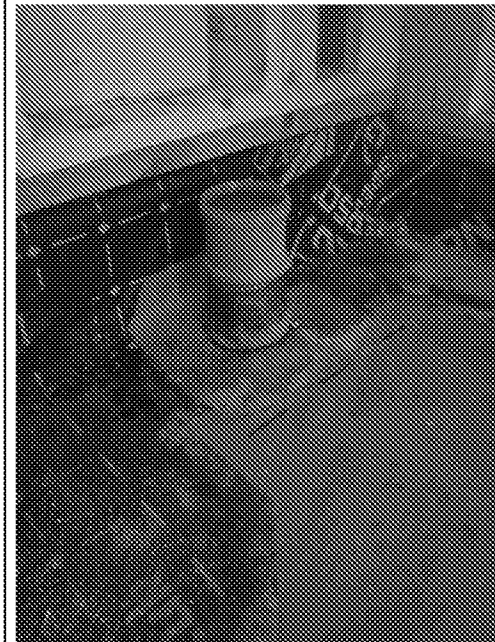
Plot 20 - sealed foul outlet WC

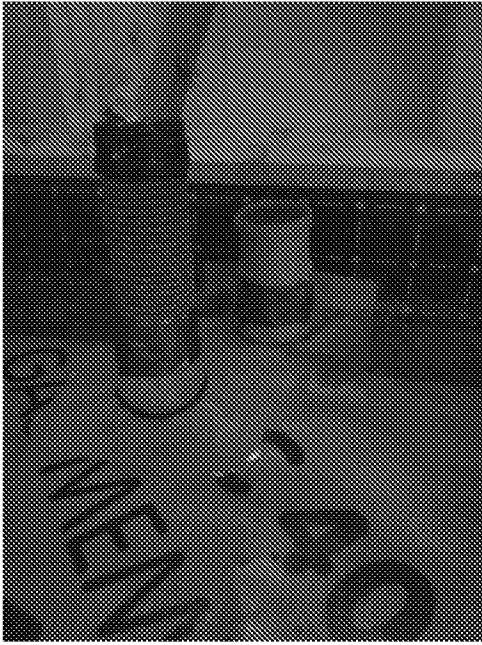
Plot 20 - sealed water in & foul outlet  
Kitchen

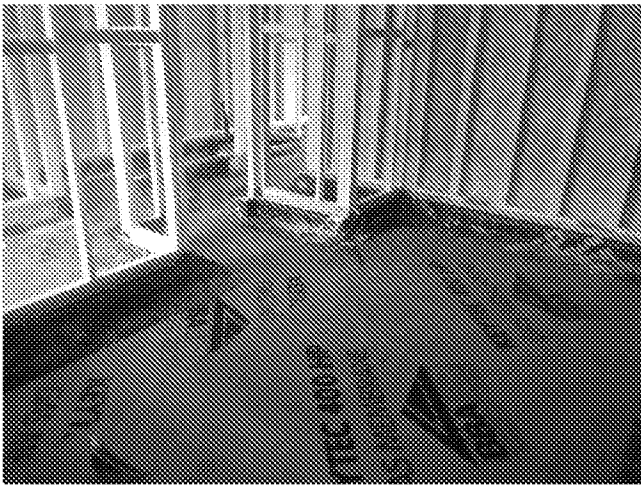
Plot 20 - front of property all good.

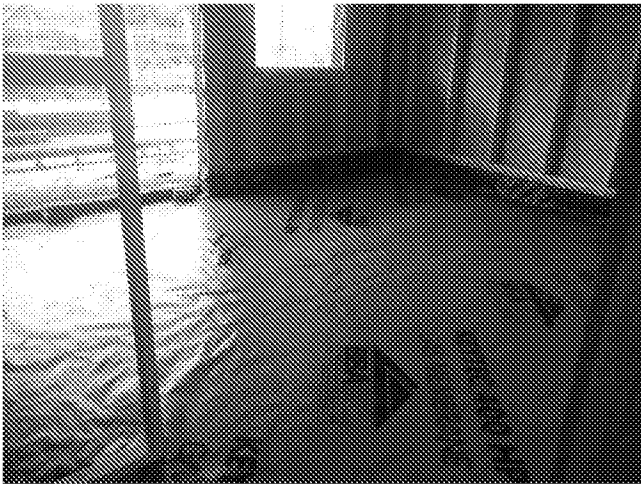
Plot 20 - rear of property all good.

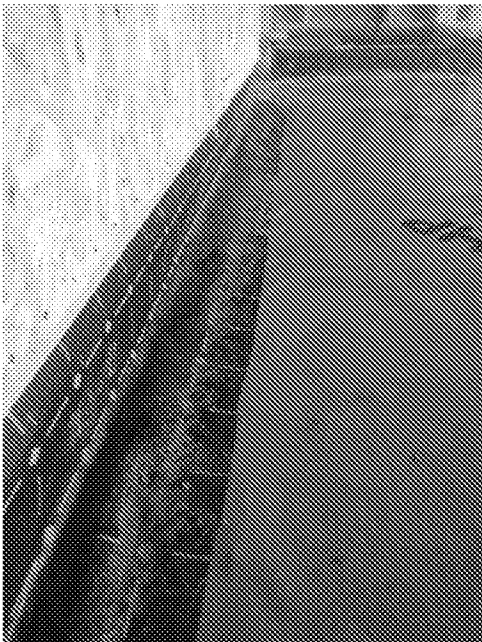
Plot 20 - perimeter seals all good.

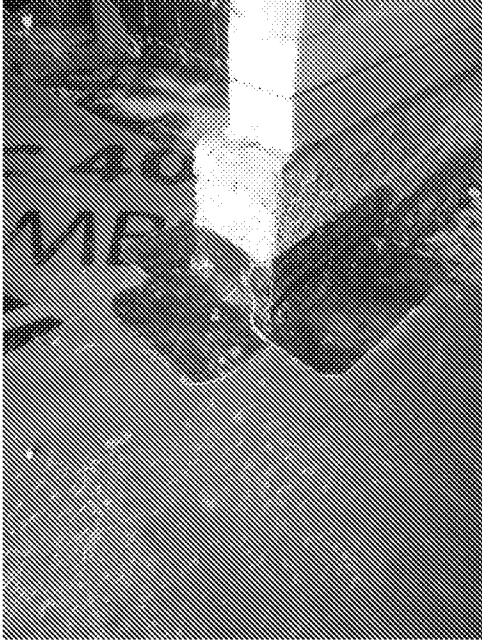
Plot 20 - tape well sealed

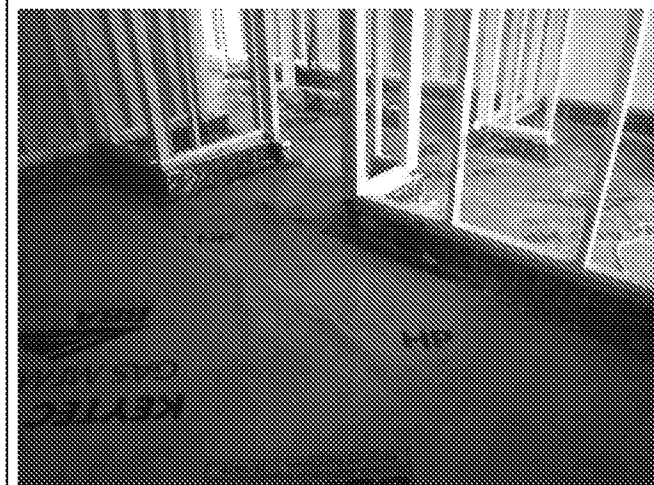
Plot 21 - front of property all good.

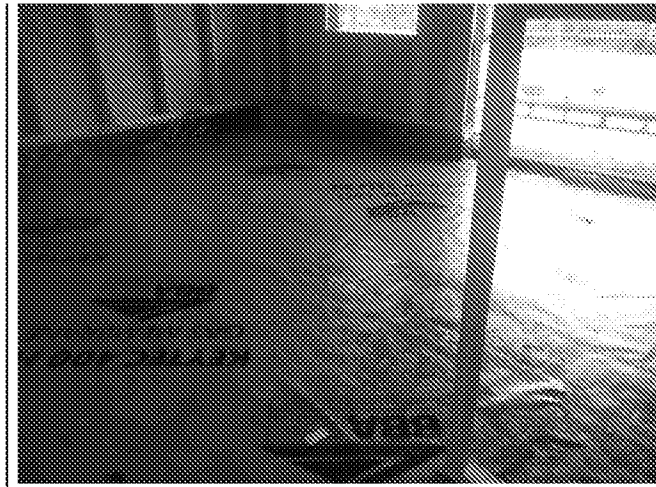
Plot 21 - rear of property all good.

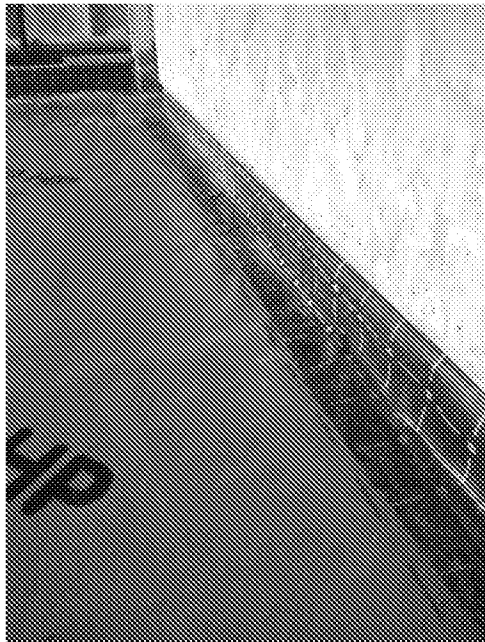
Plot 21 - perimeter well sealed.

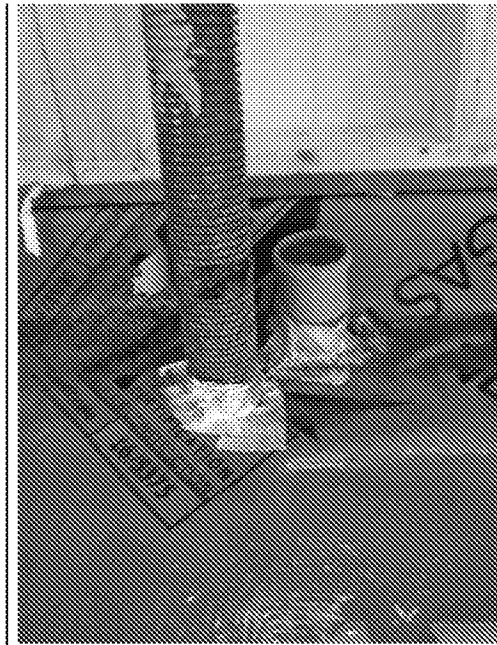
Plot 22 services

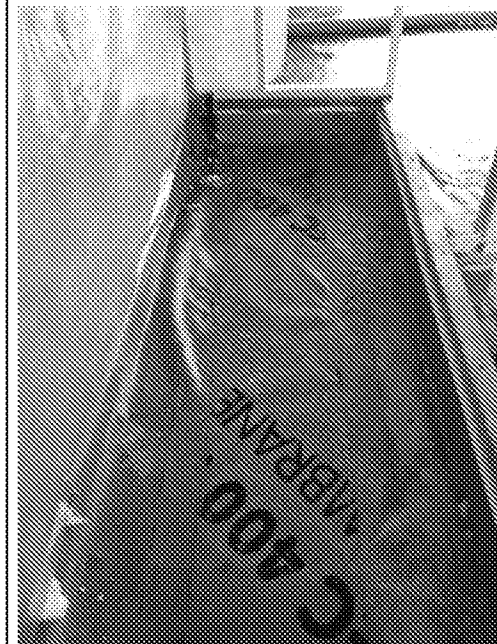
Plot 22 understair detail

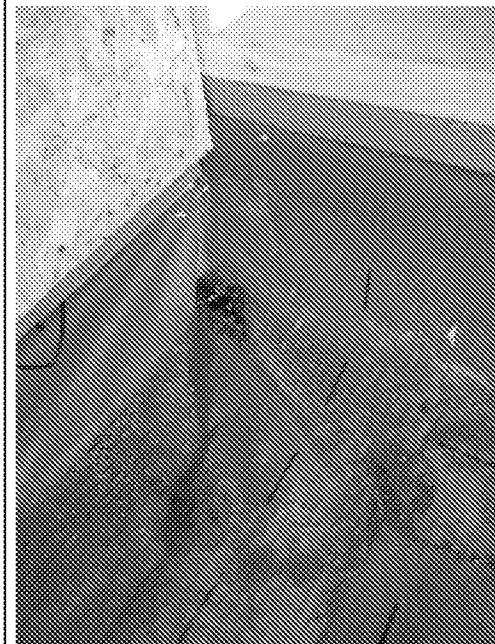
Plot 23 corner detail

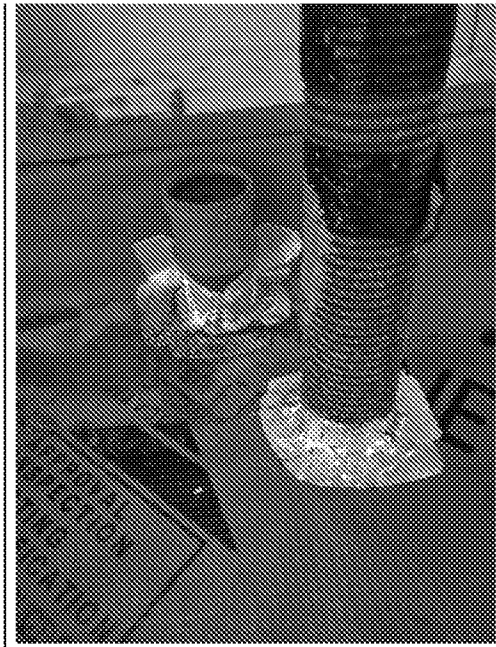
Plot 23 services

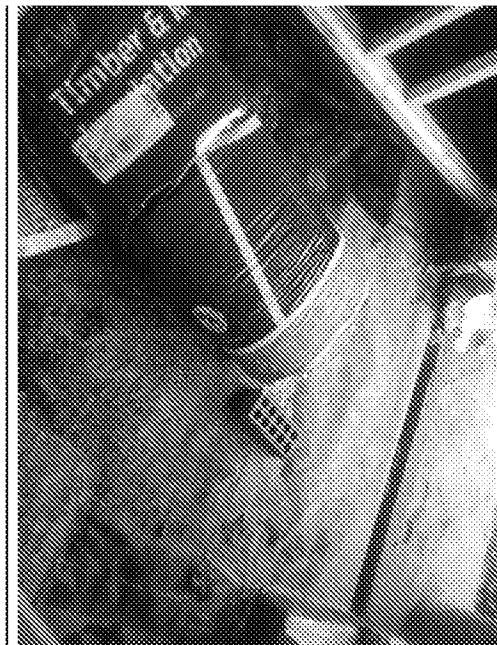
Plot 49 entrance. Undergoing insulation.

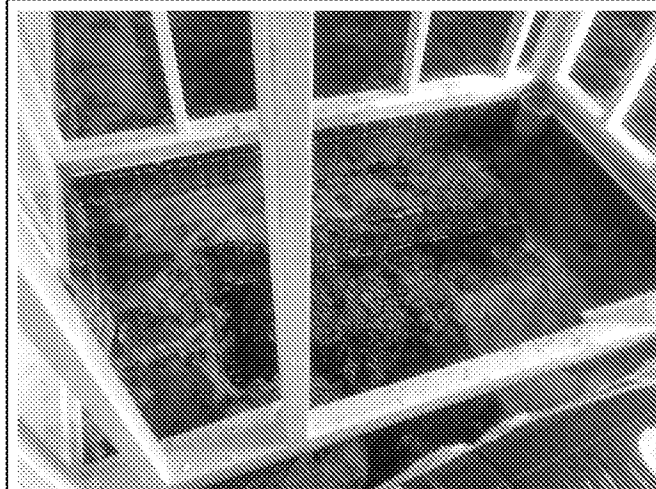
Plot 49 floor and service seal.

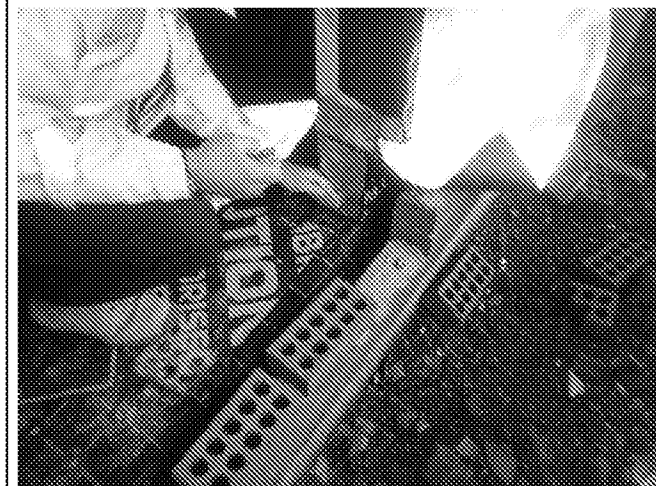
Plot 49 patching.

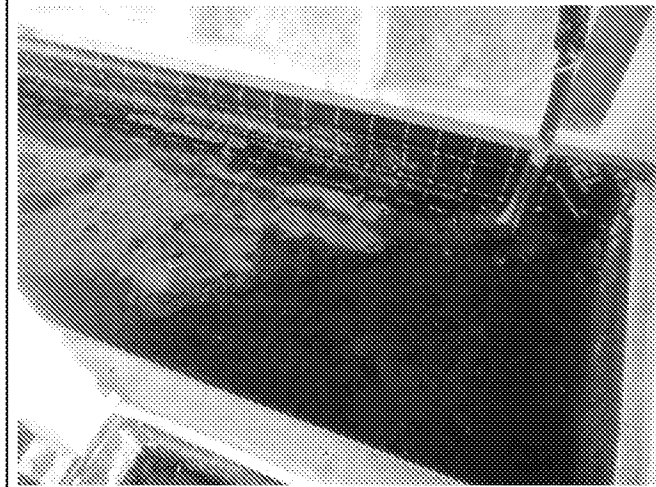
Plot 48 under stairs and service seal.

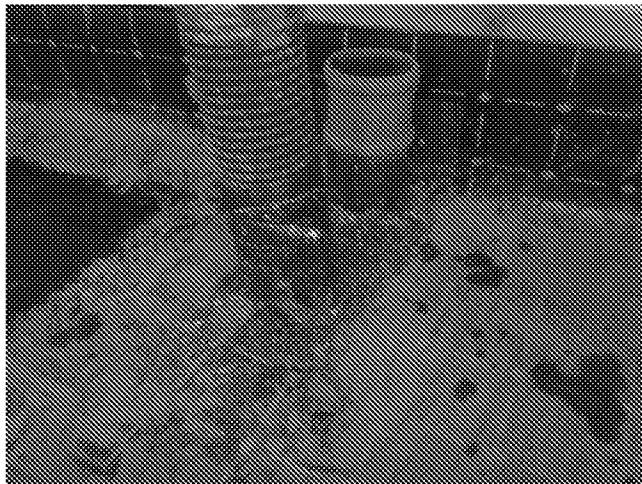
Plot 47 service seals.

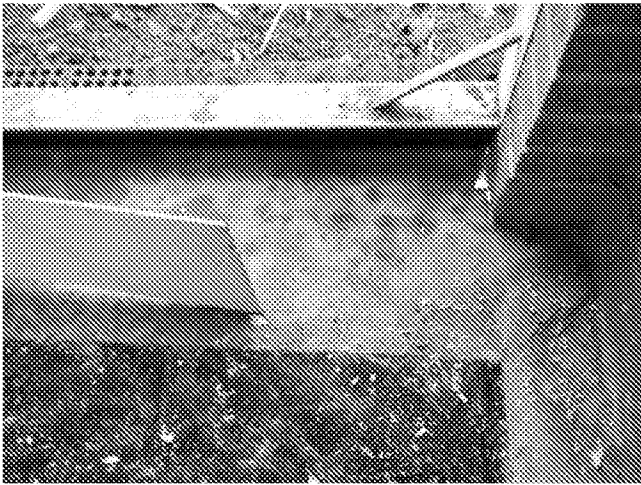
Laped patio.

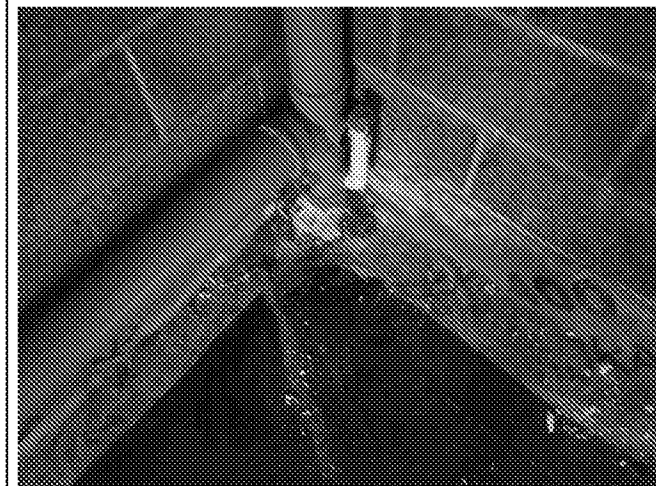
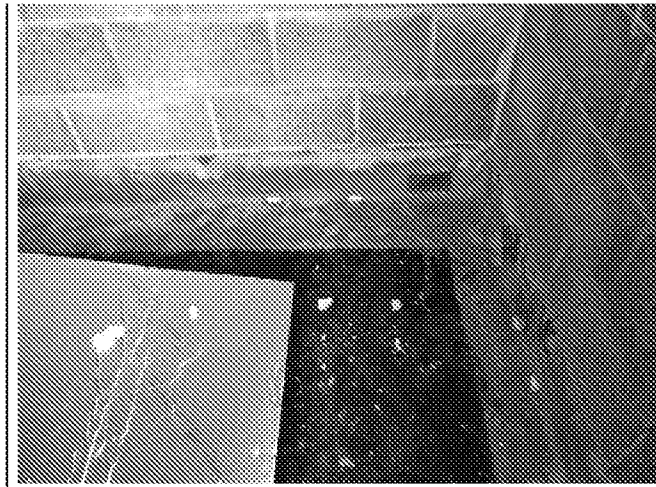
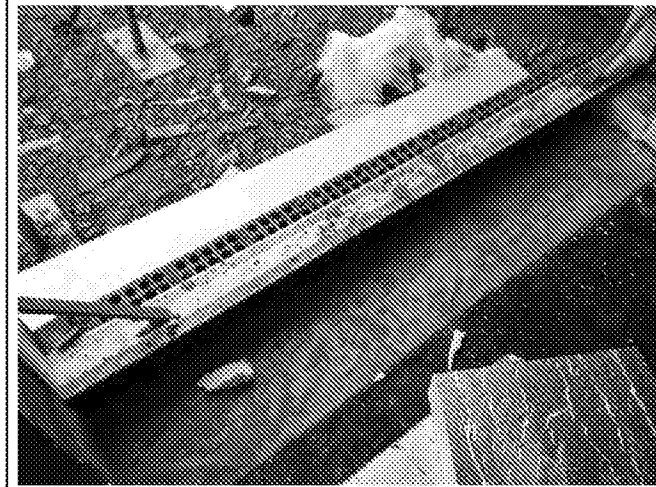
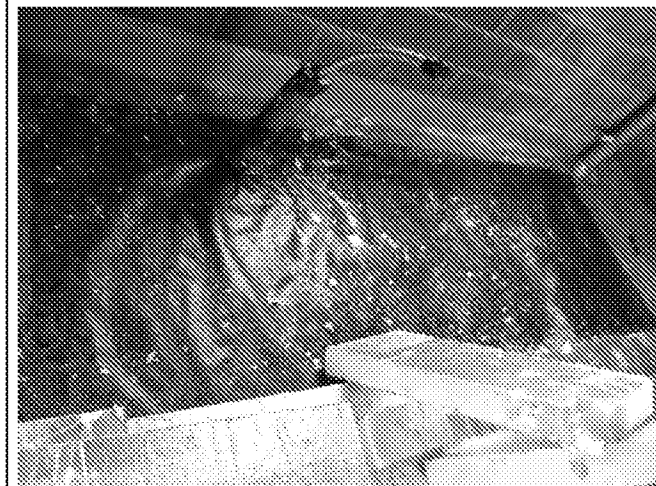
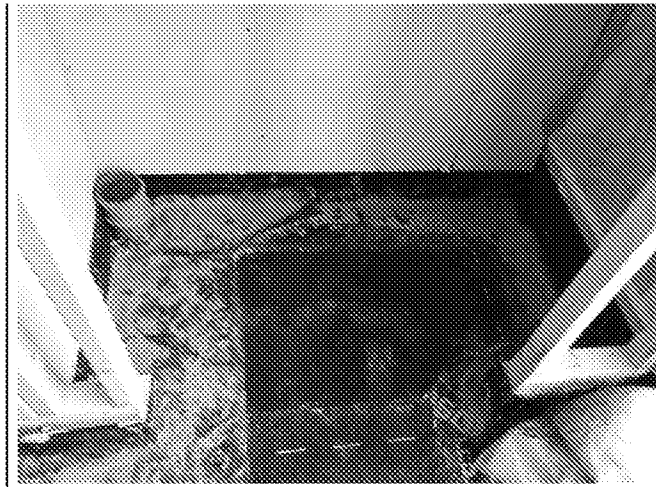
| 1.3 Gas membrane condition | 60 and 61 selotex laid, lifted to inspect below. |
| 1.6 Laps, welds and joints seals | All in very good condition. |

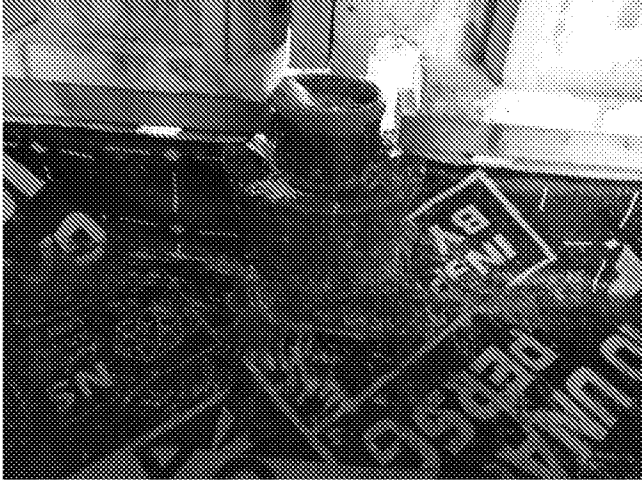
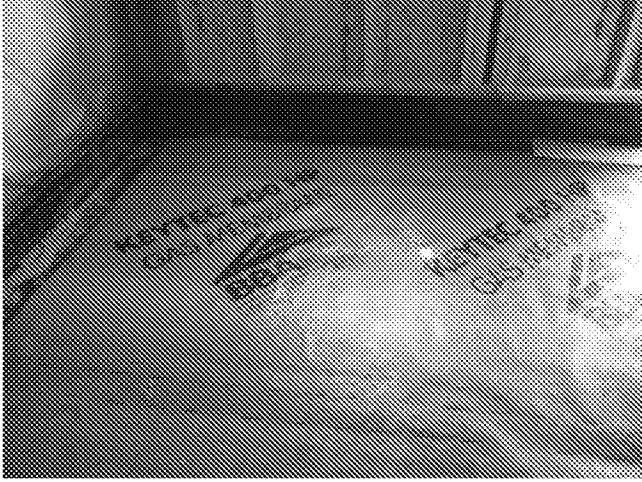
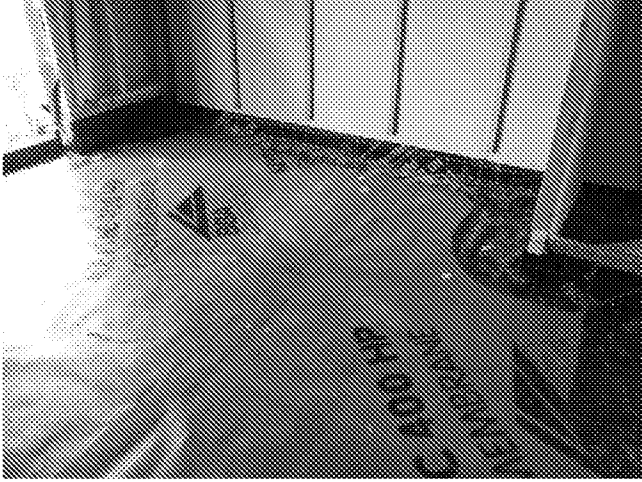
Nail under walkway. Plot 46 fail.

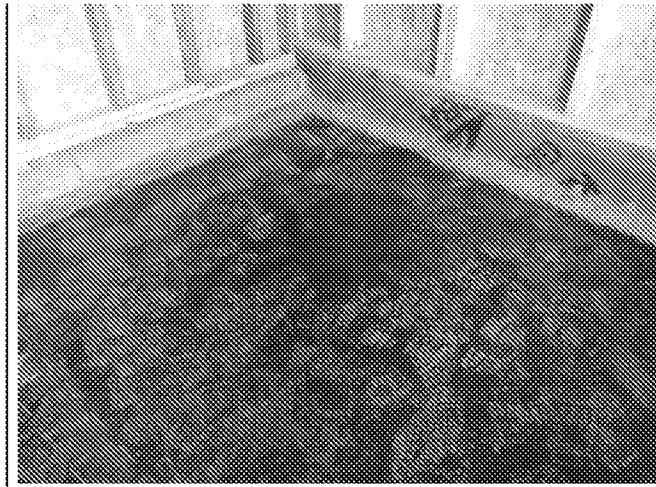
Plot 50 overview
