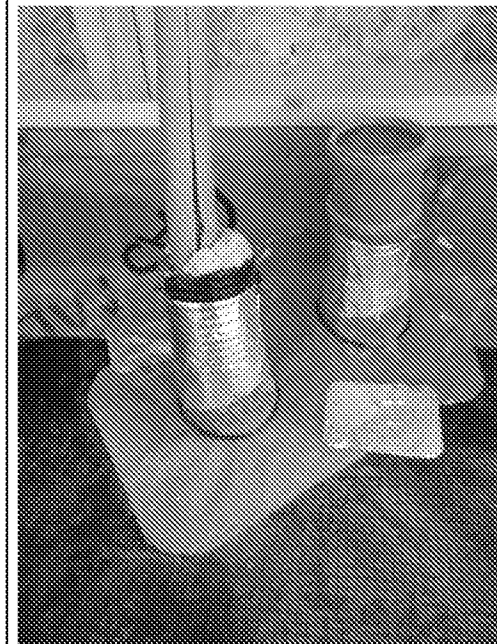
Plot 50 services

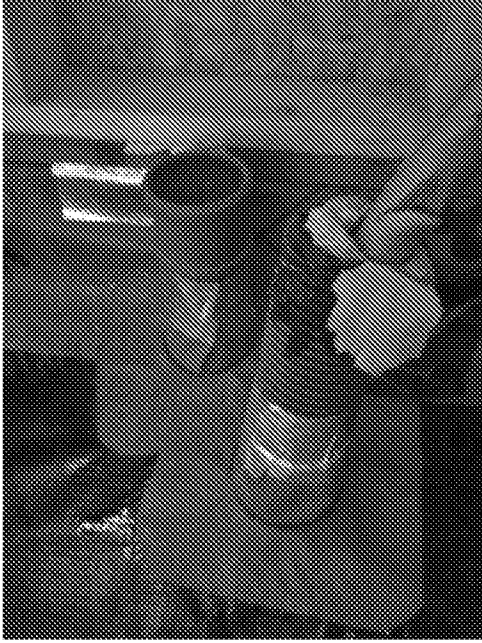
Plot 51 services

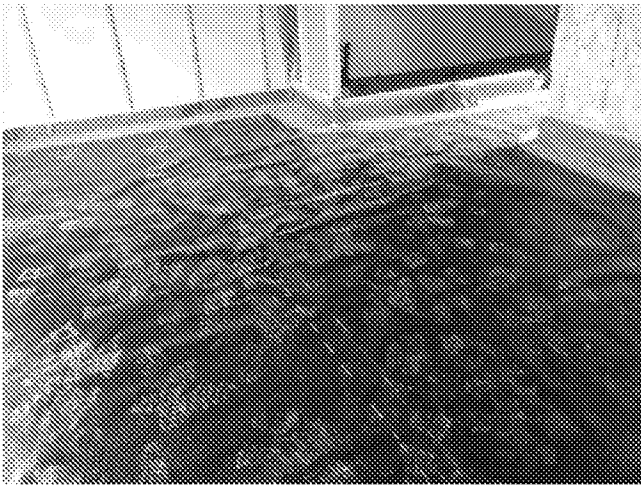
Plot 51 overview

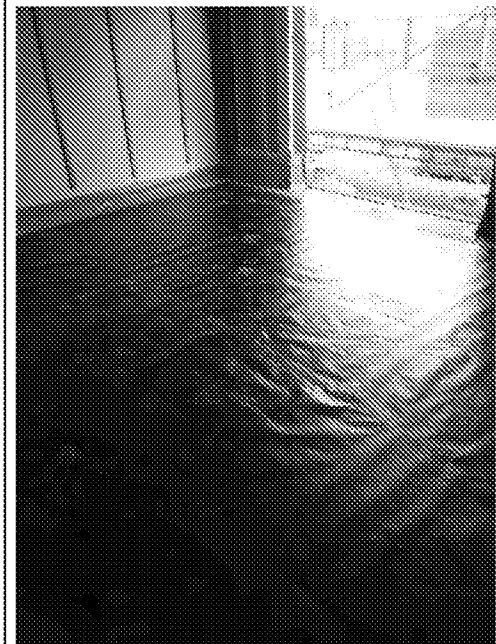
Plot 52 overview

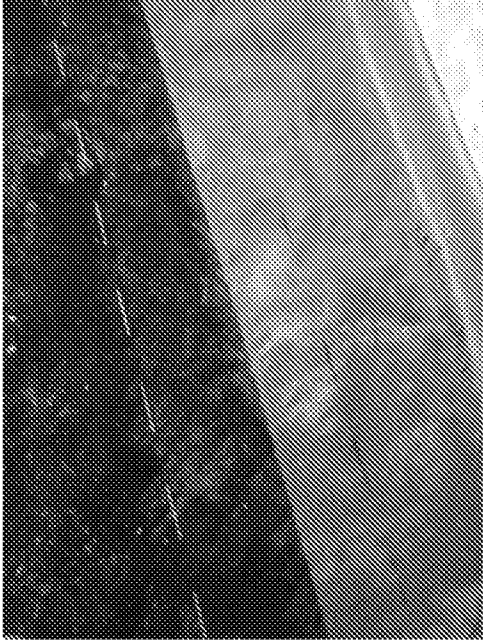
| | Plot 53 joins |

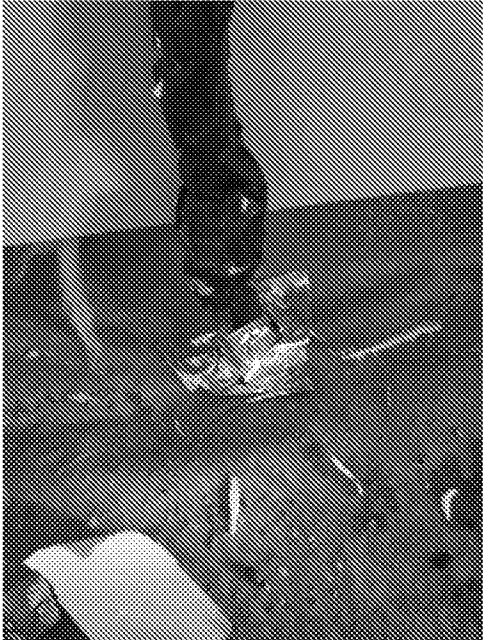
| | Plot 53 service seal |

| 1.7 Service seals | Service seals all in good condition. |

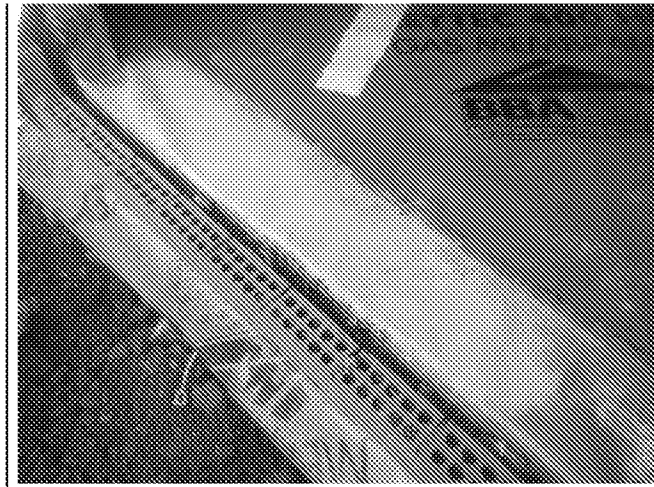
Plot 54 threshold

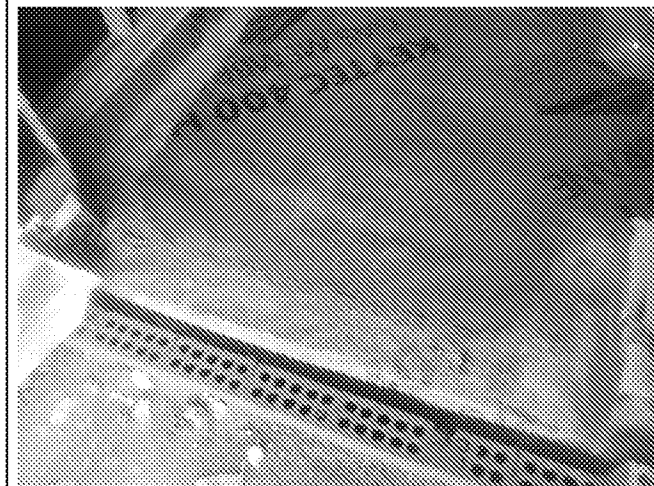
Plot 55 entrance

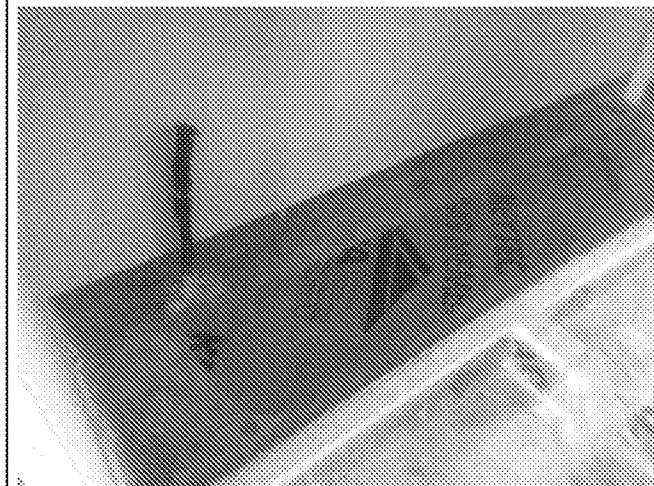
Plot 55 under stairs

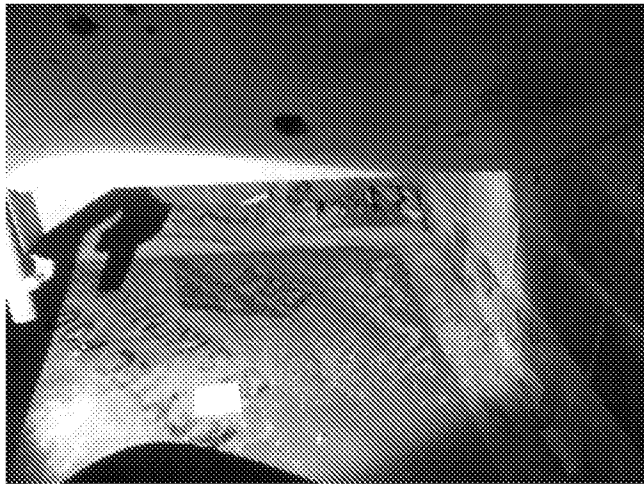
Block B understairs

| 1.3 Gas membrane condition | <p>Block B - Main floor area generally clear however membrane did require sweeping. Materials were being stored on top of membrane in stairwell and a lot of rubble and debris on membrane in the smaller rooms</p> <p>Block A membrane needs clearing and materials being stored on it</p> |

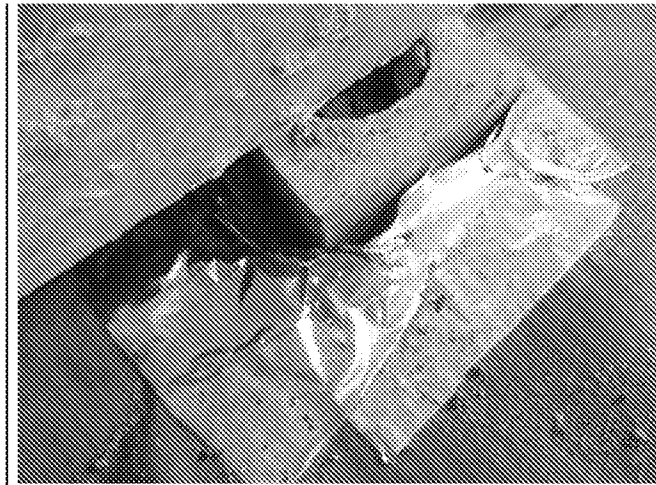
| 1.6 Laps, welds and joints seals | <p>All heat sealed joints.</p> <p>Block B - A large number of patch repairs are required</p> <p>Block A - seal around stairs is not sufficient</p> |

Block A not sealed

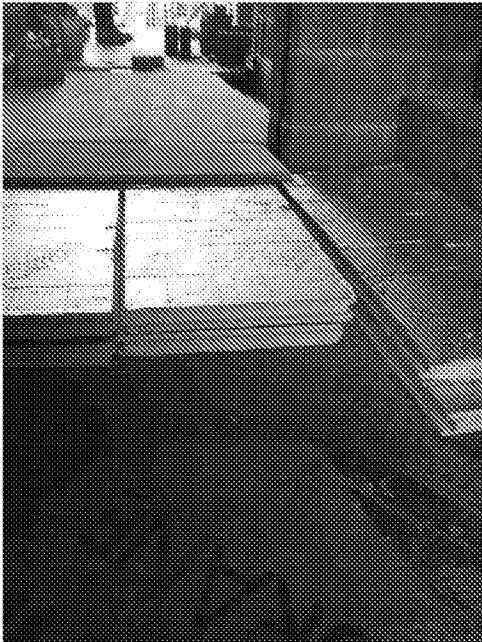
| 1.3 Gas membrane condition | Generally in good condition, insulation board laid over walkways to protect membrane |

Block B walkway
