**VERIFICATION REPORT**  
**for PLOTS 24-29 (SOIL COVER SYSTEMS) &**  
**ALL PLOTS (GROUND GAS) AT**  
**CORNFIELD CLOSE, LITTLEHAMPTON,**  
**WEST SUSSEX, BN17 6LD**  
**on behalf of**  
**THAKEHAM CLIENT LTD**

| <b>Date:</b> | <b>01/06/2021</b> |
| <b>Reference:</b> | <b>GE18103/VR/PLOTS 24-29 (Soil) &amp; All Plots (Gas)/JUN21</b> |

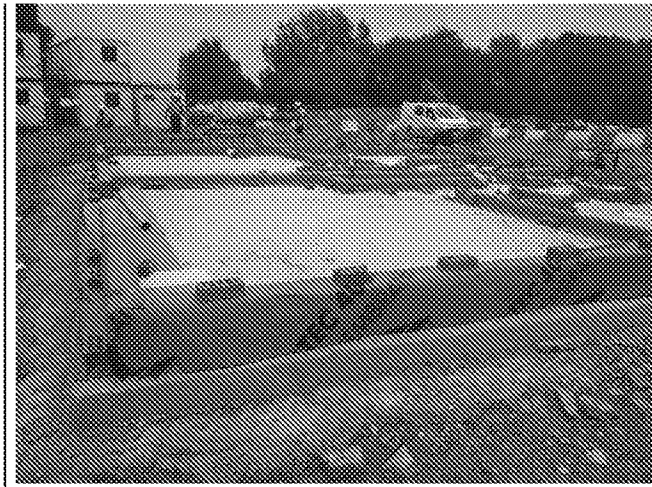
Area - incomplete

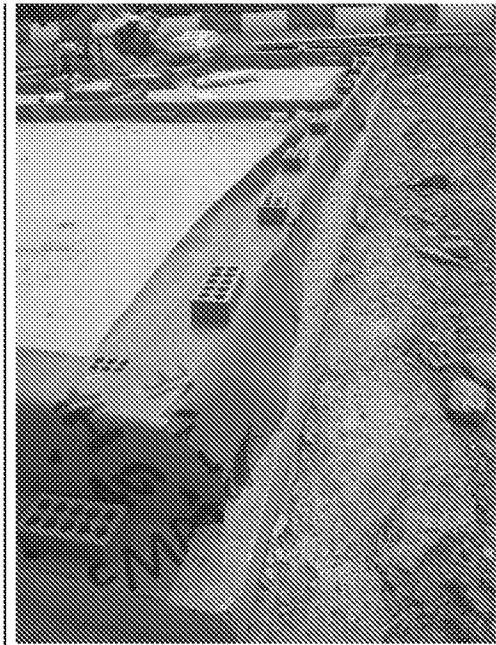
Outer North West - still unfinished

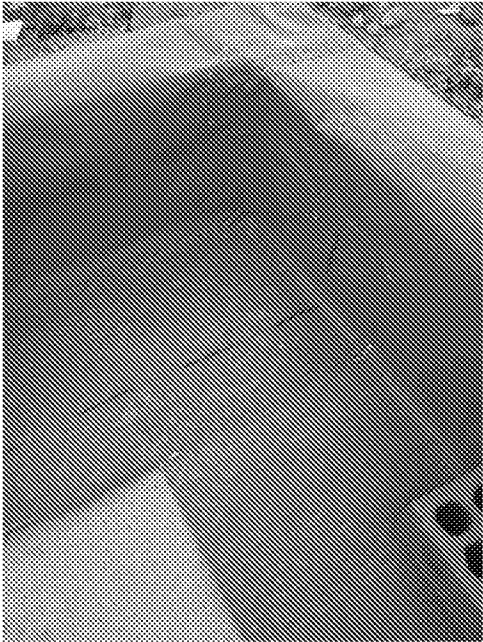
| | Overlap on inside corner. |

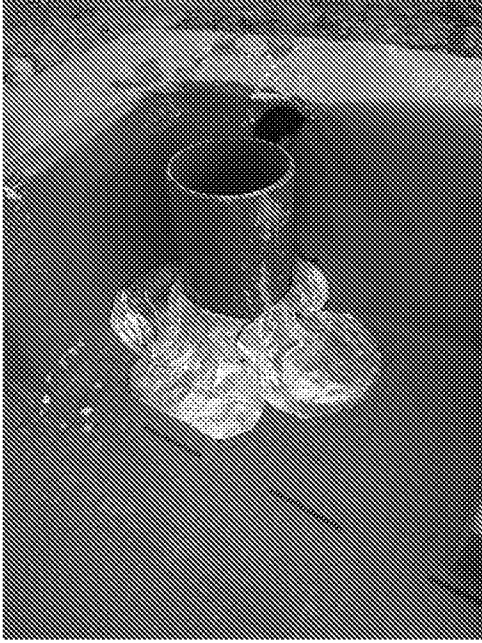
Alum tape around service duct

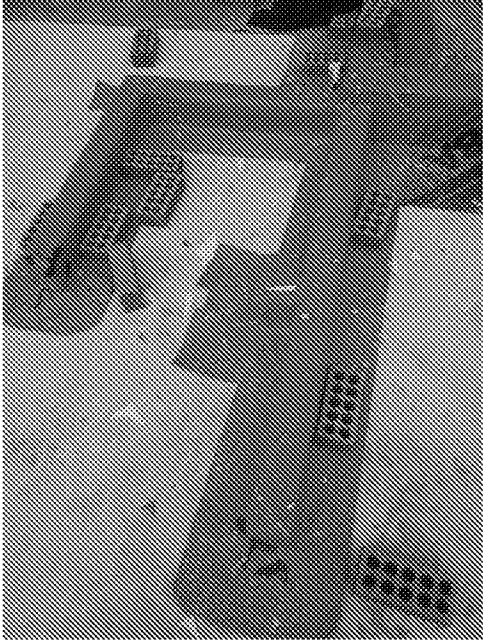
| | Sufficient length for overlap |

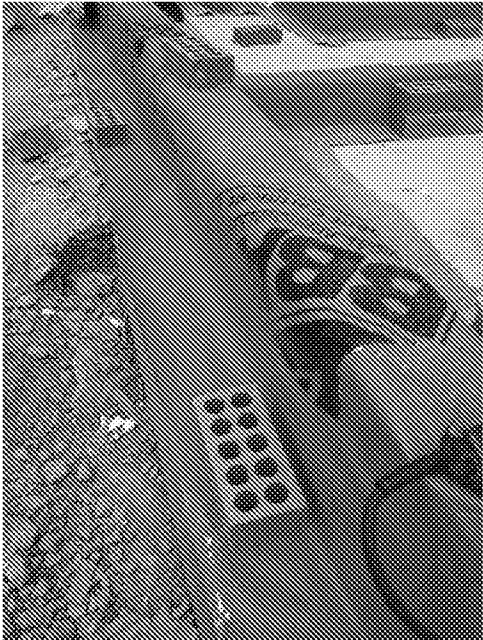
| | Outer layer seal |

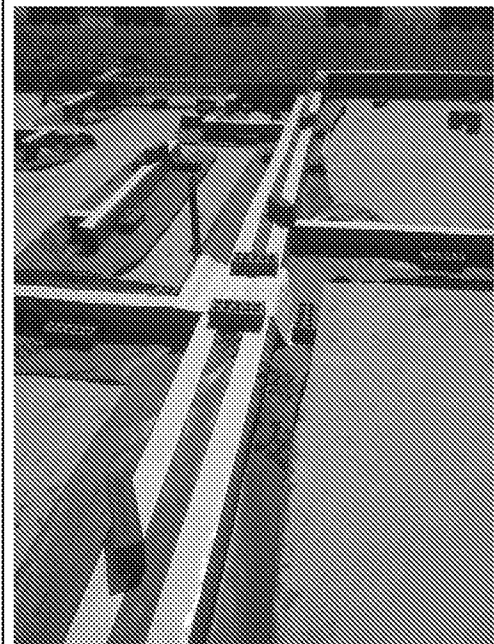
Plot 8 and 9

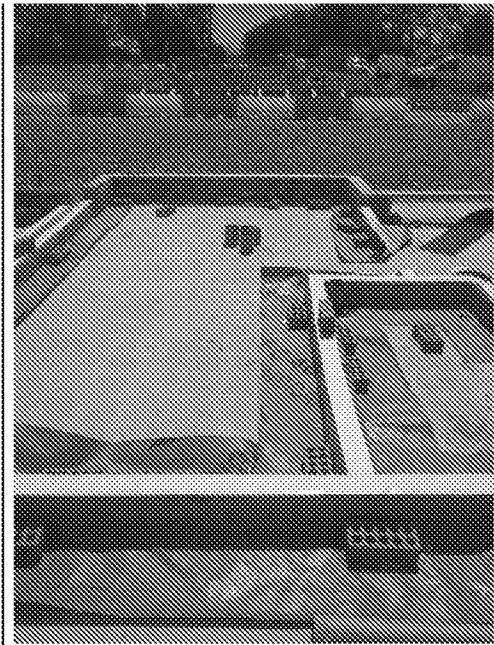
Plot 9 overview

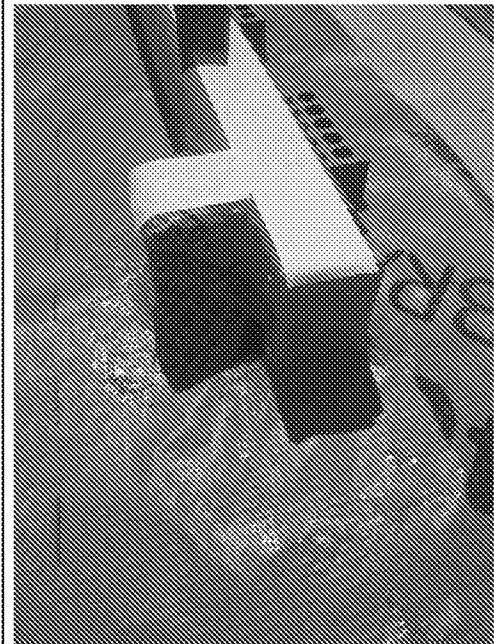
Plot 9 corner

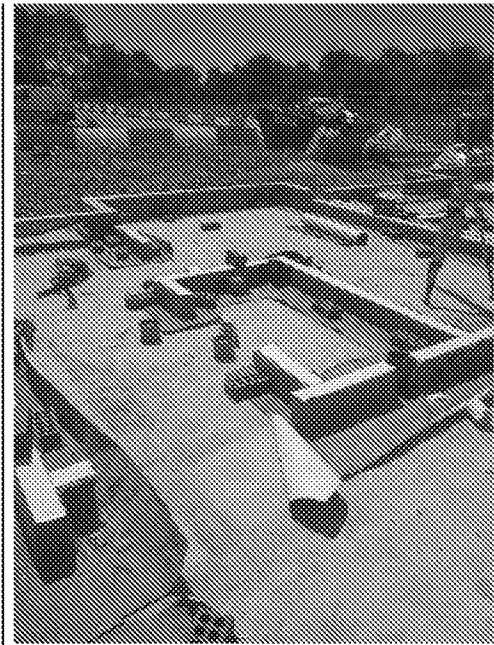
Plot 10 overview

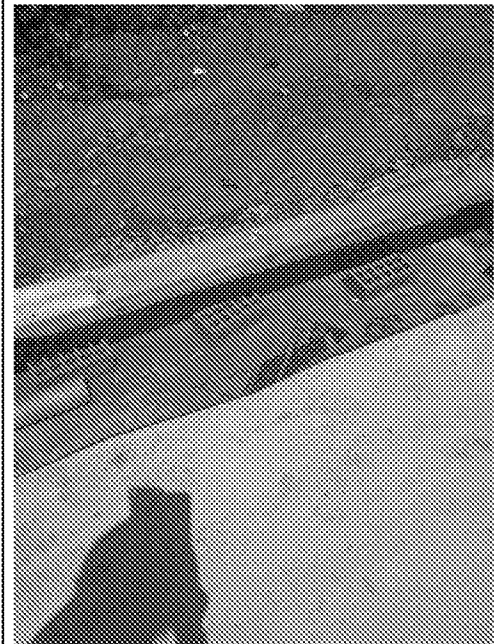
Plot 10 wall

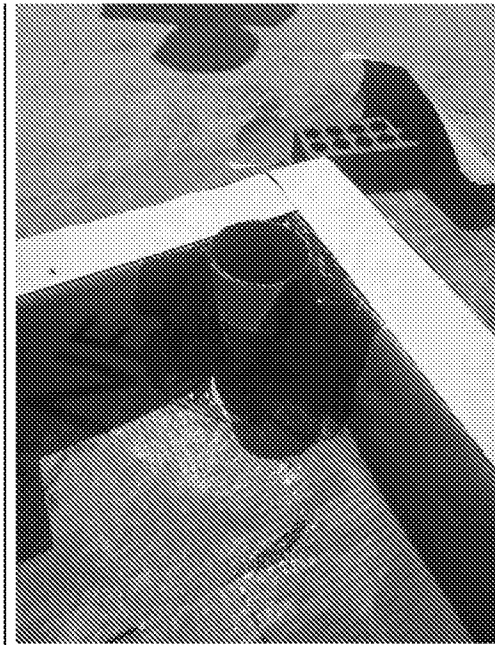
Plot 10 services

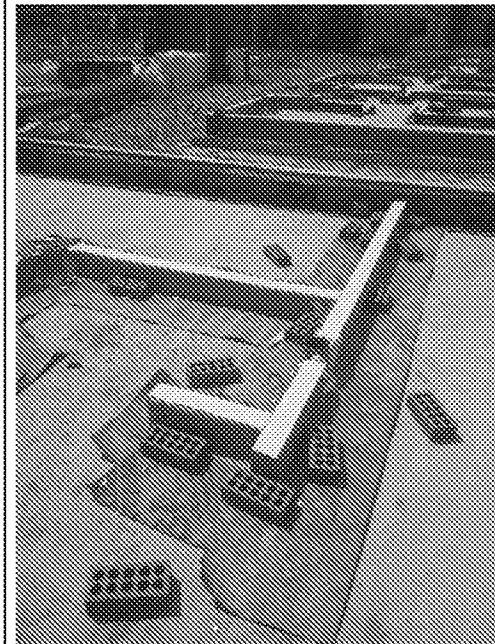
Plot 11 overview

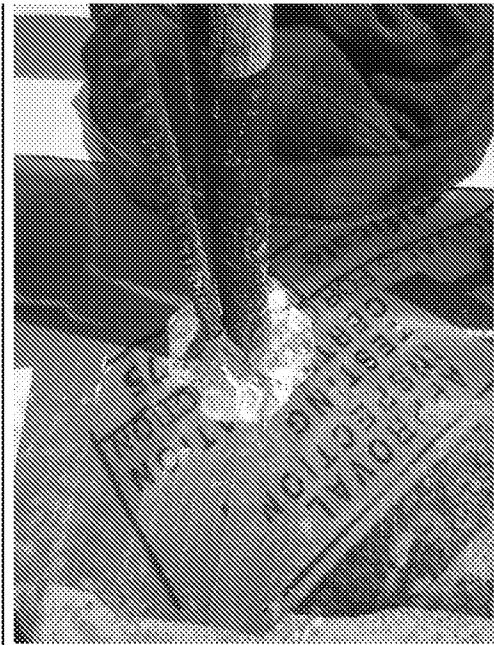
Plot 11 services

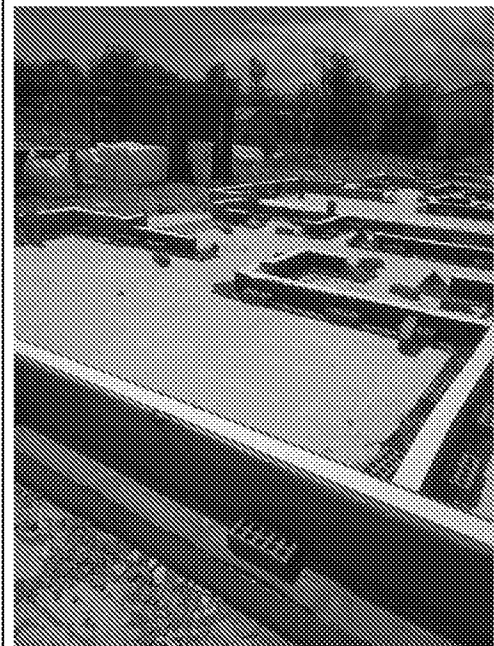
Plot 12 overview

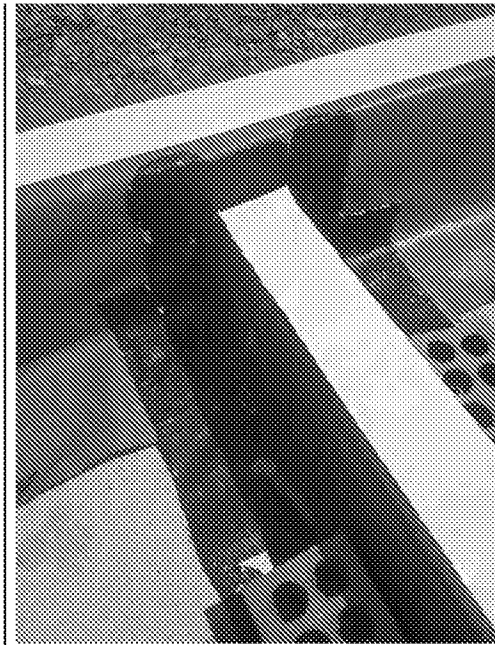
Plot 12 seal

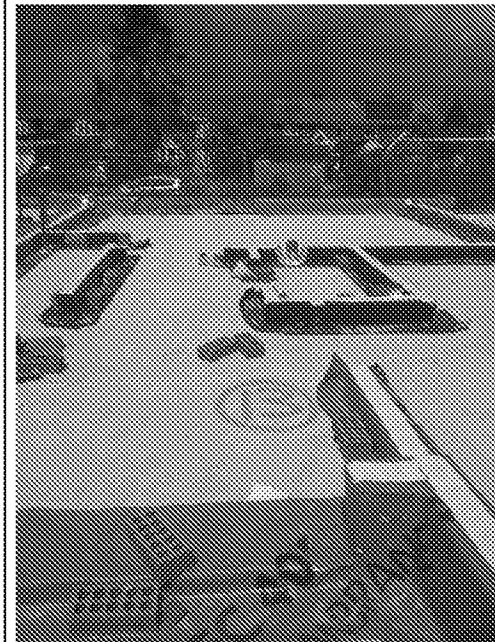
Plot 13 overview

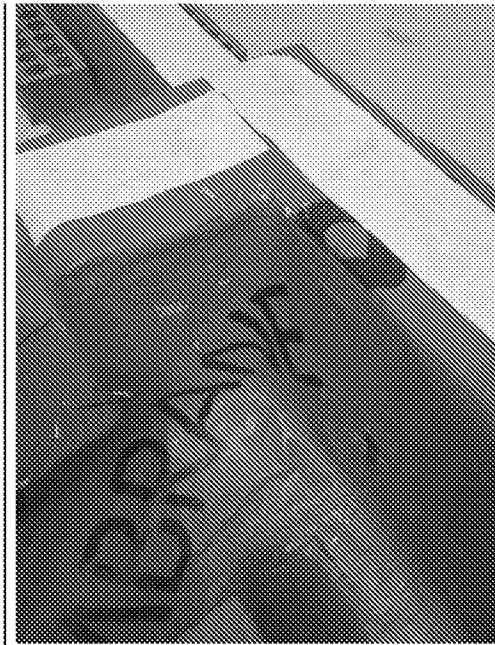
Plot 13 corner

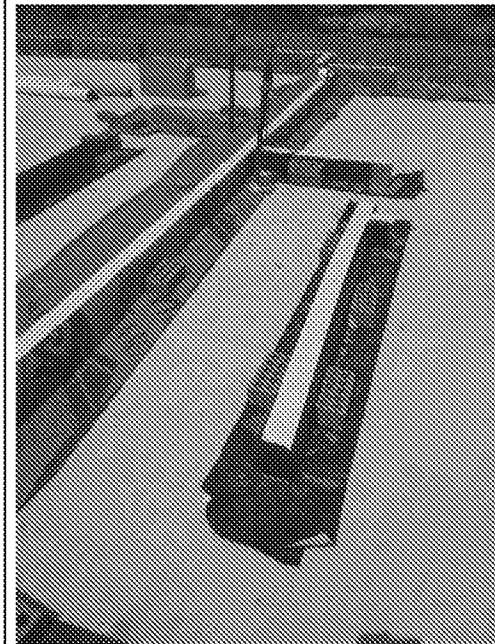
Plot 13 detail

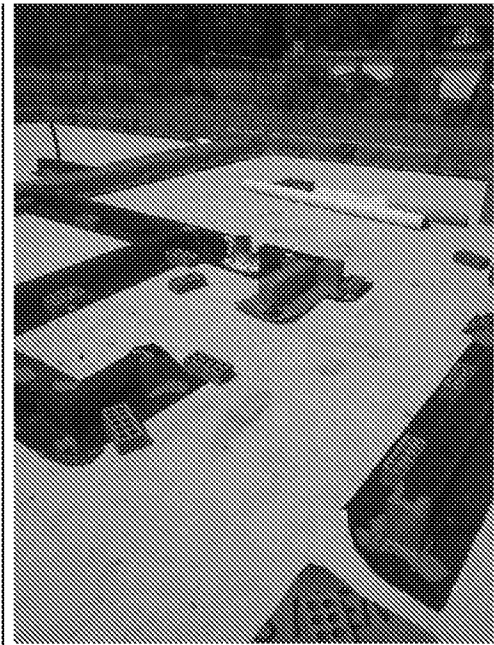
Plot 14 overview

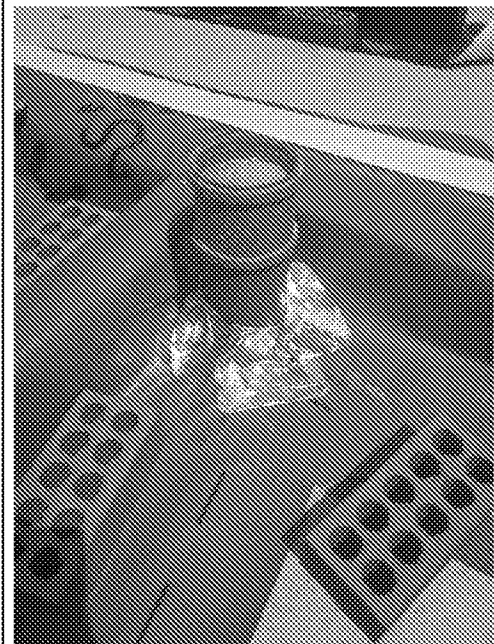
Plot 14 services

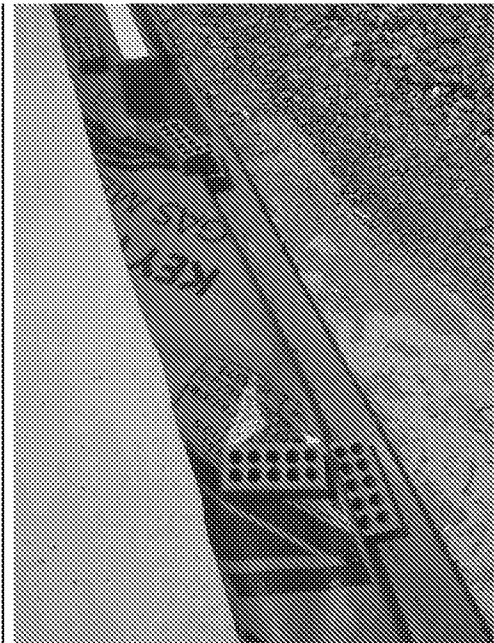
Plot 14 doorway

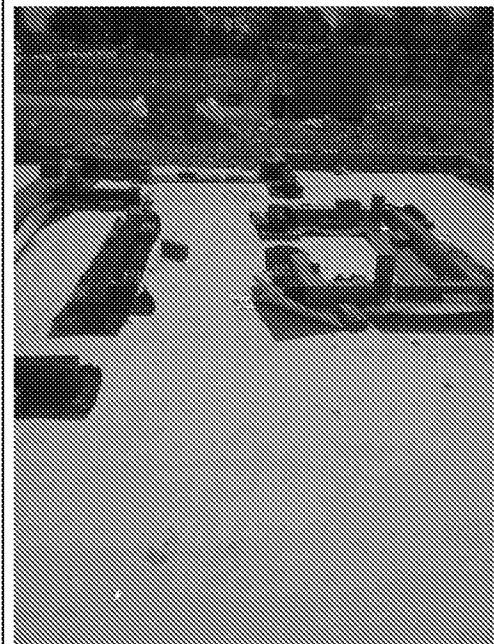
Plot 15 overview

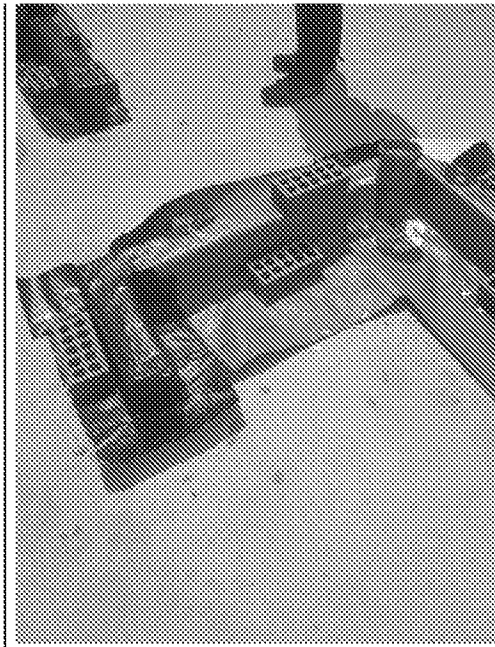
Plot 15 corner

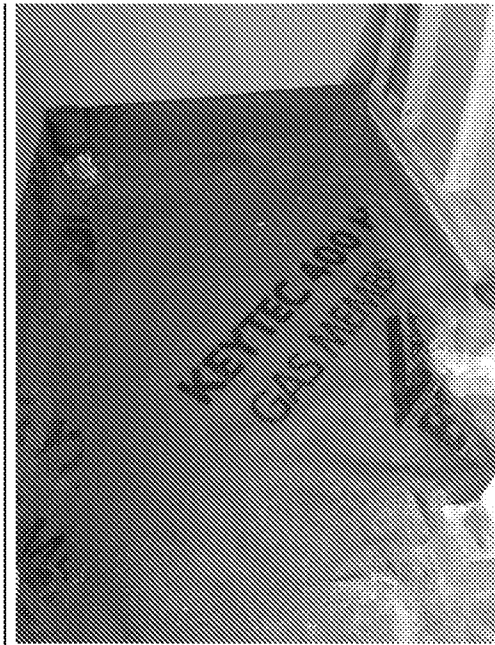
Plot 1 services

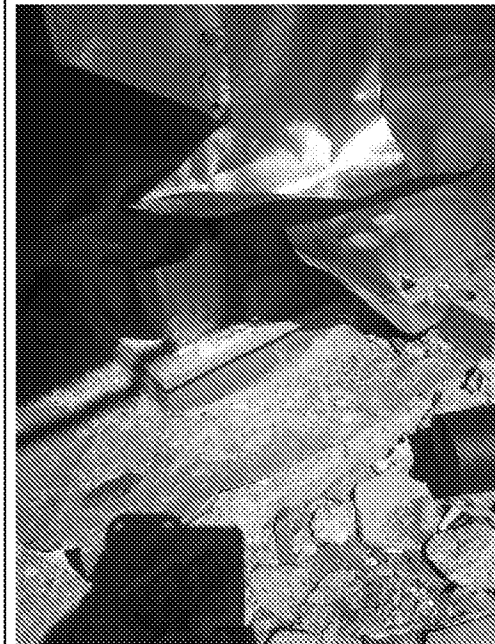
Plot 1steel

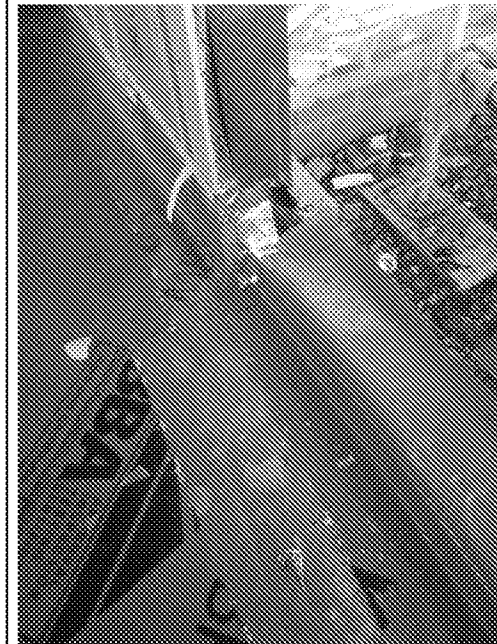
Plot door threshold

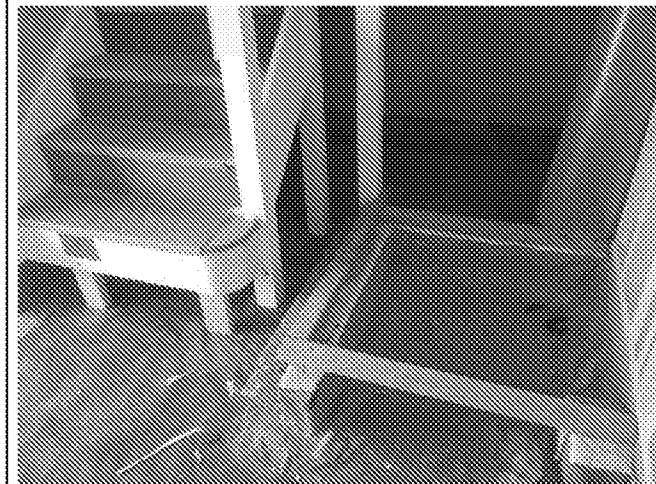
Plot 1 stairwell

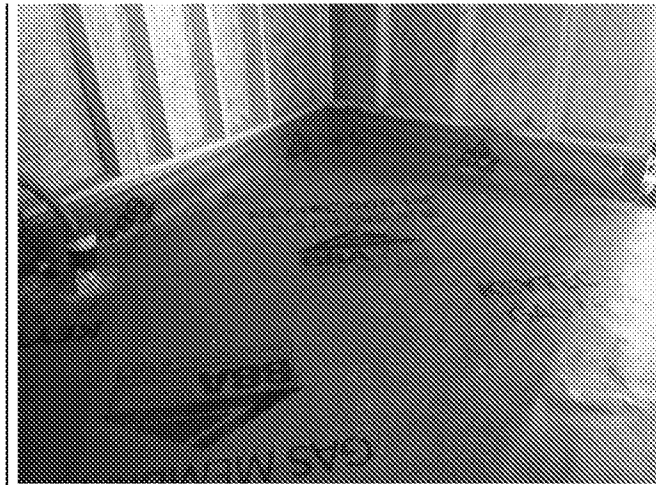
Plot 1 overview

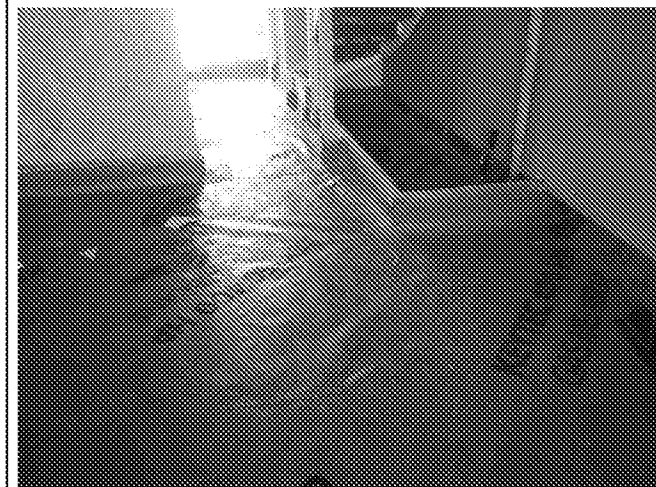
Plot 2 overview

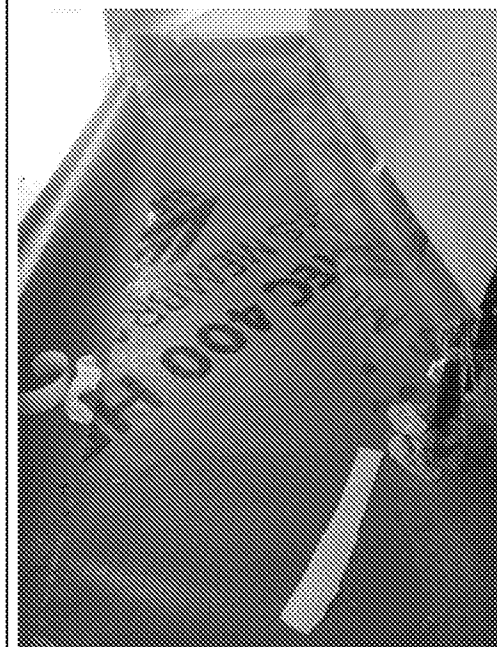
Plot 2 under stairs

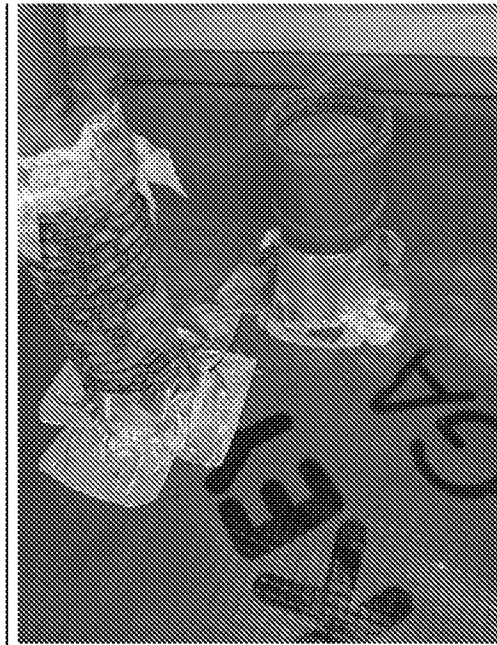
Plot 2 services

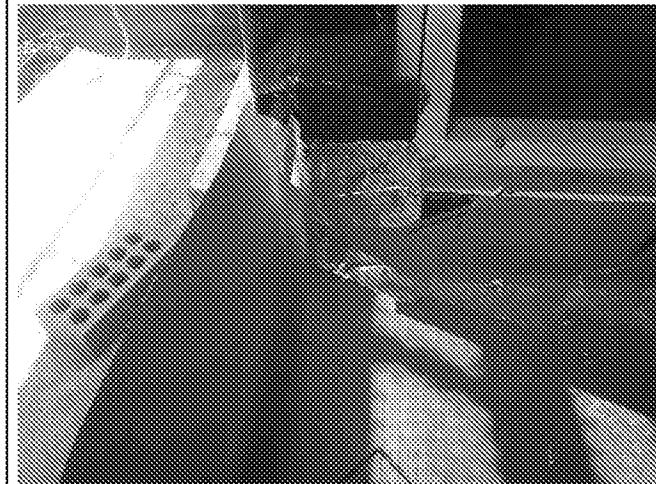
Plot 2 details

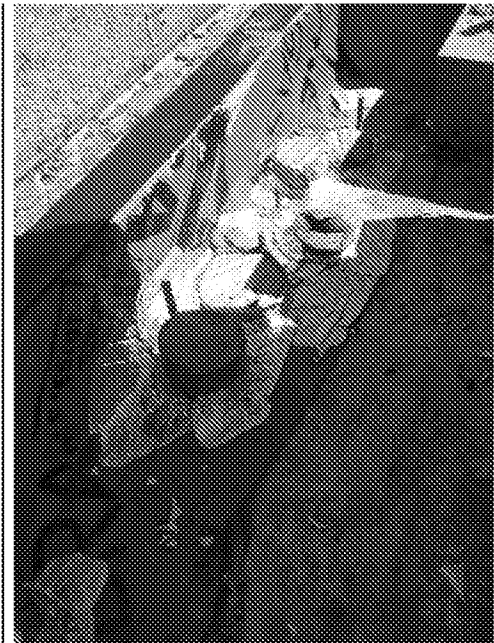
Block A services

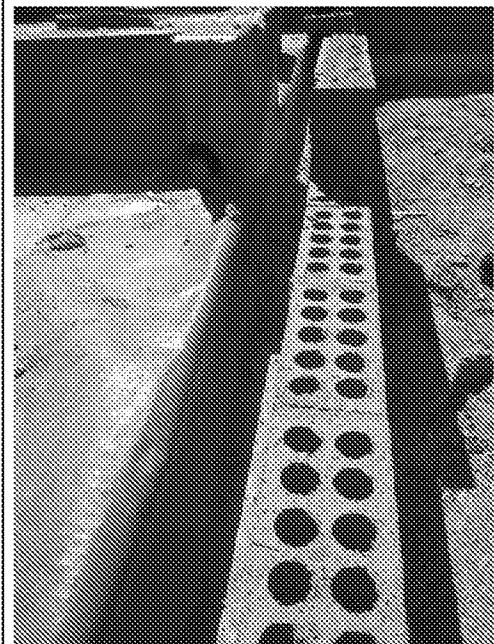
Block A cavity

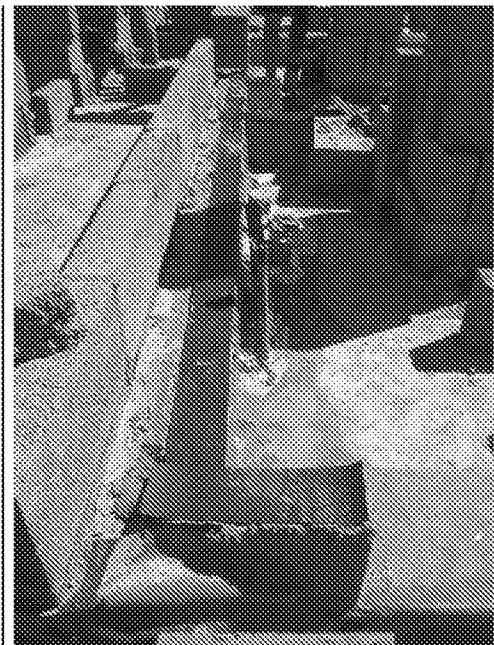
Block A tape under blockwork

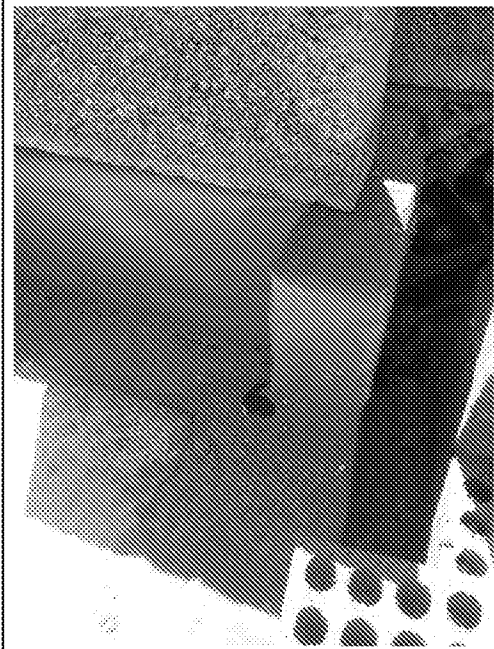
Block A corner

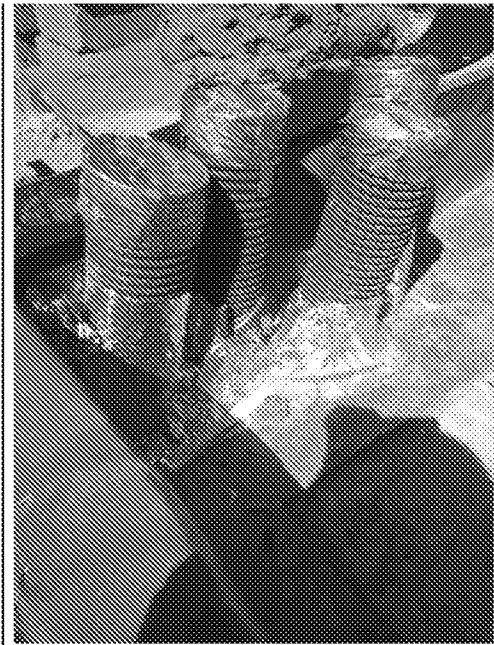
Block A water

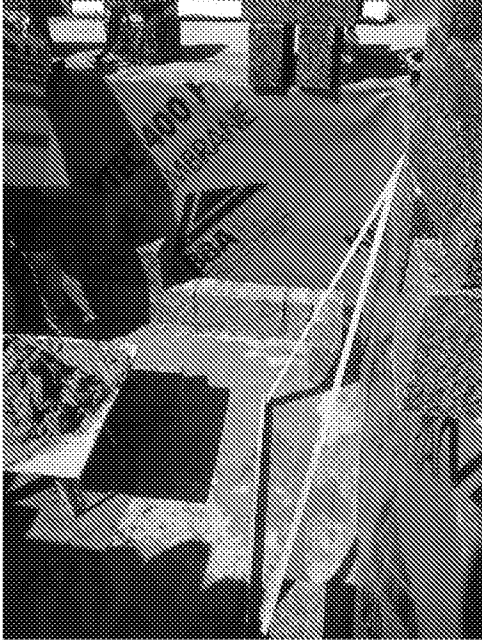
Block B overview

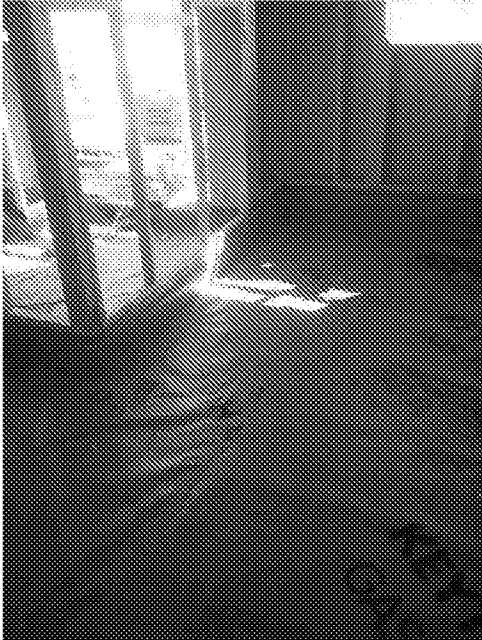
Plot 3 overview

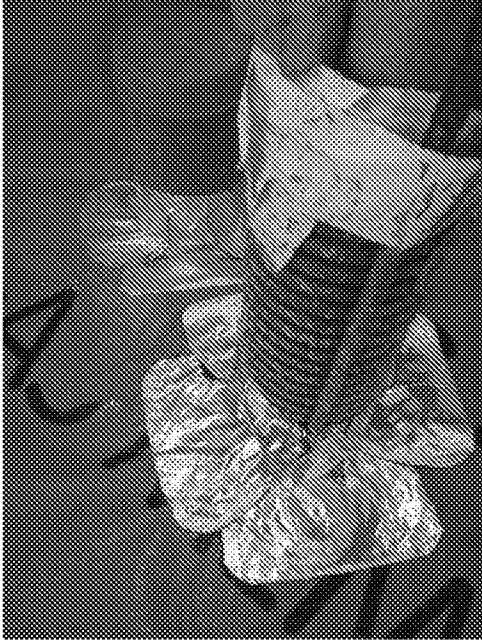
Plot 3 services

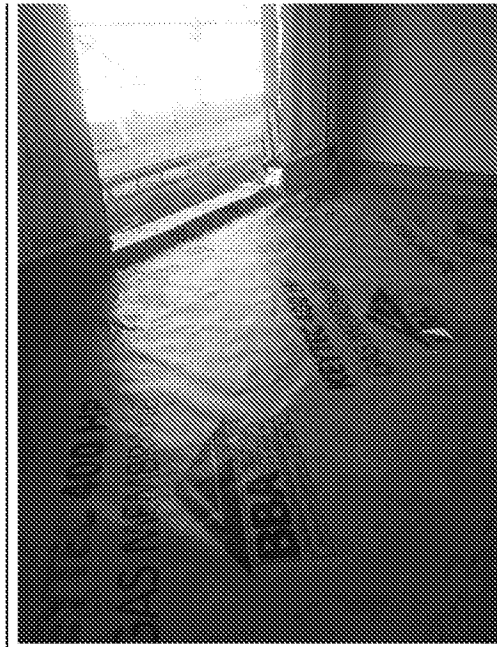
Plot 3 overview

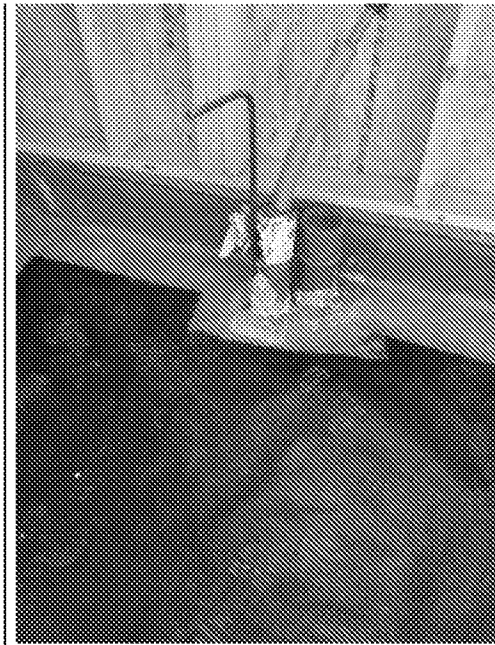
Plot 4 - service seal

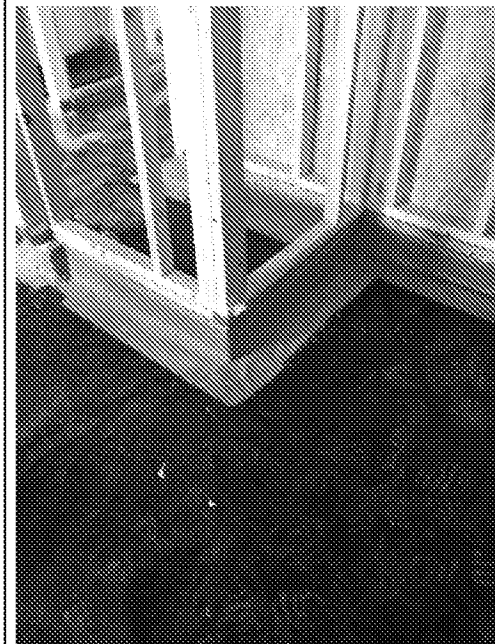
Plot 4 - join between wall and floor

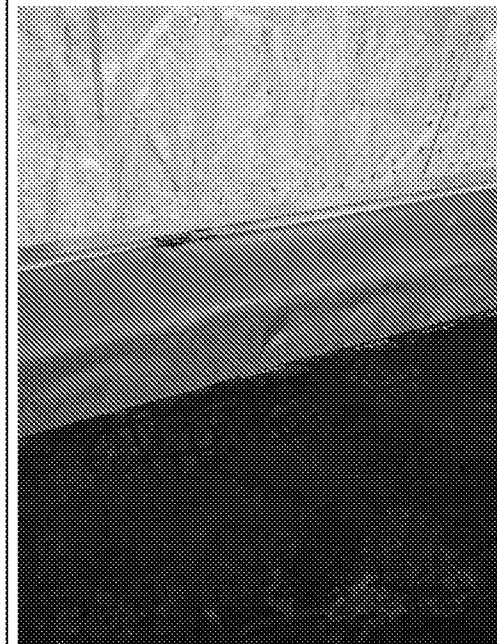
Plot 4 - Black putty tape sealant  
under frame

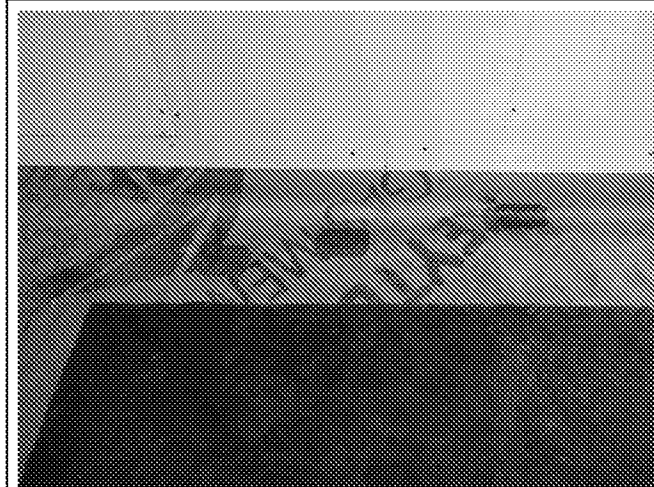
Plot 4 - Patching of any holes has  
already been completed

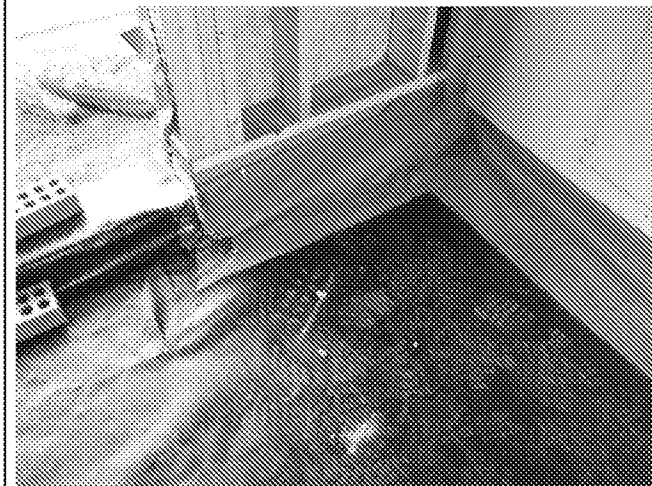
Plot 5 -Threshold corner detail

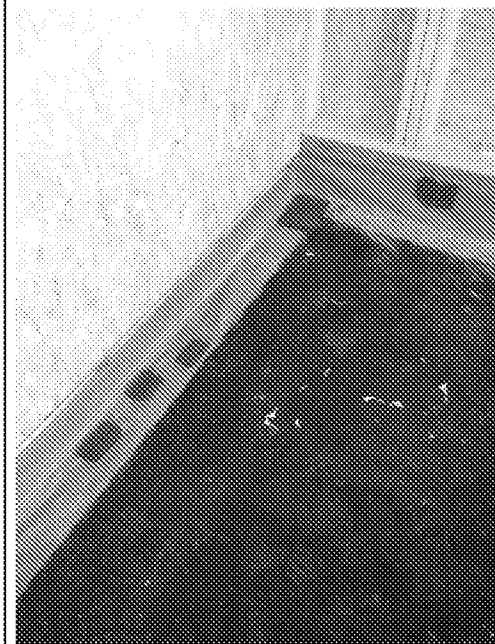
Plot 5 - Patching of holes already complete

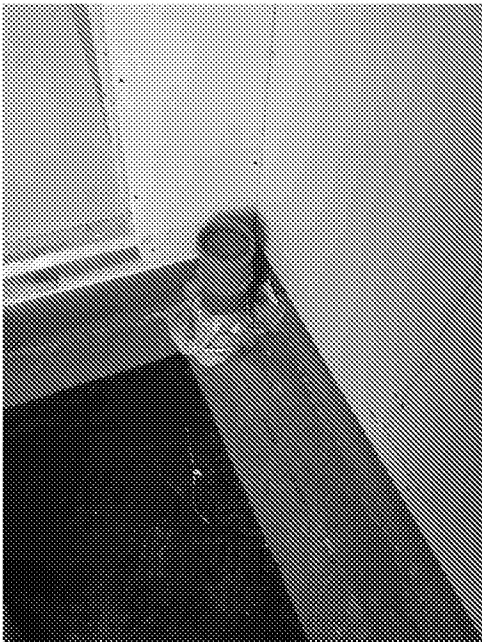
Plot 5 - service seal

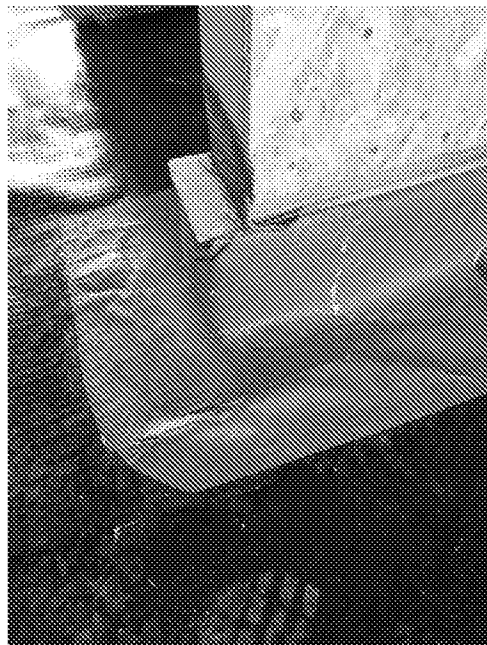
Plot 5 - Corner detail

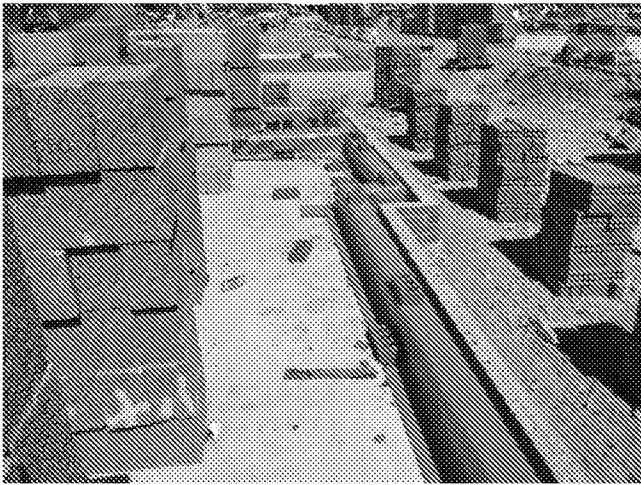
Block B - perimeter

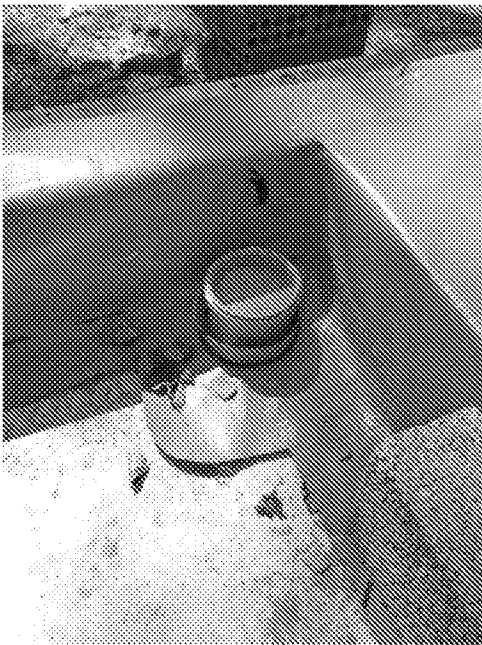
Block B - services not yet sealed

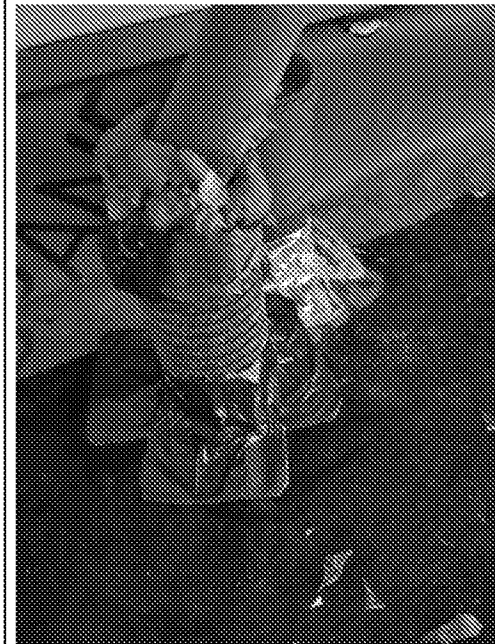
Plot 6 services

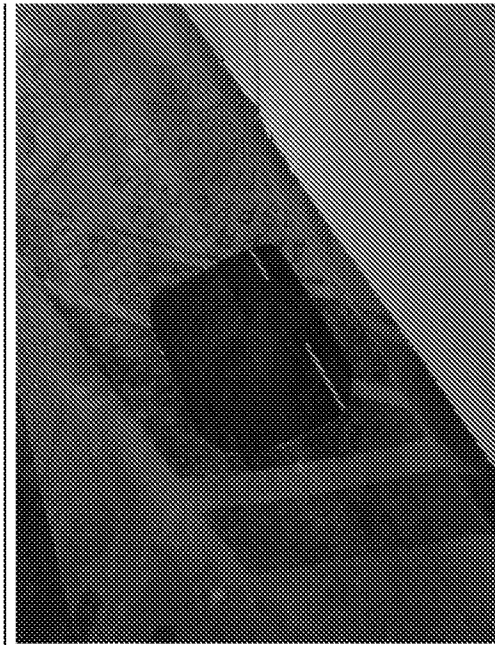
Plot 6 repair

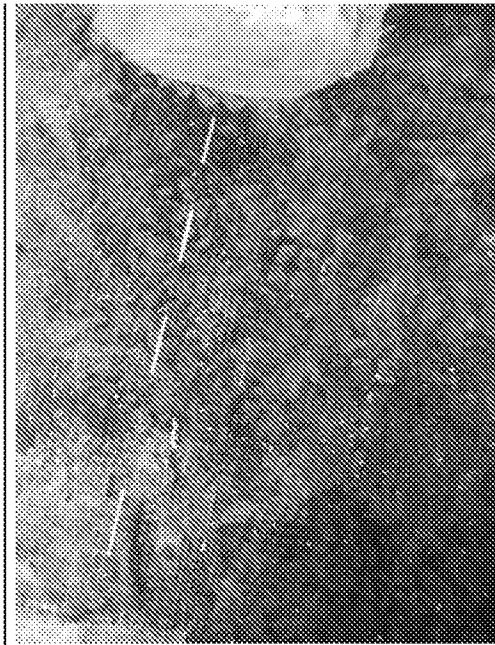
Plot 7 joins

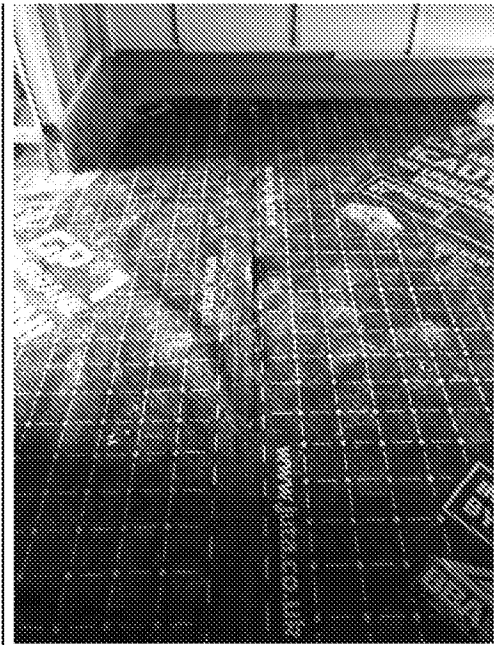
Plot 8 join

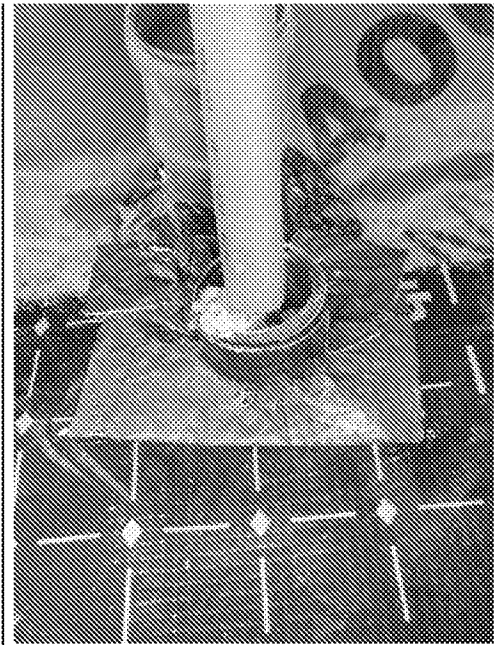
Plot 9 service seal

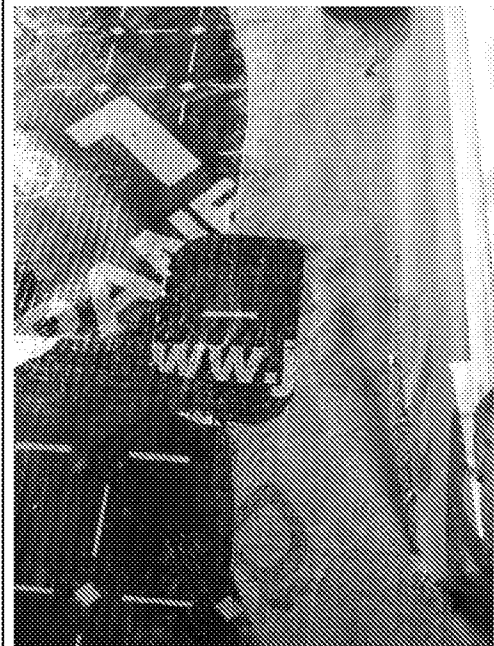
Plot 9 patch repair

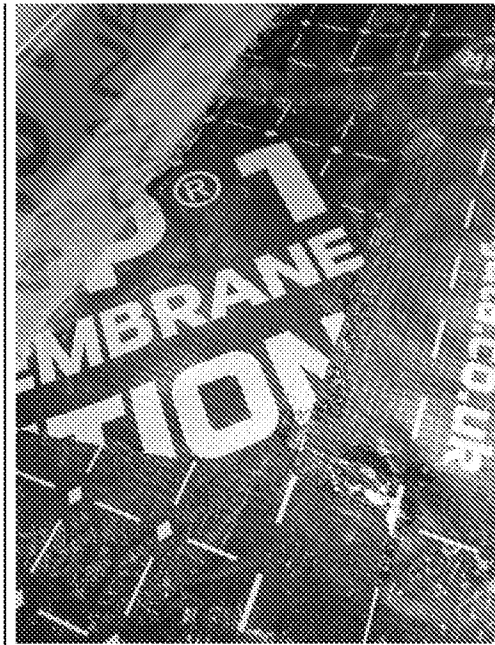
Pot 10 membrane joins

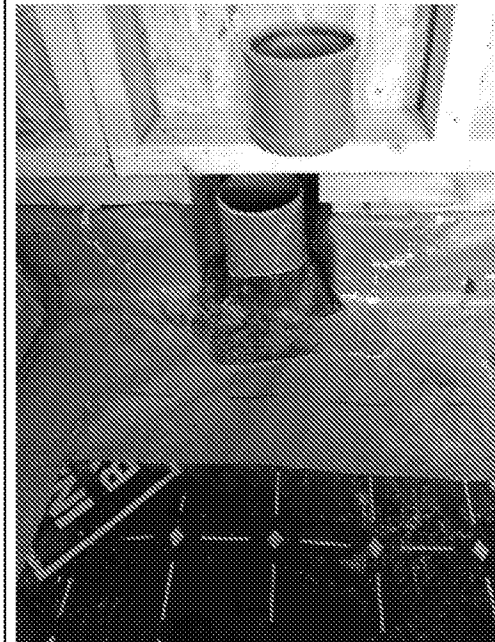
Plot 10 services

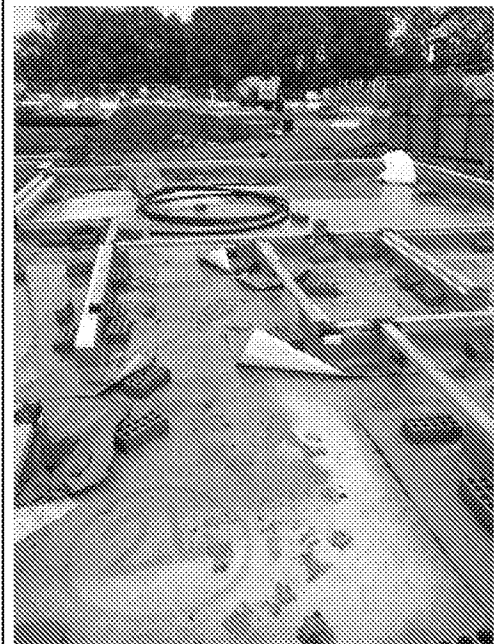
Plot 24 reinspection

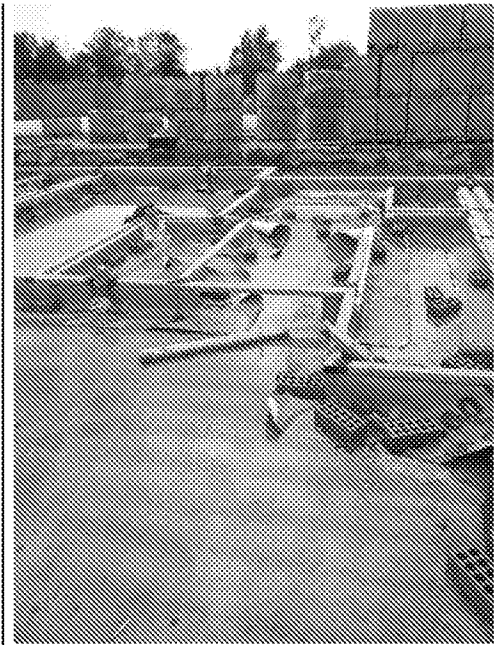
Plot 25 reinspection

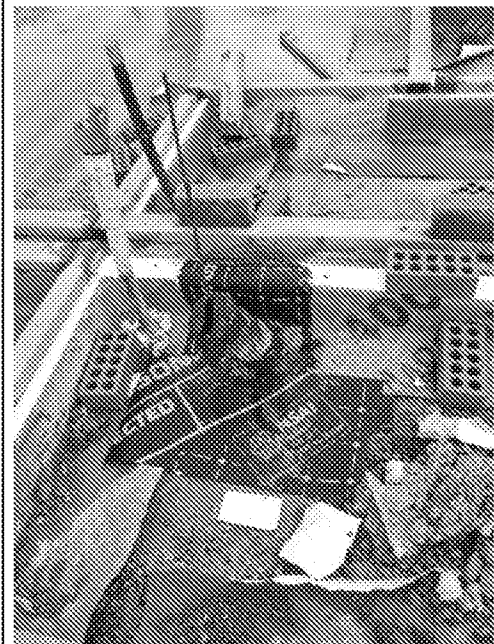
Plot 26 service

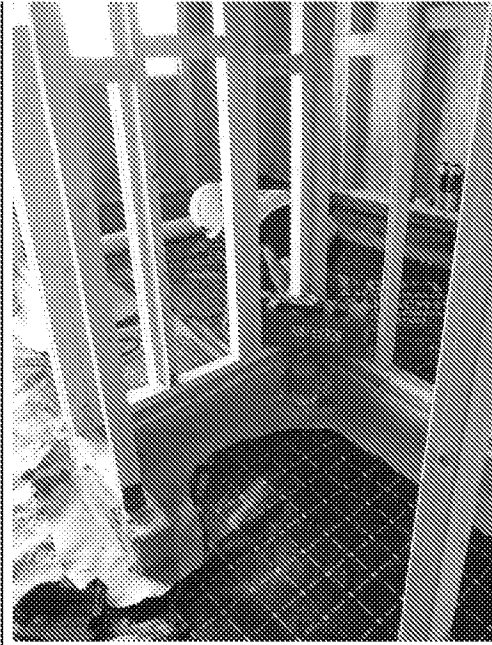
Plot 11 in progress

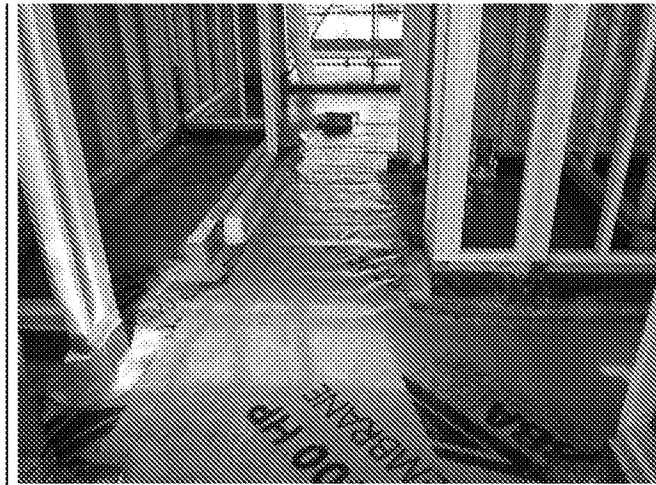
| 1.1 Condition of sub-grade and underside of membrane | Good condition where visible. Membrane sealed in Plots 12-13. |

Plot 12 - View across floor

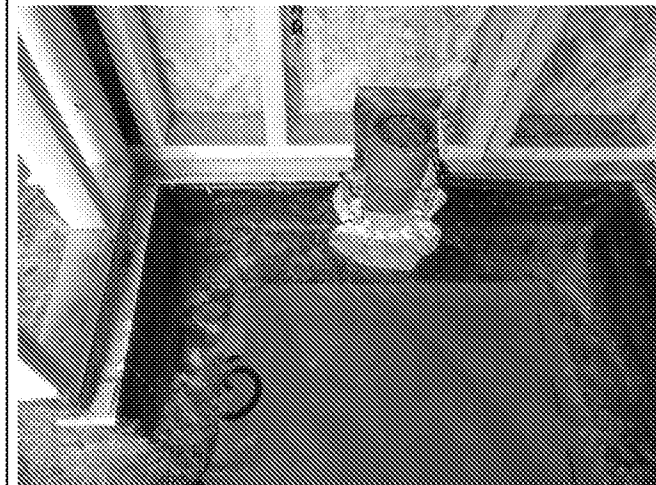
| 1.7 Service seals | Service seals using membrane and tape. All well sealed and in good condition. |

Plot 12 - service seal

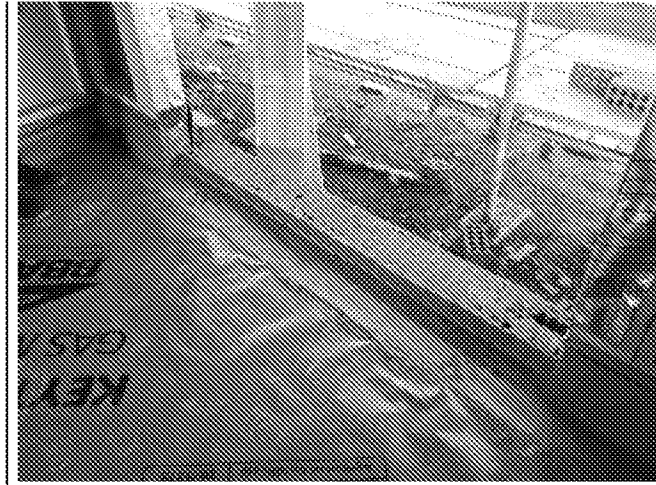
Plot 12 - Threshold

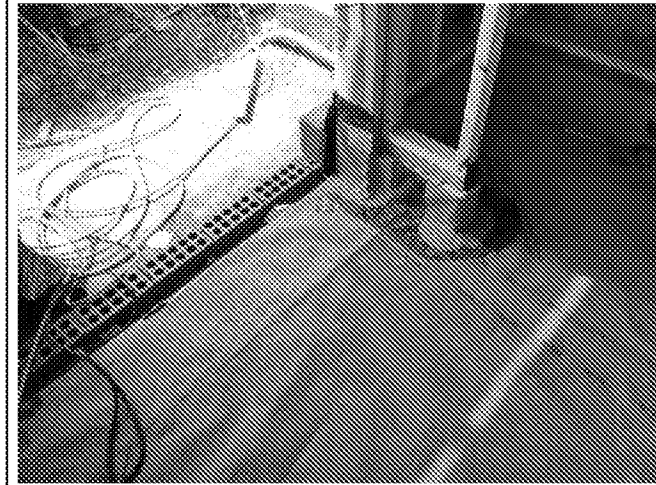
Plot 13 - Threshold

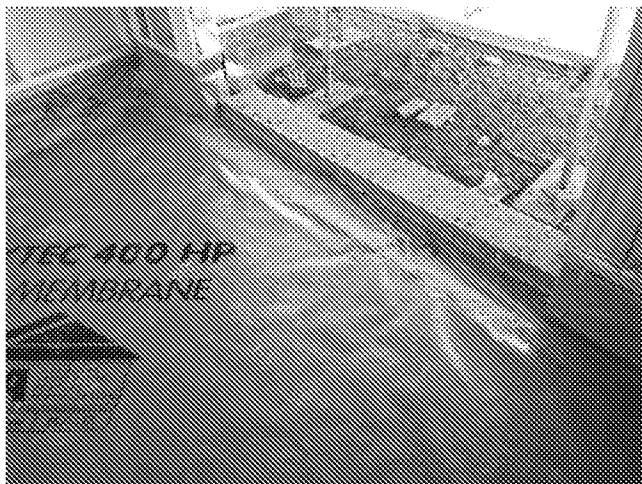
Plot 13 - Threshold

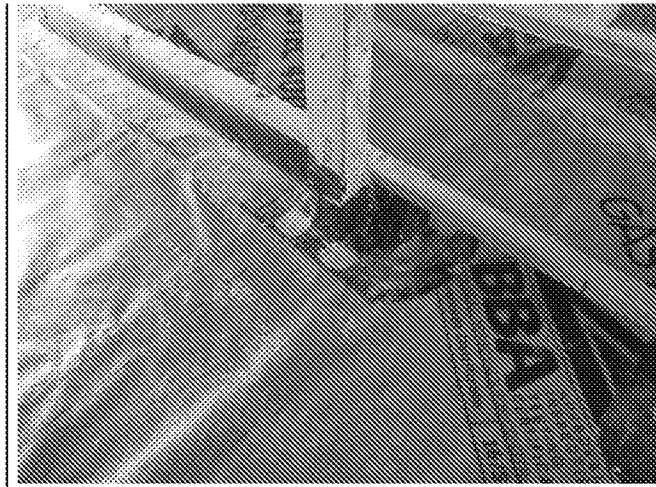
Plot 13 - Patching

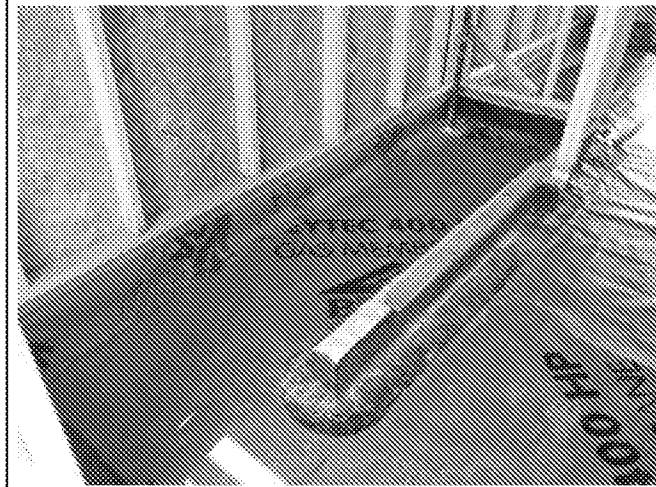
Plot 13 - Under stairs
