**VERIFICATION REPORT**  
**for PLOTS 24-29 (SOIL COVER SYSTEMS) &**  
**ALL PLOTS (GROUND GAS) AT**  
**CORNFIELD CLOSE, LITTLEHAMPTON,**  
**WEST SUSSEX, BN17 6LD**  
**on behalf of**  
**THAKEHAM CLIENT LTD**

| <b>Date:</b> | <b>01/06/2021</b> |
| <b>Reference:</b> | <b>GE18103/VR/PLOTS 24-29 (Soil) &amp; All Plots (Gas)/JUN21</b> |

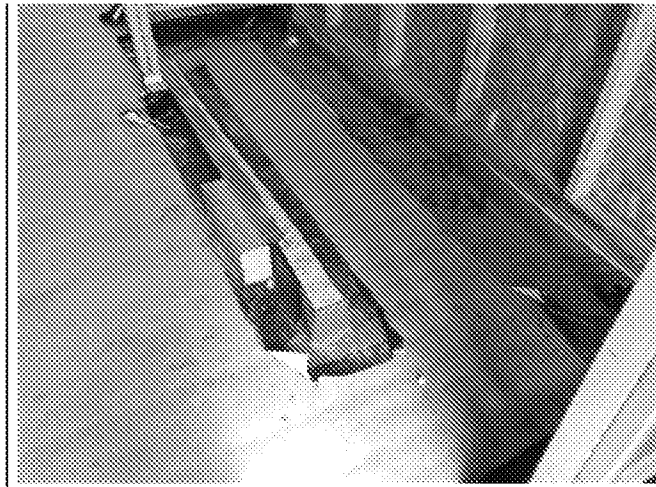
Plot 15 - Under stairs

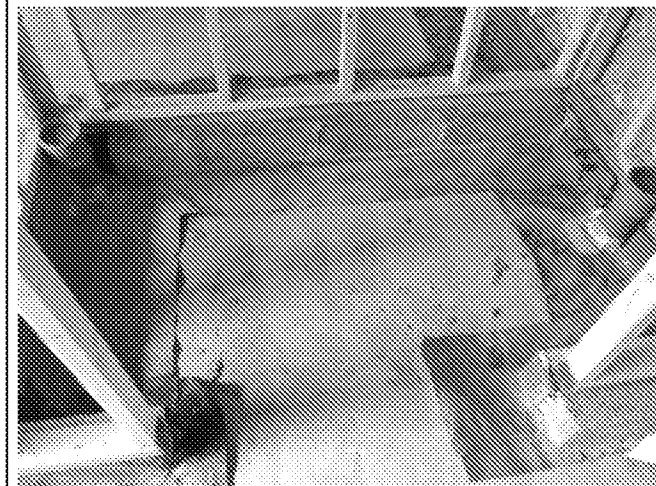
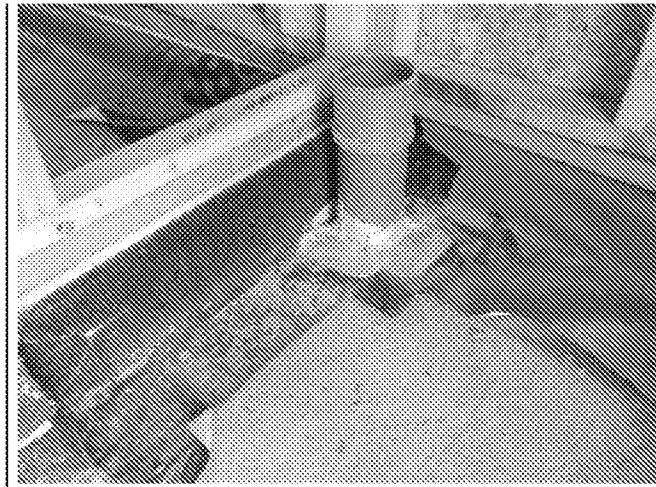
Plot 15 - Services sealed

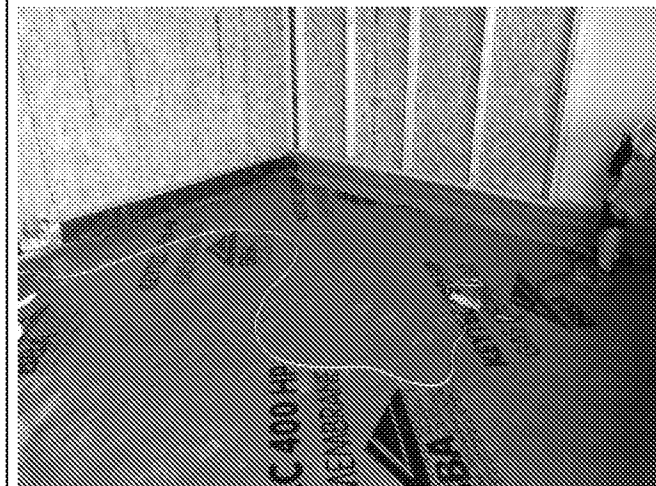
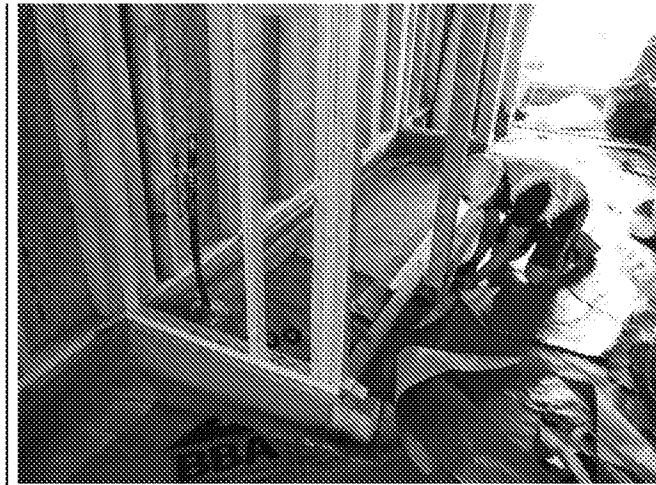
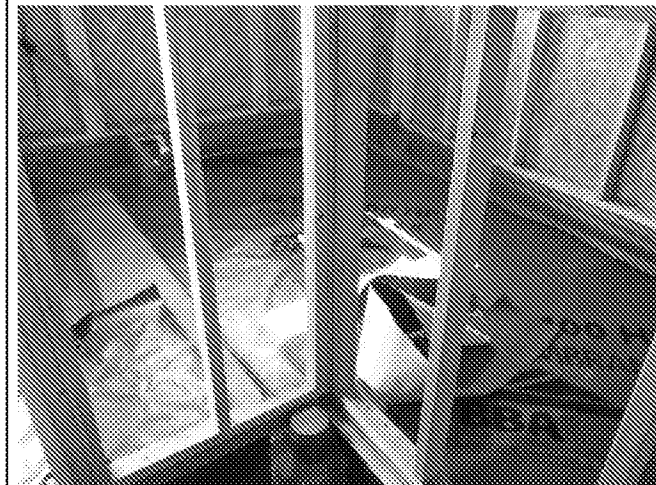
Plot 14 in progress

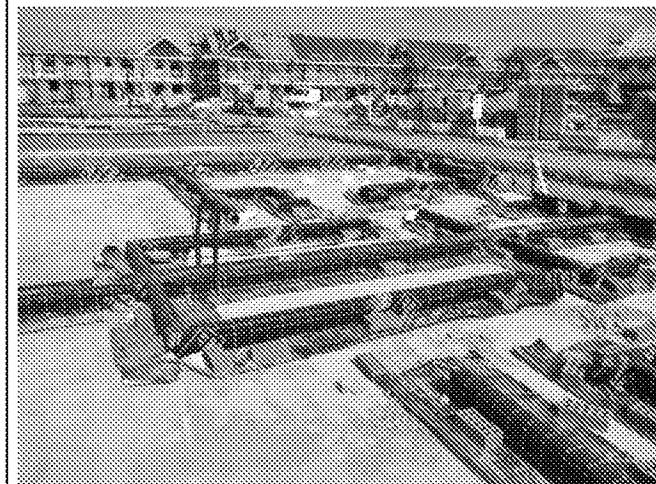
Plot 20-21(Phase 4) - View across plots

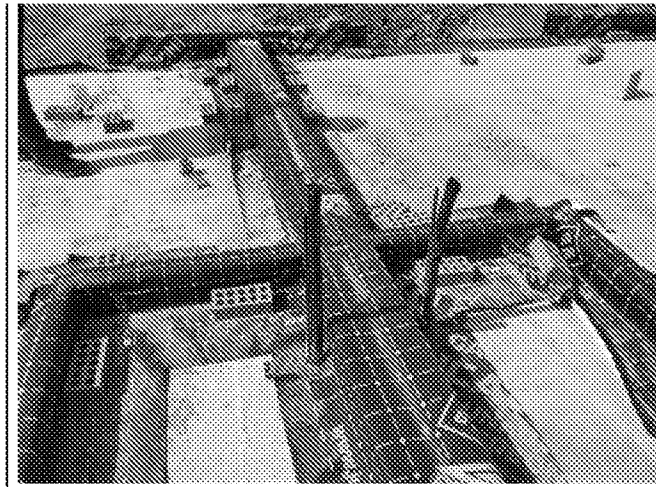
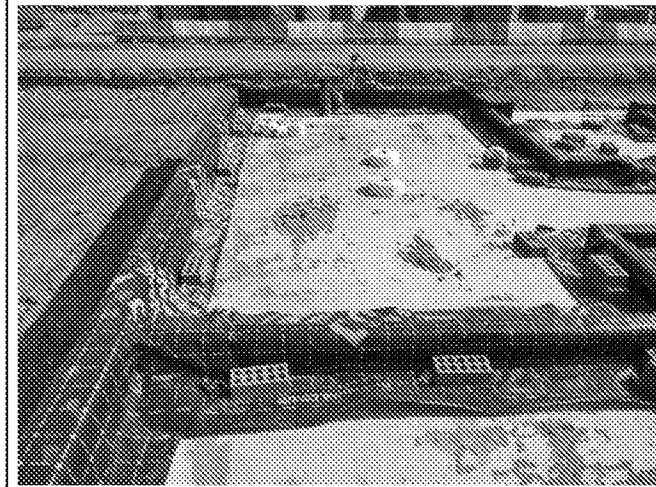
Plot 20-21(Phase 4)

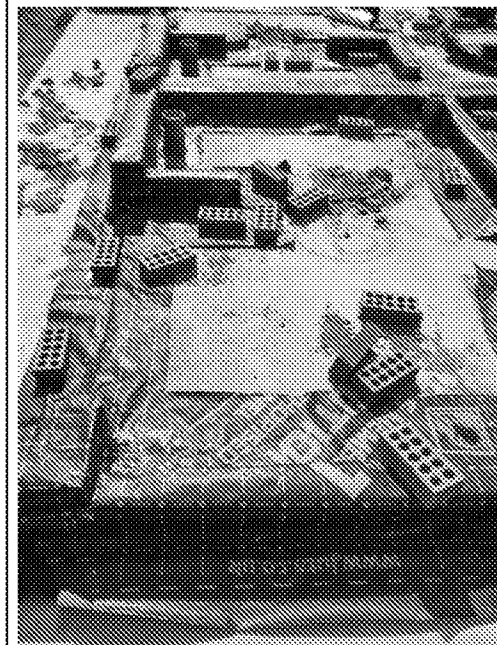
Plot 20-21(Phase 4) - walls and doorway

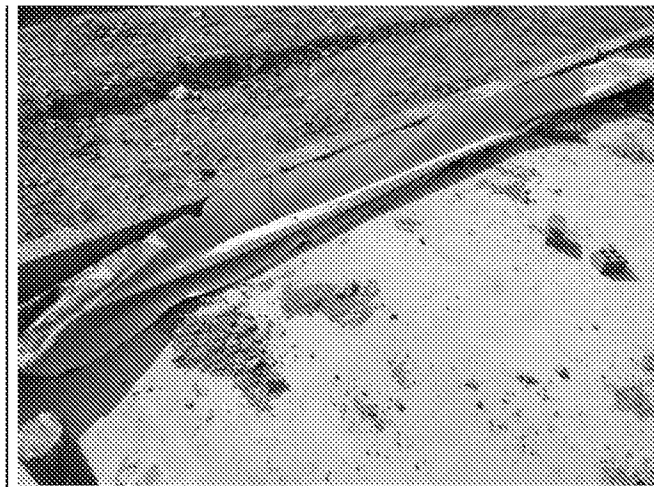
Plot 20-21(Phase 4) - Wind damage

Plot 20-21(Phase 4) - Damaged membrane will be replaced before bitumen tape placement

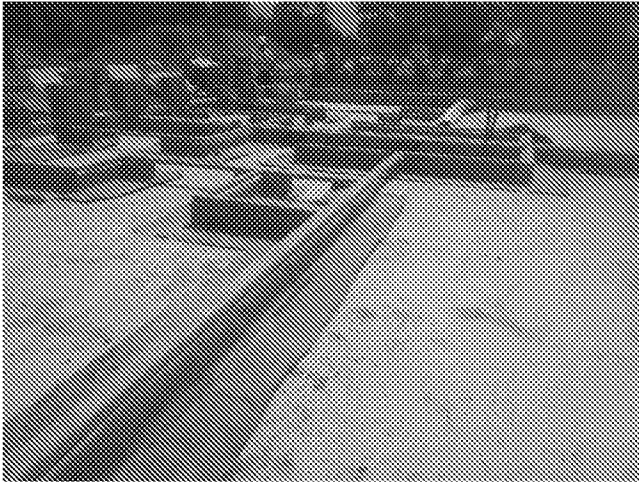
Plots 36-37. View across plots.

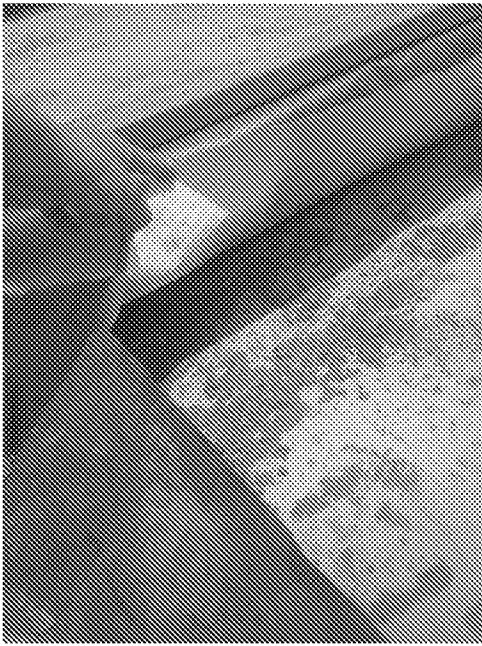
Plots 36-37. Example of underside of membrane.

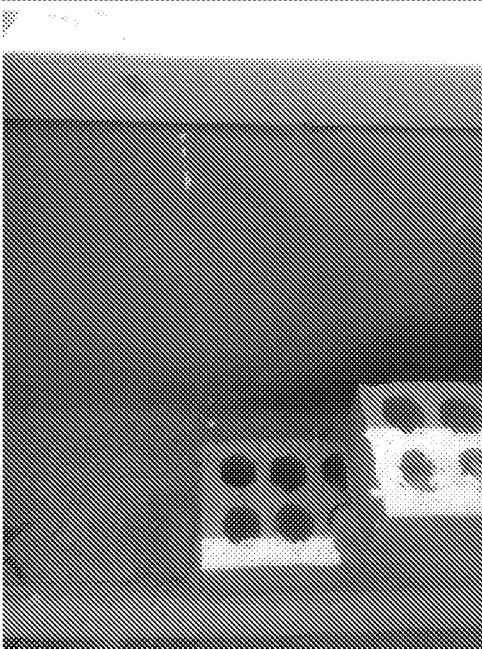
Plots 38-39. Example of weld.

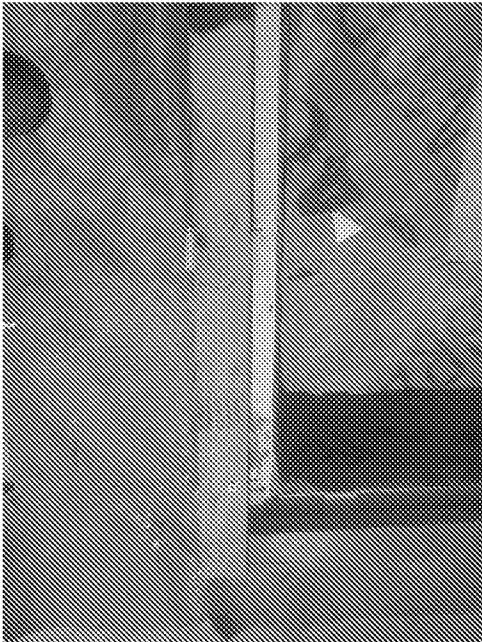
Plots 38-39. Example of butyl tape under wooden frame.

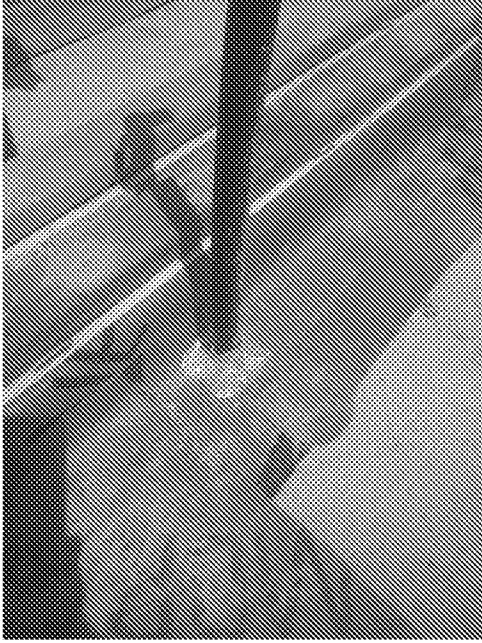
Plots 38-39. Service seal using foil backed butyl tape.

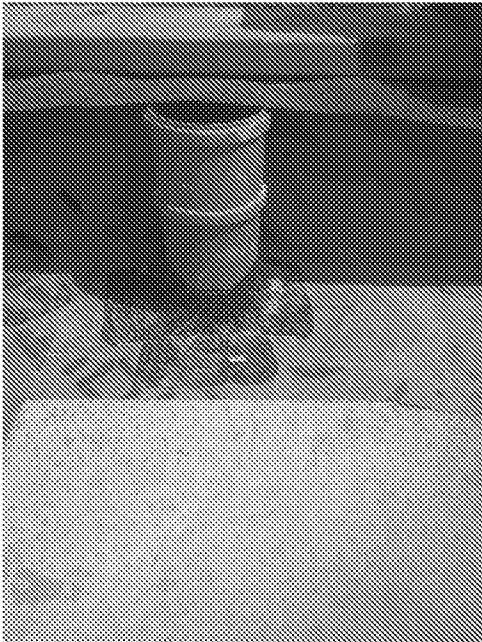
Plots 38-39. Service seal using butyl tape.

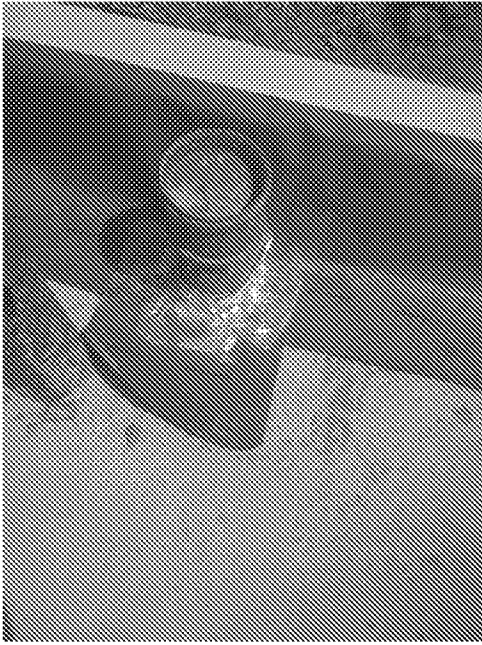
Plot 40-41. Servicing seal.

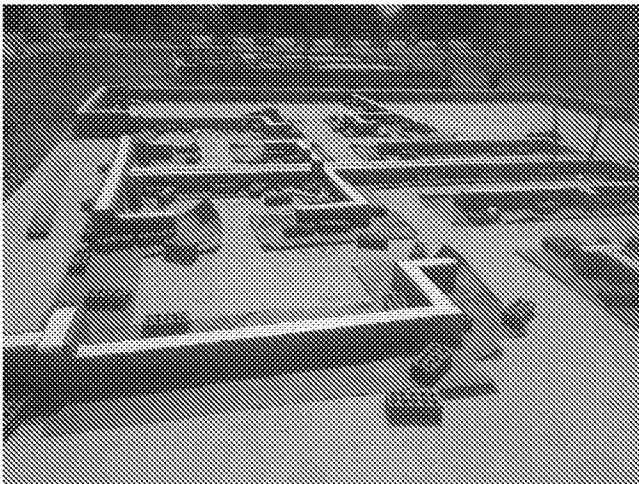
Plots 40-41. View across Plots showing butyl tape laid out for fixture of wooden frame.

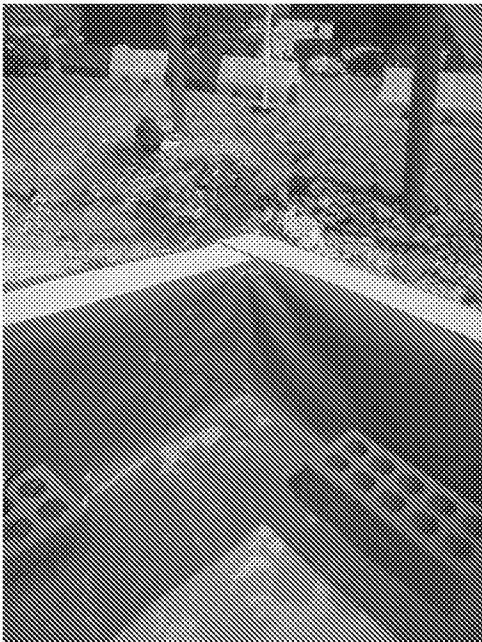
Plots 40-41. Corner detail.

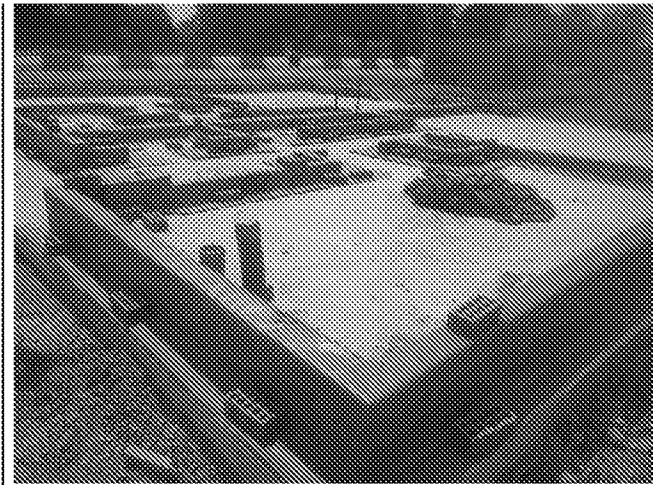
Plots 42-43. View across plots.

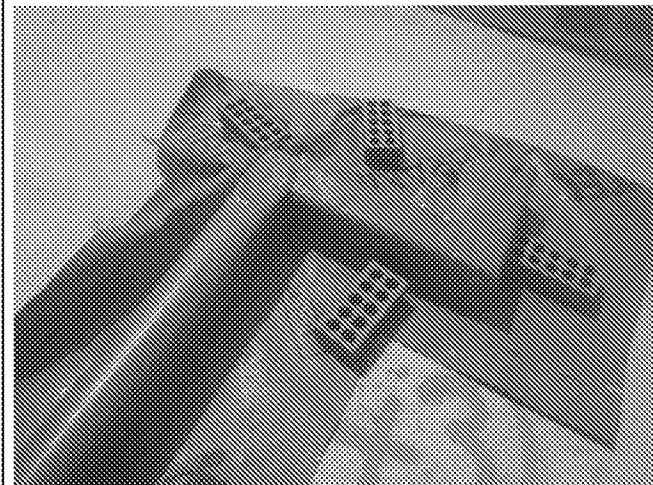
Plots 42-43. Corner detail.

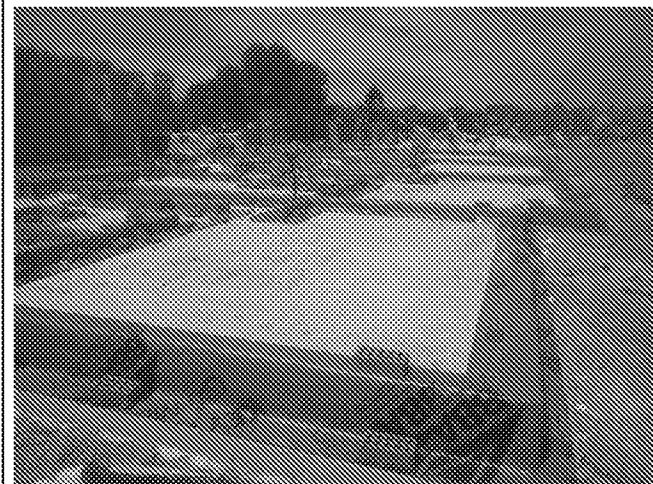
Plots 24-27. View across plots.

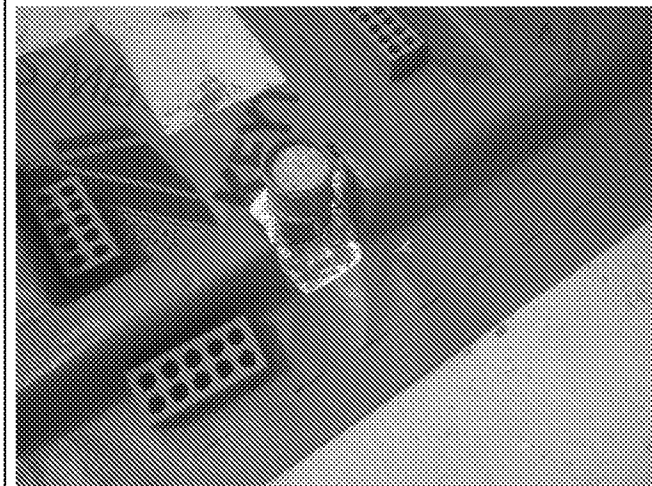
Plots 24-27. Service seal.

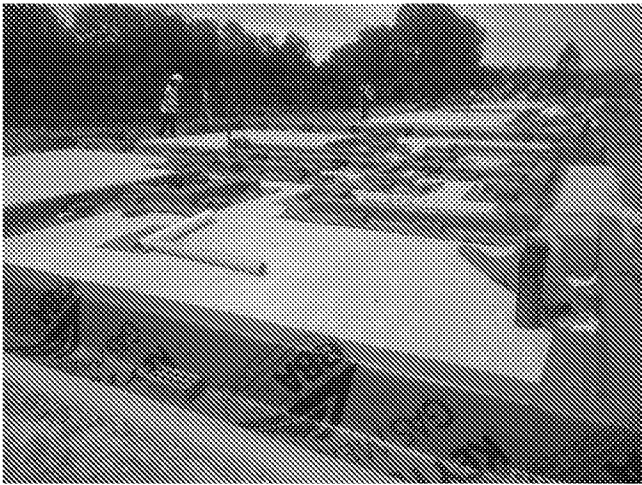
| | Plots 22-23. View across plots. |

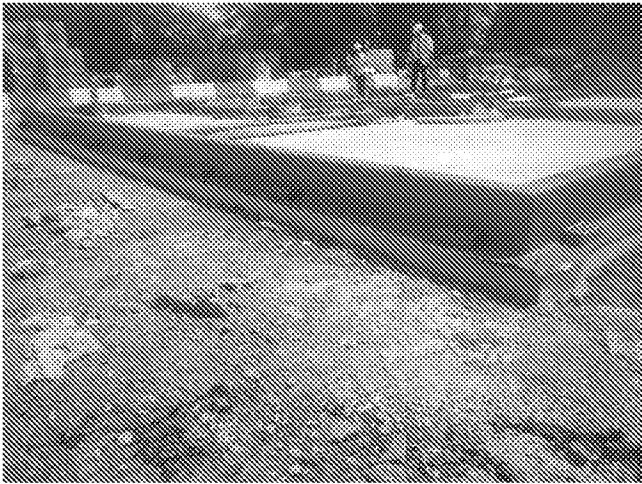
| | Plots 22-23. Lapping over external wall. |

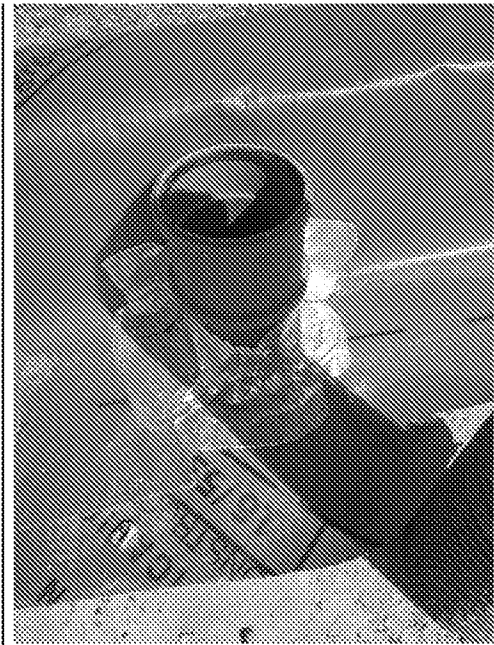
Plot 23 services

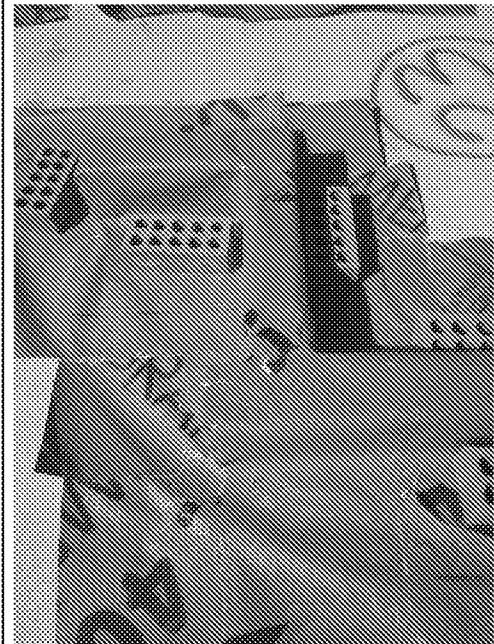
Plot 23 corners

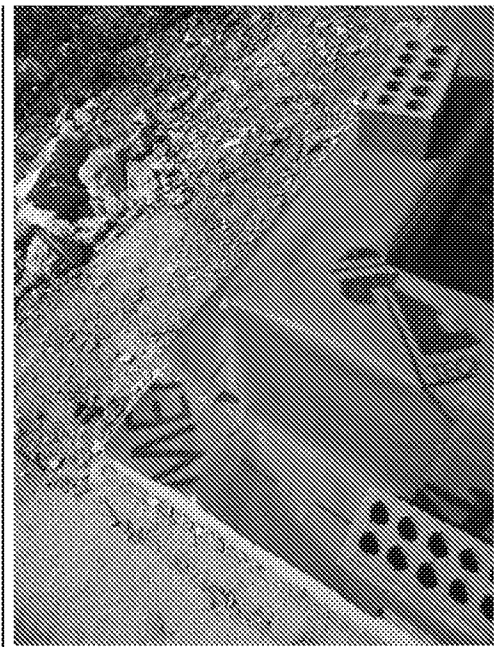
Plot 23 corner

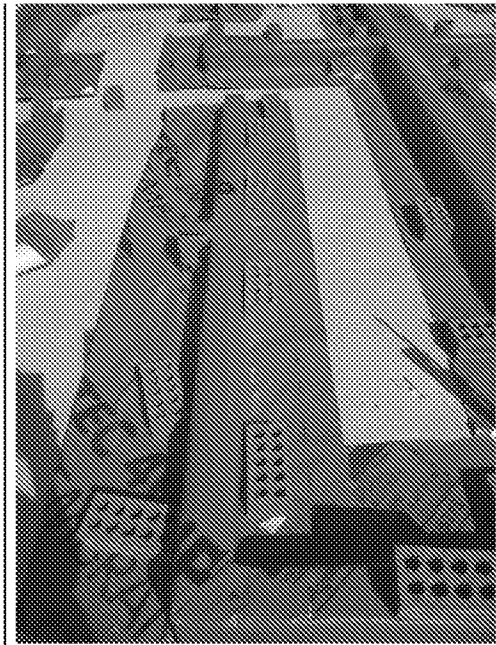
Plot 22 walls

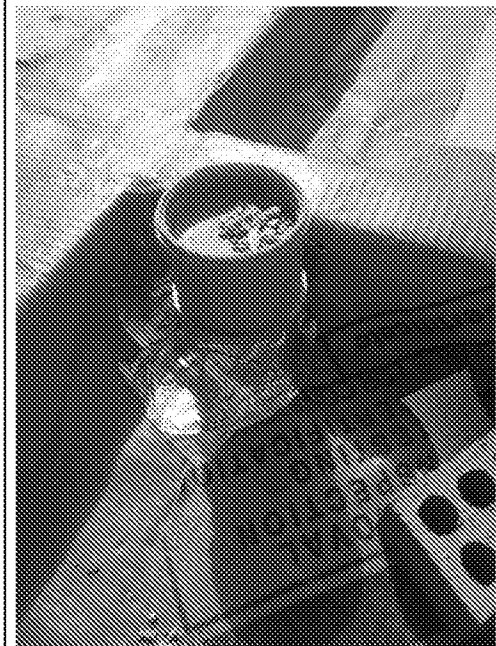
Plot 22 service detail

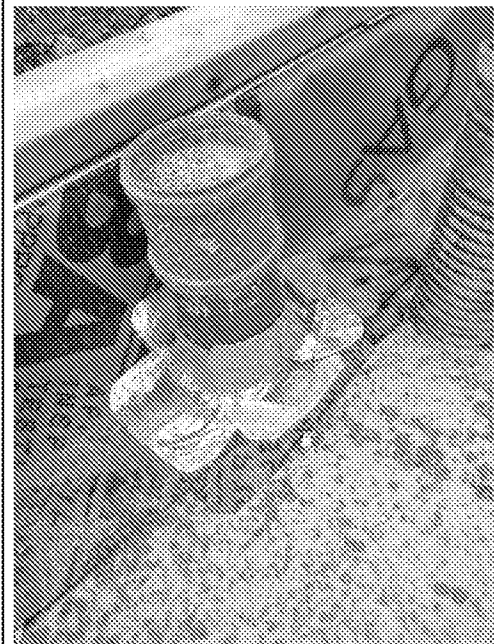
Plot 24 services

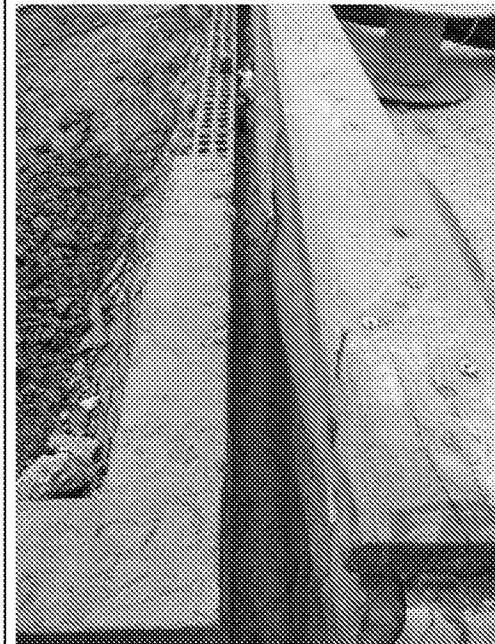
Plot 24 cavity

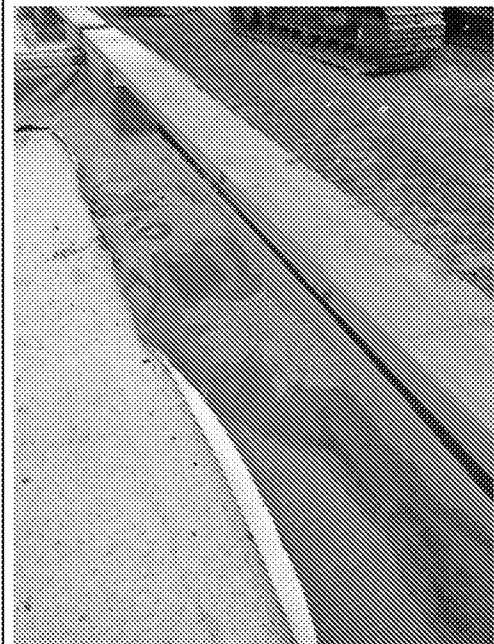
Plot 25 threshold

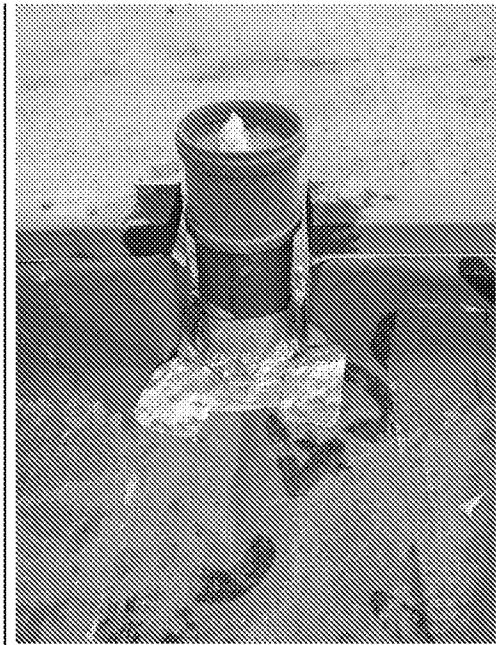
Plot 25 service

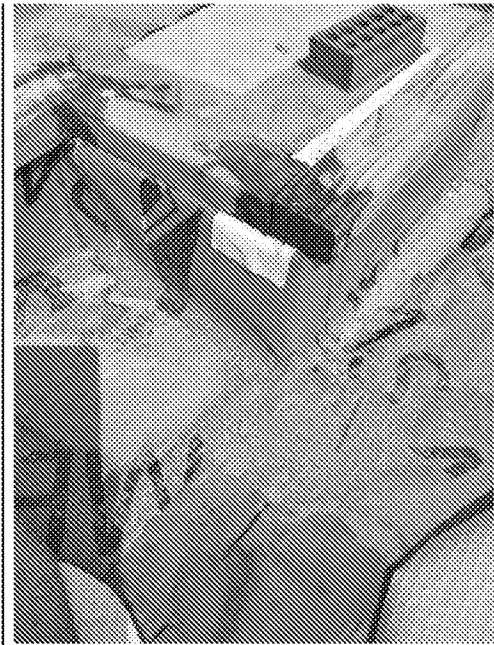
Plot 26 corner

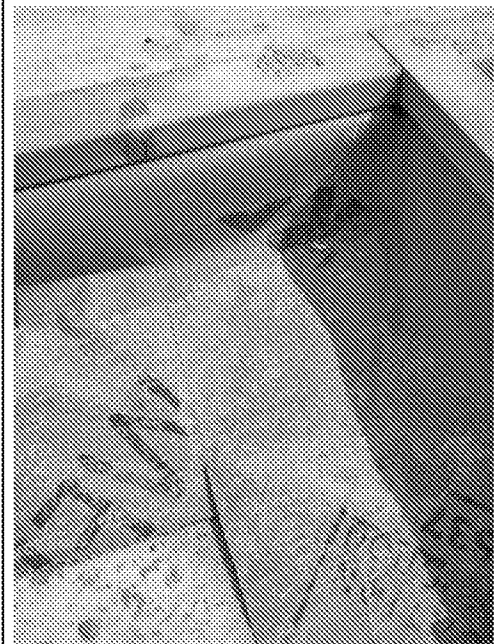
Plot 26 lapping

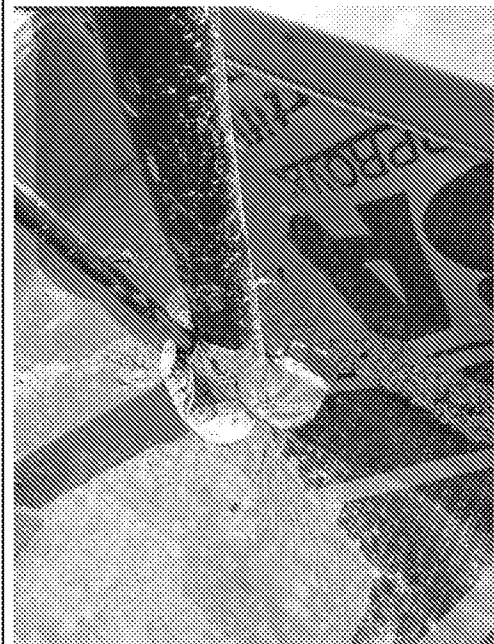
Plot 27 service

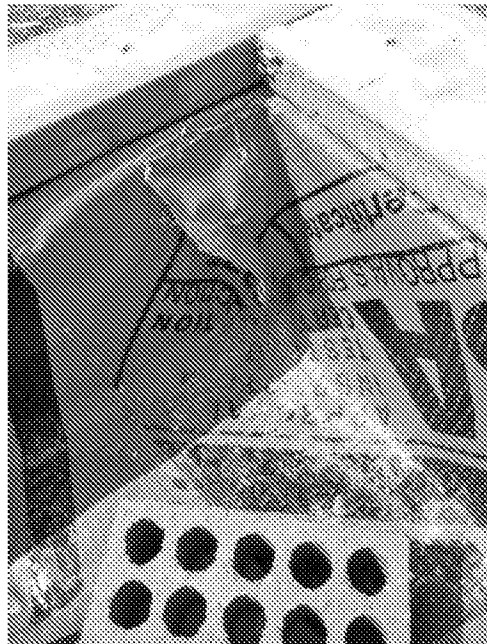
Plot 28 corner needs sealing

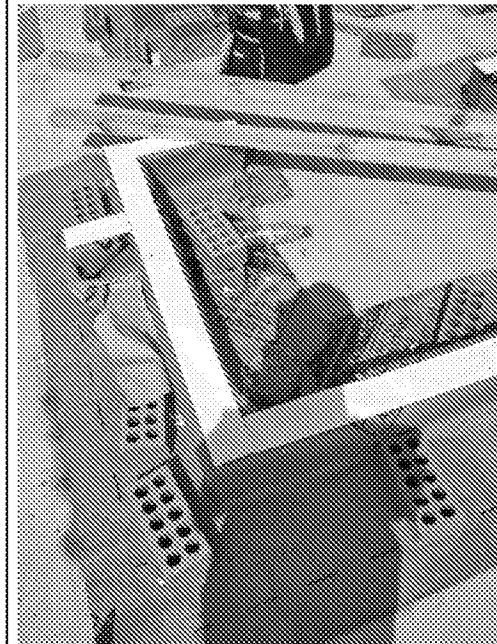
Plot 28 tape for frame

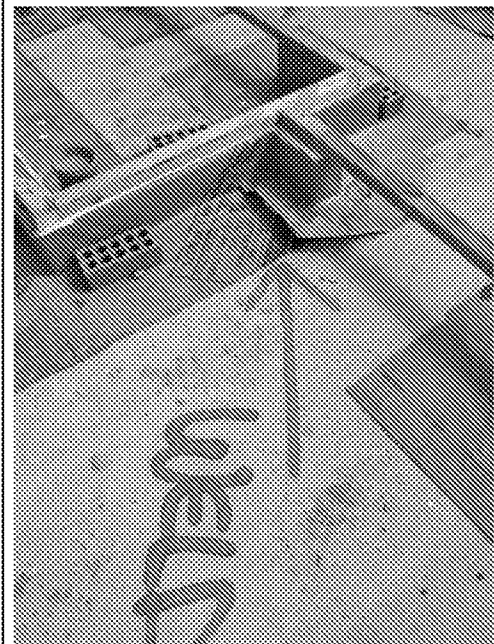
Plot 31 seal needs attention

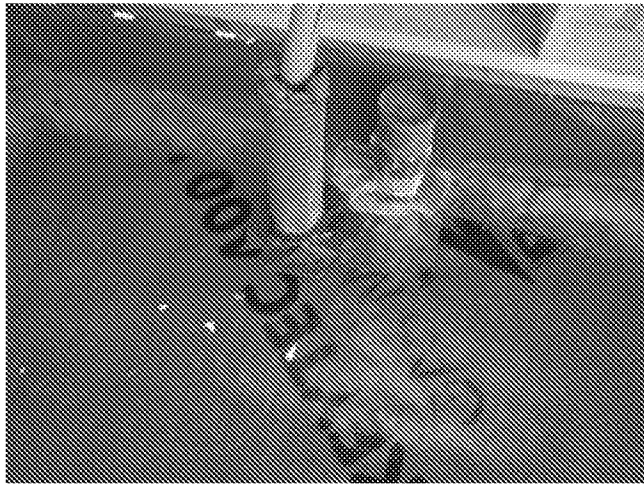
Plot 40 - example of service seal

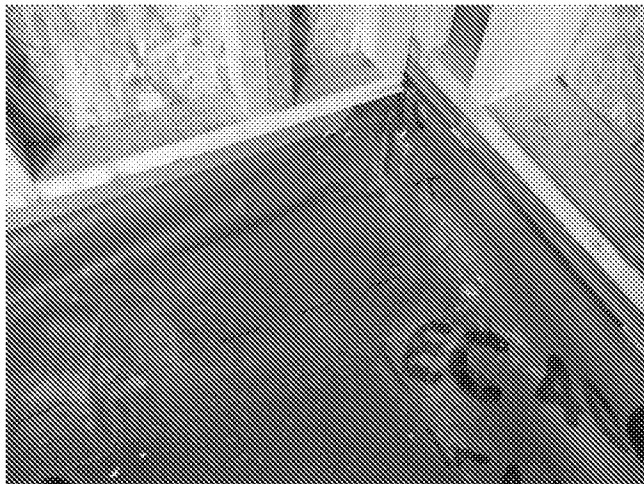
Plot 40 - Corner detail

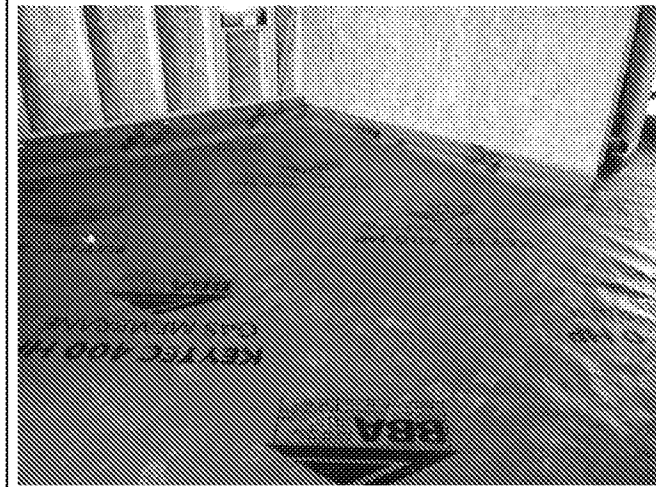
Plot 40 - floors sealed
