Inspection Report

| Site ; 468<br>Place ; LITTLEHAMPTON | | Division:<br>District:<br>Tape No: 1 | | Start MH: PPCP 30<br>End MH: LAT 1<br>Total Length: | |

## 468 Littlehampton - Defects

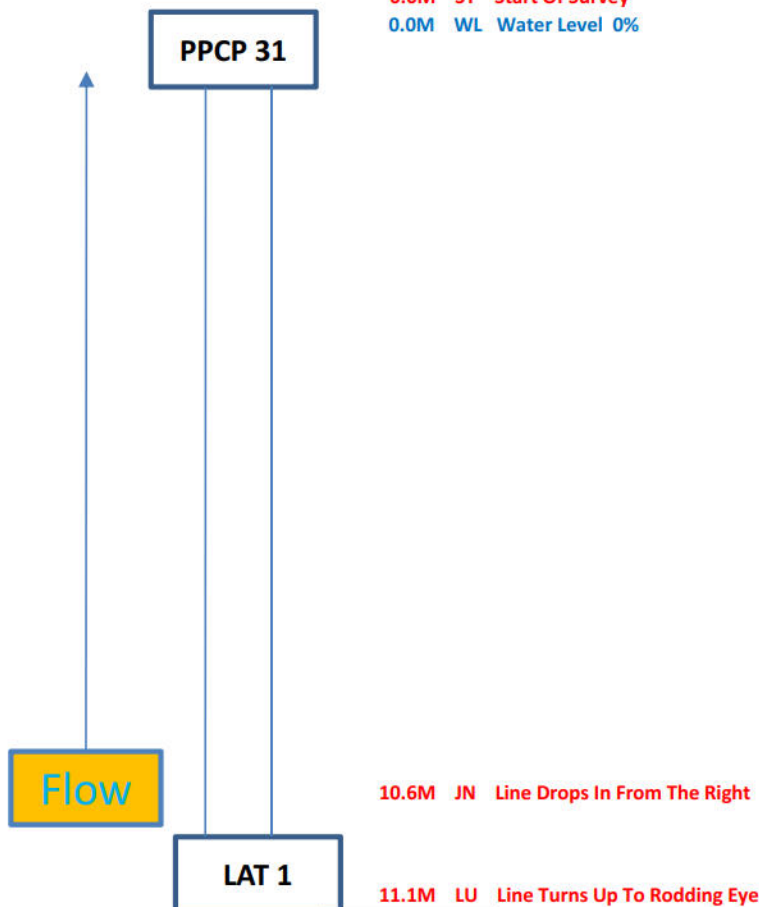
REM; THERE ARE NO MAJOR DEFECTS WITH THIS SECTION OF PIPE

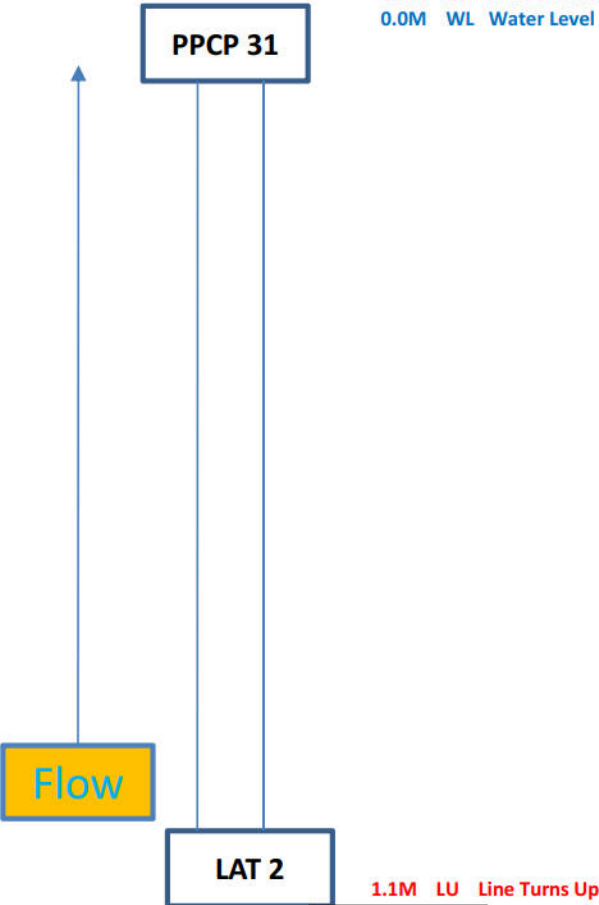
REM; THERE ARE NO MAJOR DEFECTS WITH THIS SECTION OF PIPE

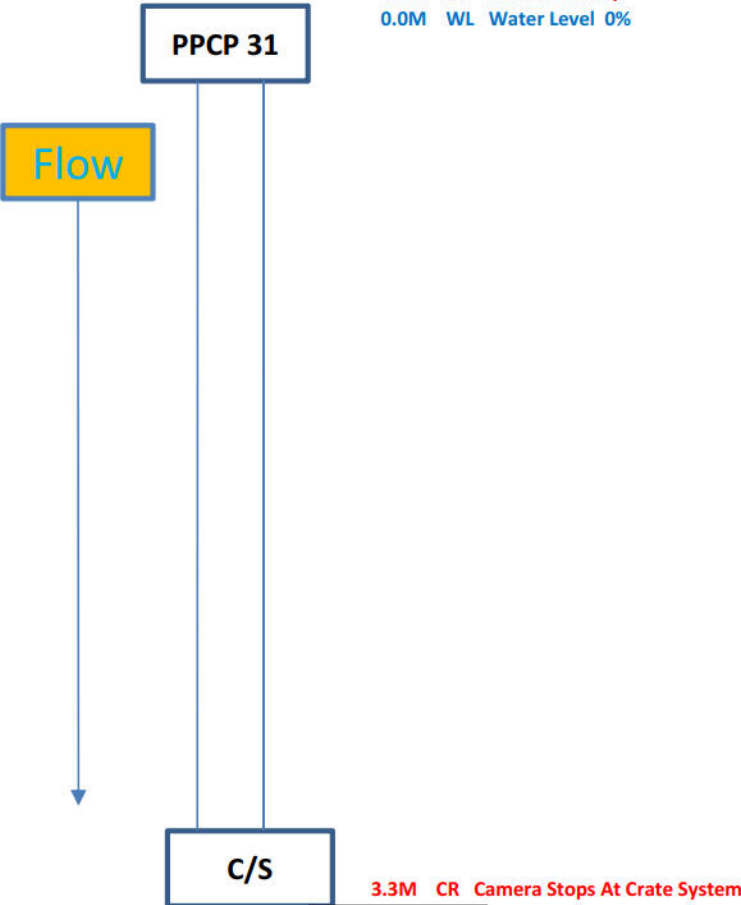
REM; THERE ARE NO MAJOR DEFECTS IN THIS SECTION OF PIPE

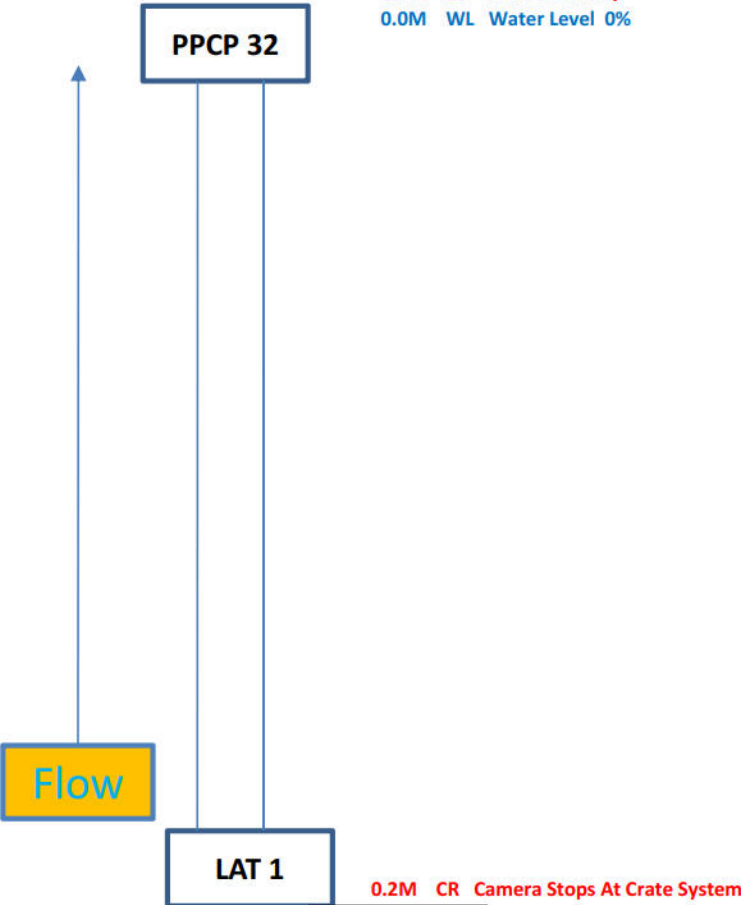
REM; THERE ARE NO MAJOR DEFECTS WITH THIS SECTION OF PIPE

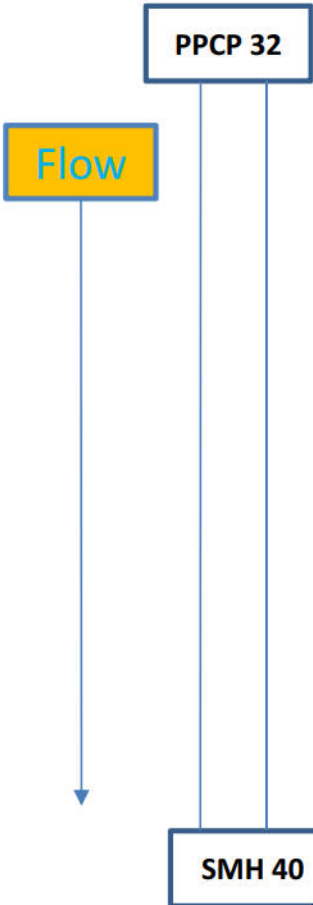
0.5M MC Pipe Changes To Clay

8.1M MH Camera Enters Manhole SMH 40

REM; THERE ARE NO MAJOR DEFECTS IN THIS SECTION OF PIPE

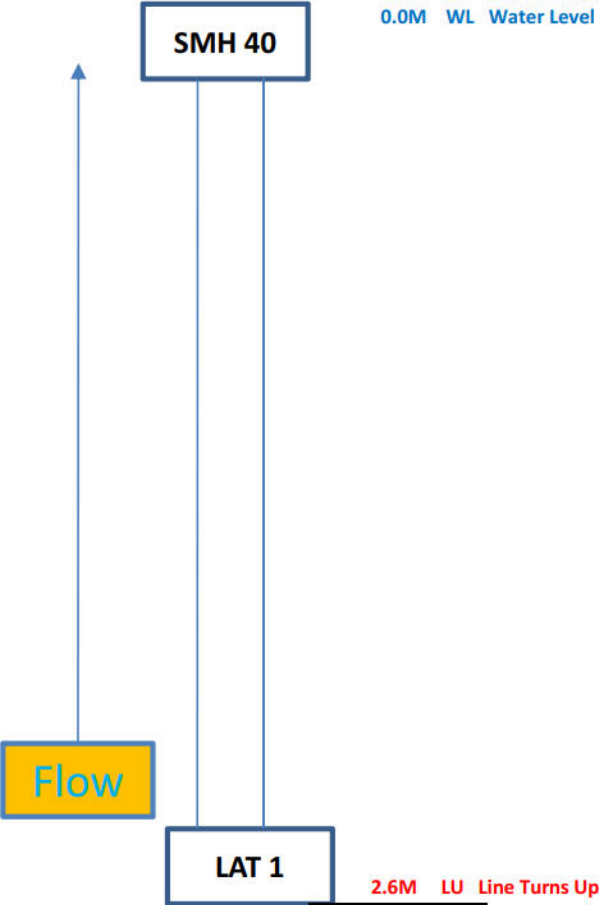
REM; THERE ARE NO MAJOR DEFECTS WITH THIS SECTION OF PIPE

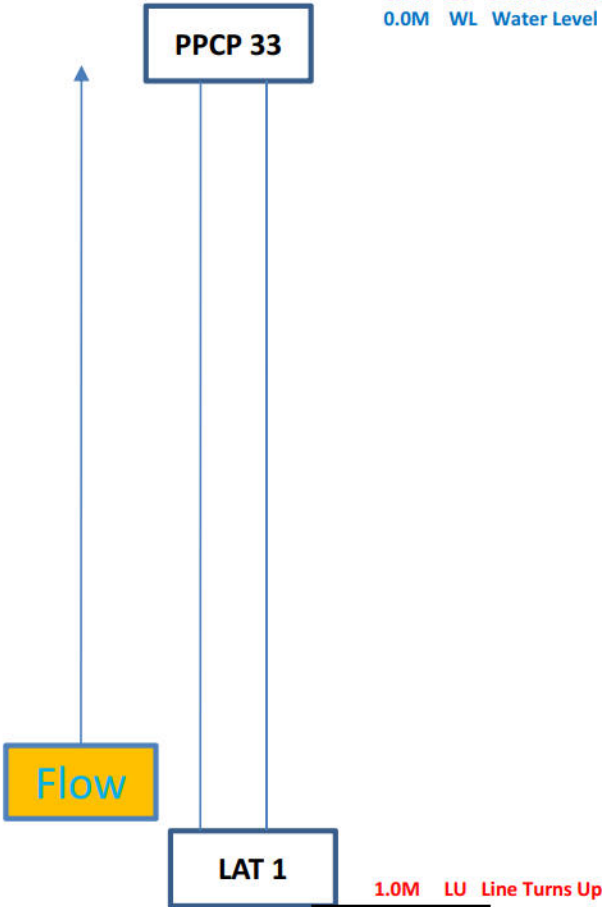
REM; THERE ARE NO MAJOR DEFECTS WITH THIS SECTION OF PIPE

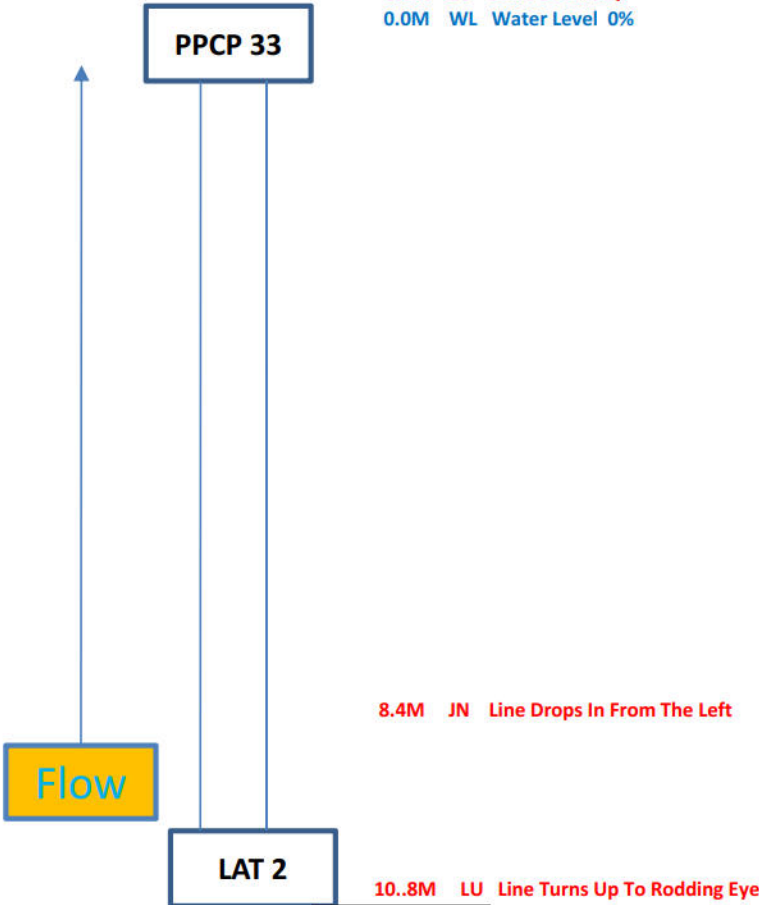
REM; THERE ARE NO MAJOR DEFECTS WITH THIS SECTION OF PIPE

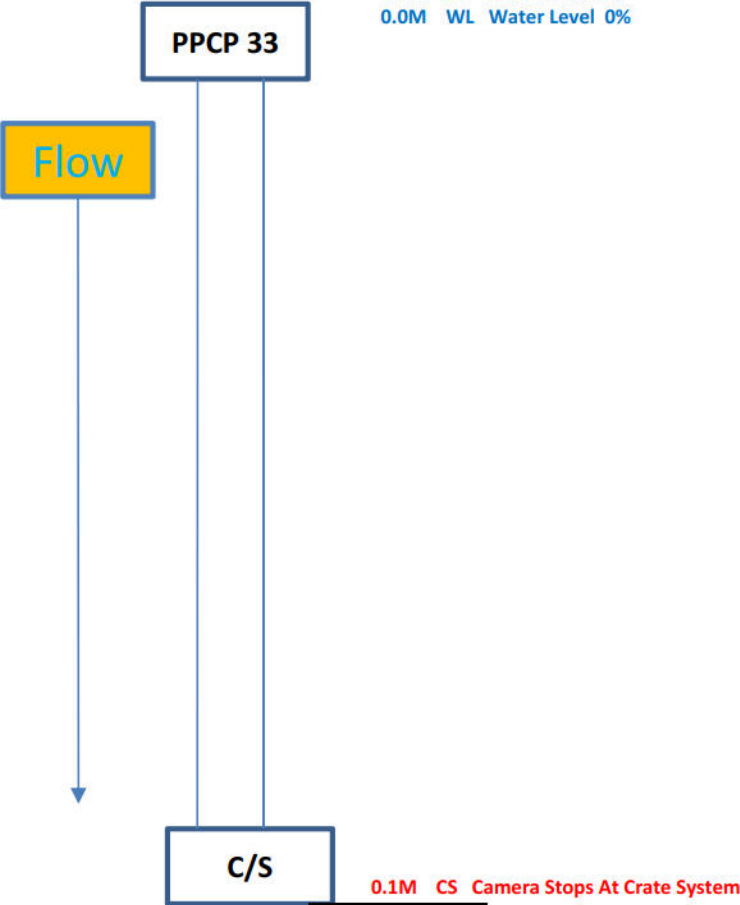
REM; THERE ARE NO MAJOR DEFECTS IN THIS SECTION OF PIPE

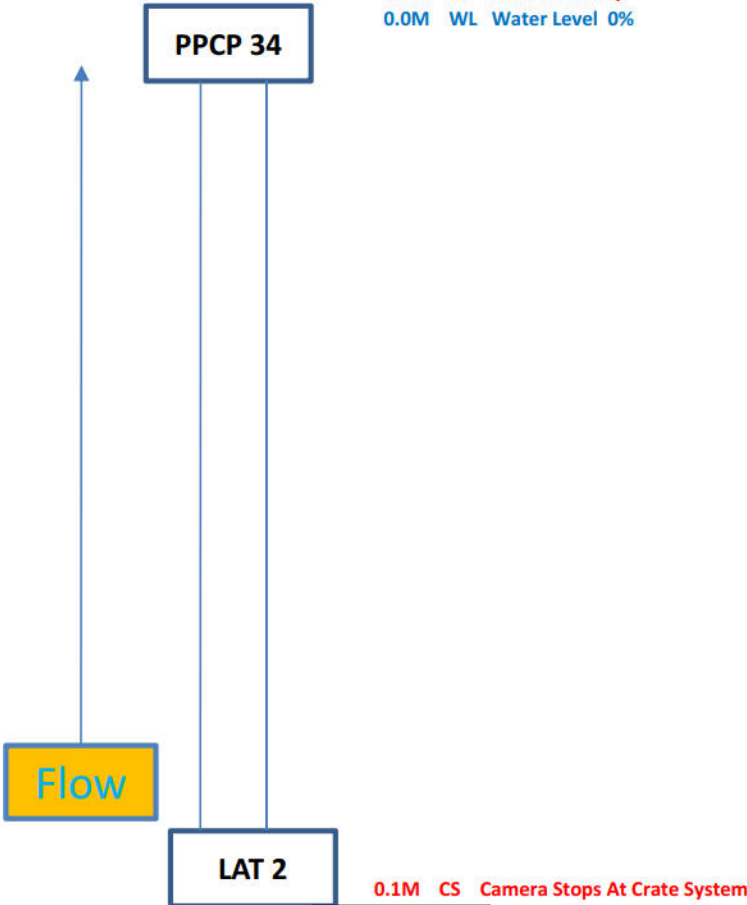
REM; THERE ARE NO MAJOR DEFECTS WITH THIS SECTION OF PIPE

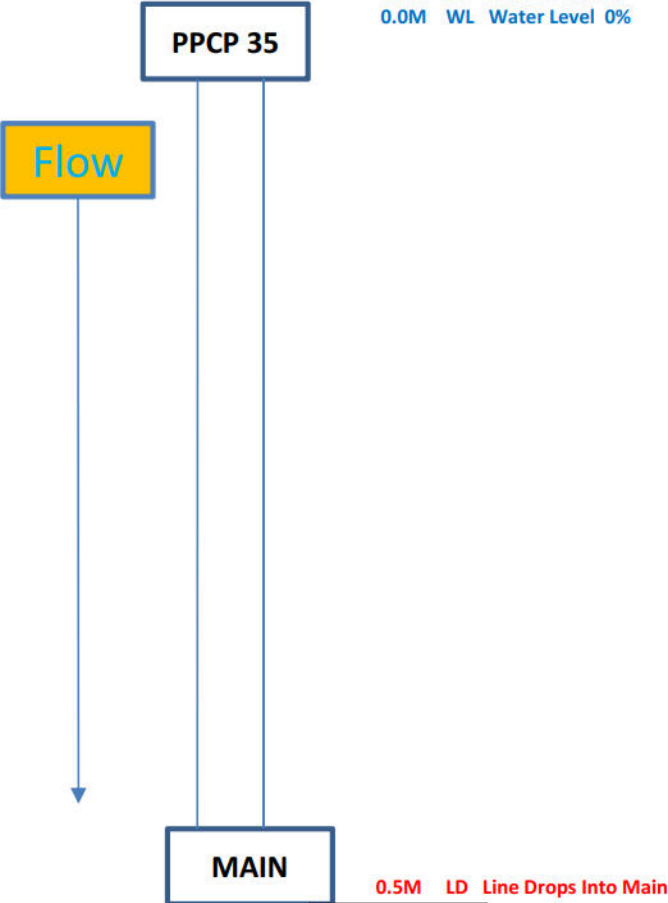
REM; THERE ARE NO MAJOR DEFECTS IN THIS SECTION OF PIPE

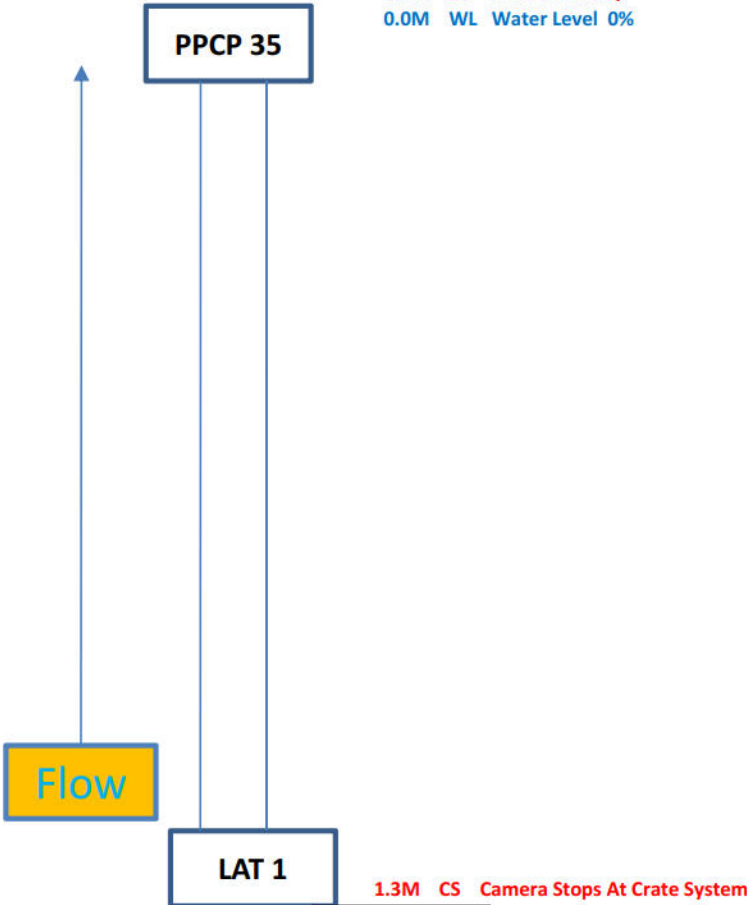
REM; THERE ARE NO MAJOR DEFECTS WITH THIS SECTION OF PIPE

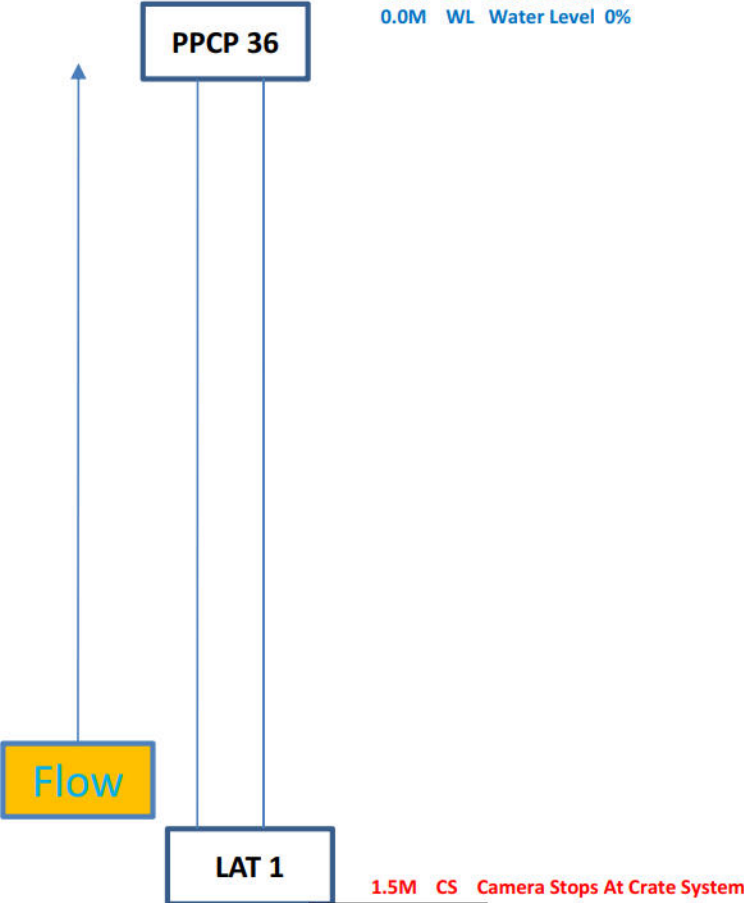
REM; THERE ARE NO MAJOR DEFECTS WITH THIS SECTION OF PIPE

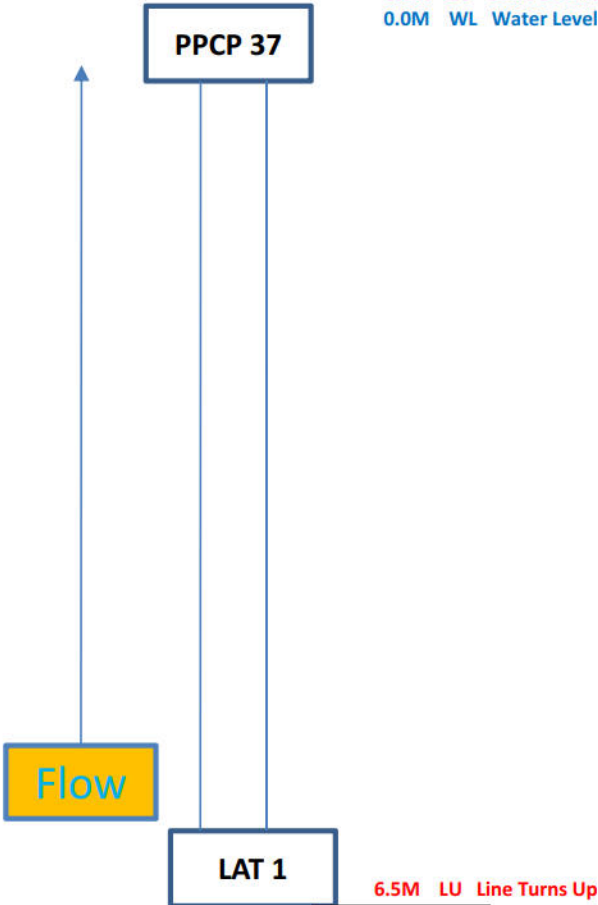
REM; THERE ARE NO MAJOR DEFECTS WITH THIS SECTION OF PIPE

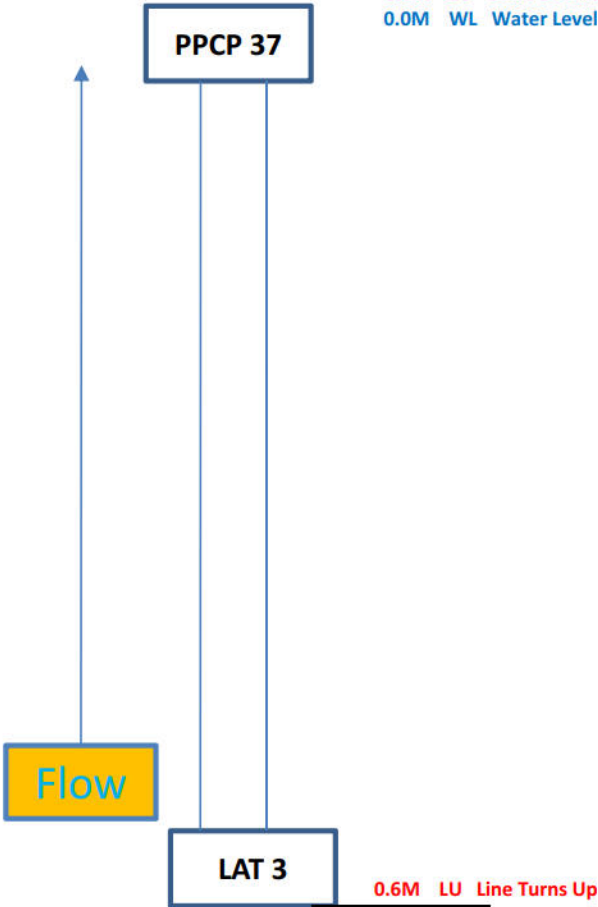
REM; THERE ARE NO MAJOR DEFECTS WITH THIS SECTION OF PIPE

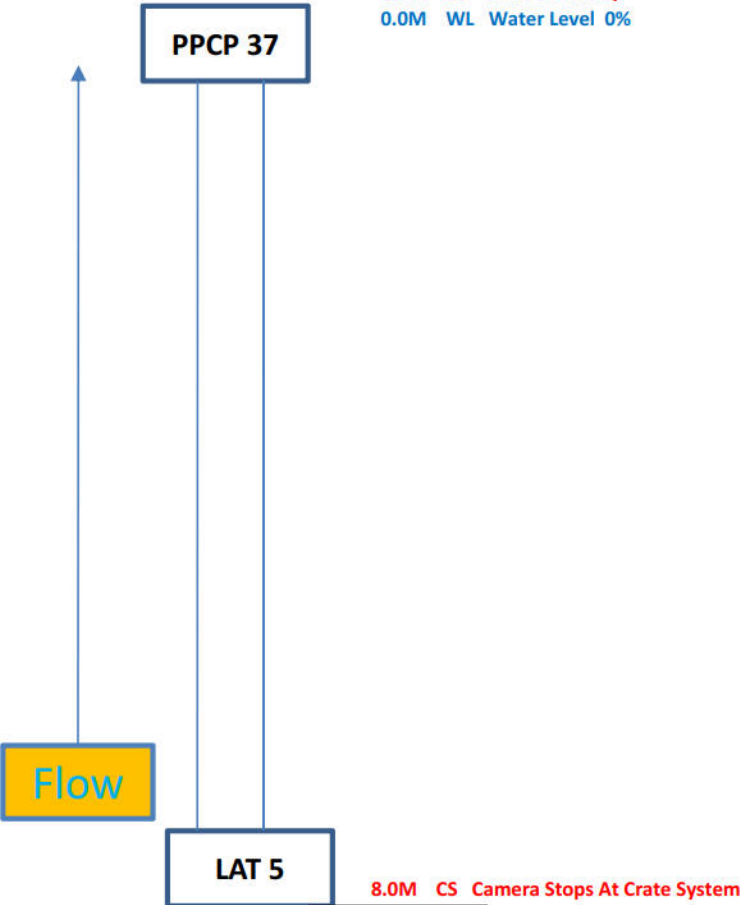
REM; THERE ARE NO MAJOR DEFECTS WITH THIS SECTION OF PIPE

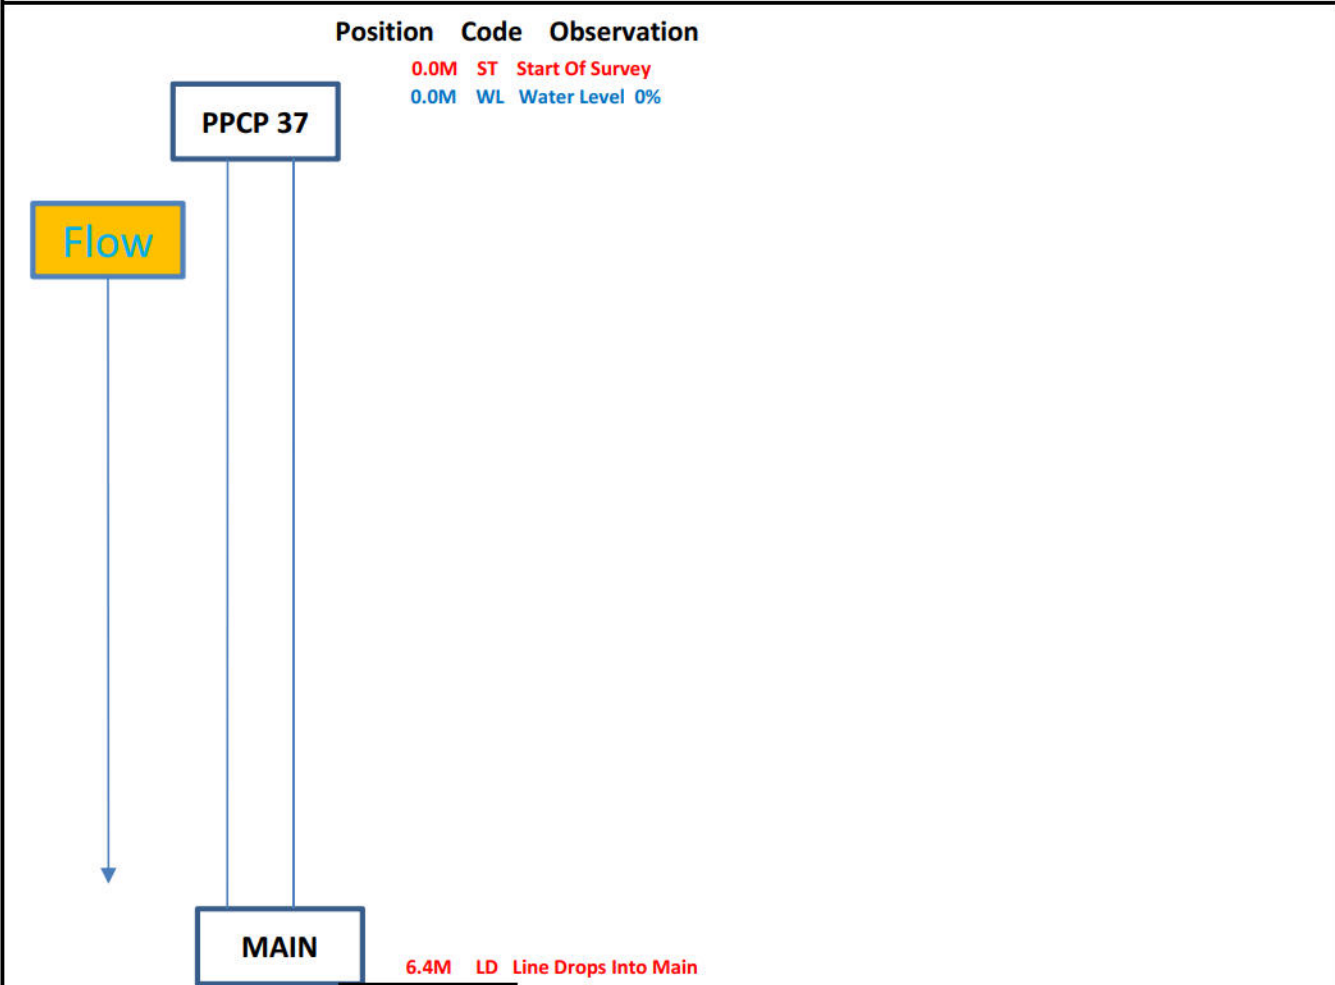
REM; THERE ARE NO MAJOR DEFECTS IN THIS SECTION OF PIPE

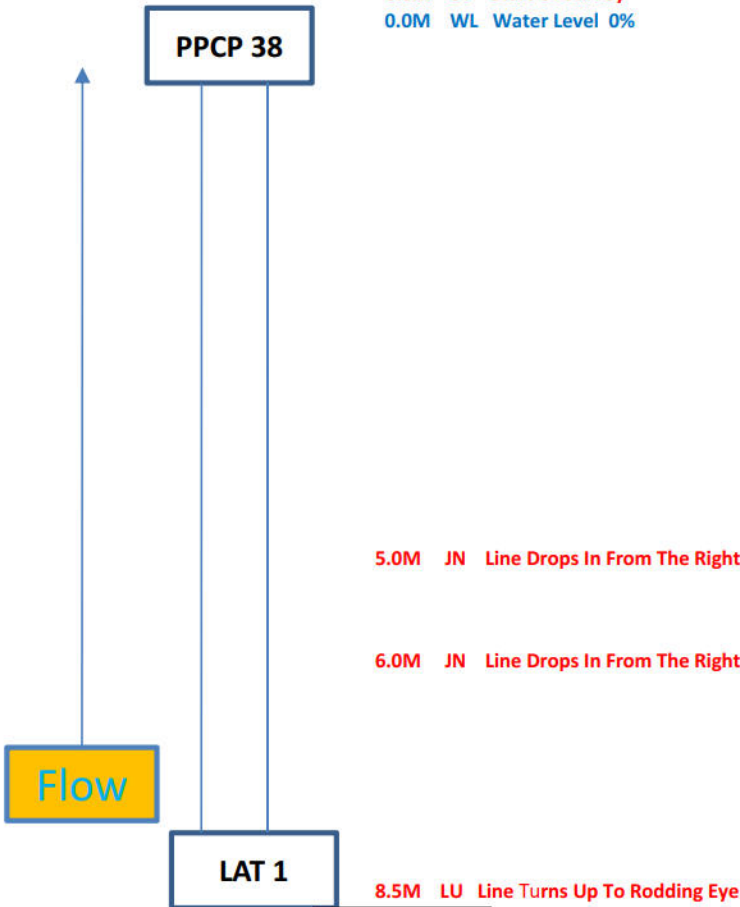
REM; THERE ARE NO MAJOR DEFECTS WITH THIS SECTION OF PIPE

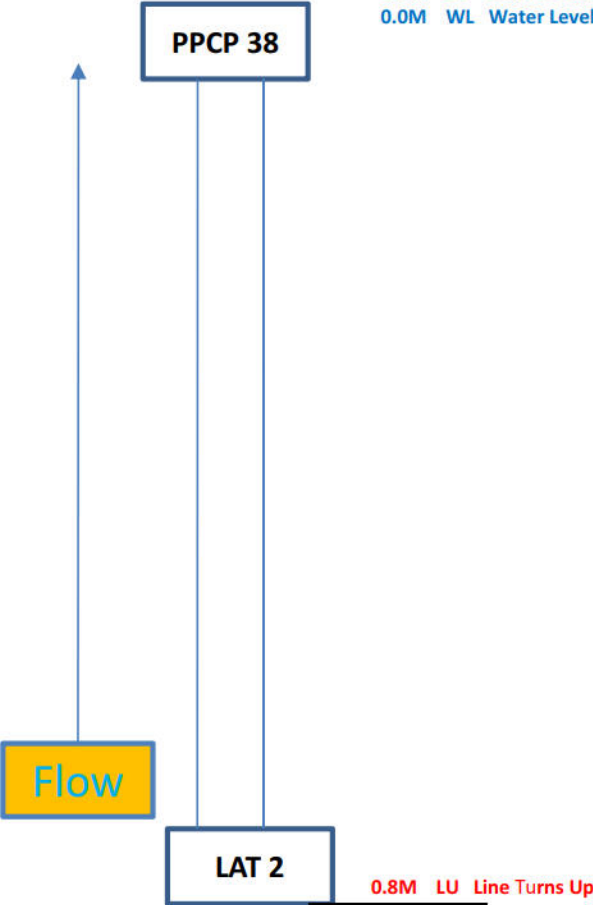
REM; THERE ARE NO MAJOR DEFECTS WITH THIS SECTION OF PIPE

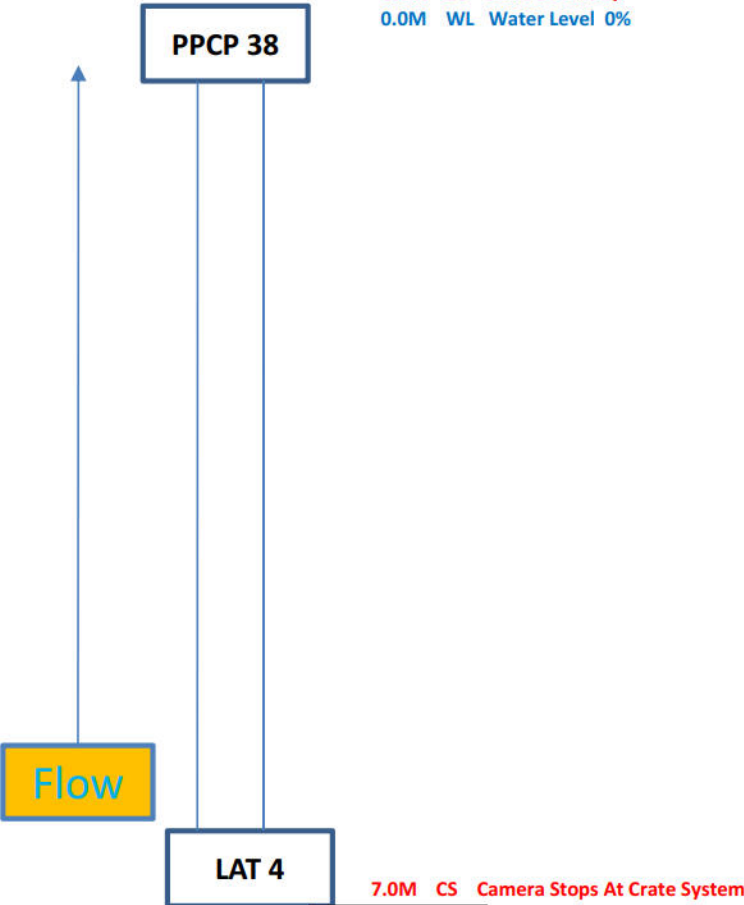
REM; THERE ARE NO MAJOR DEFECTS WITH THIS SECTION OF PIPE

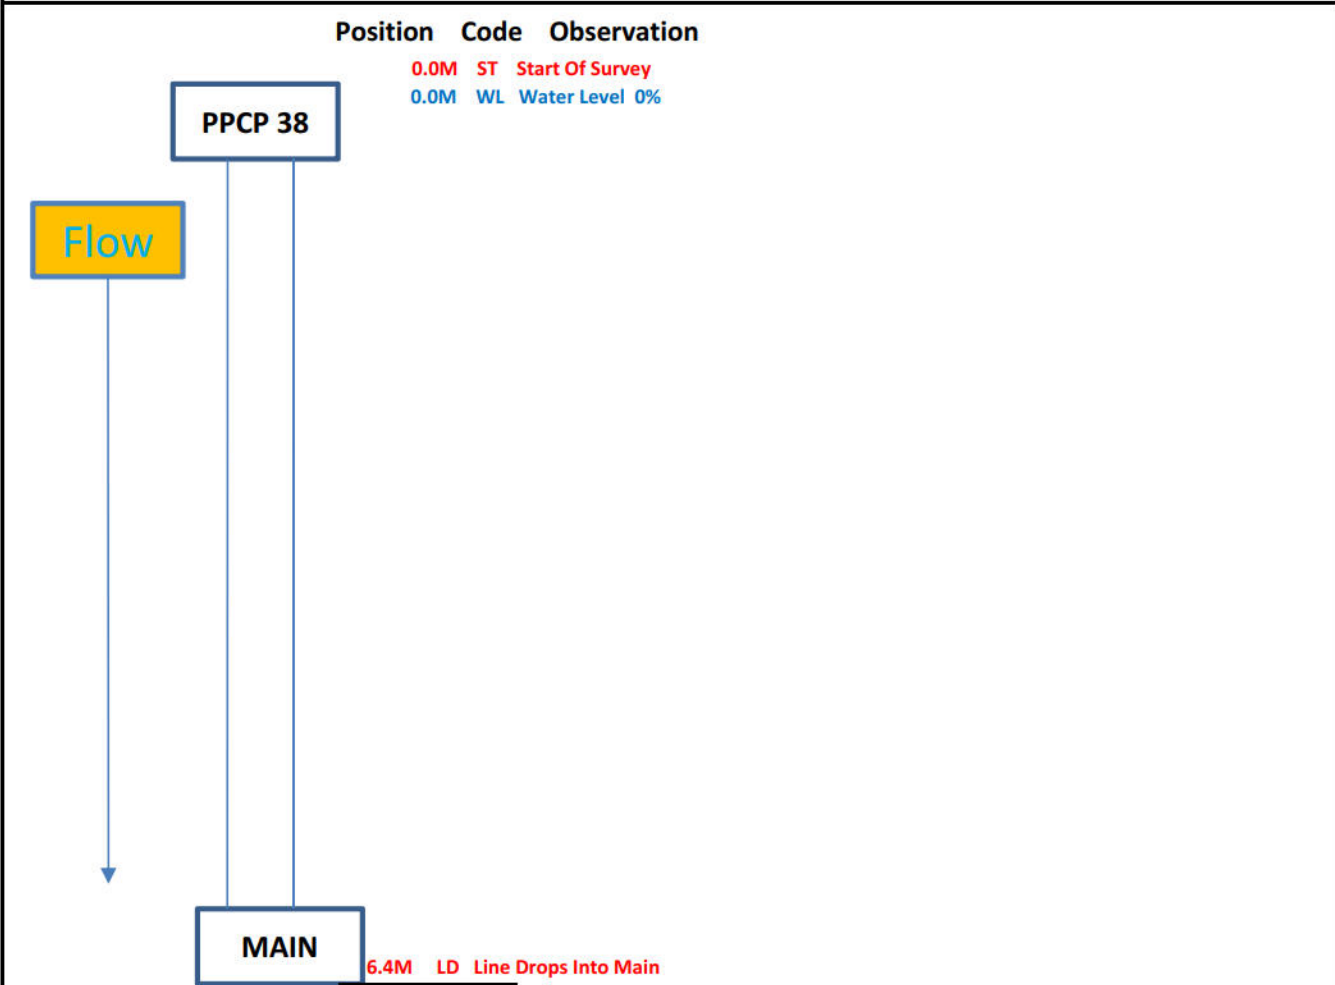
REM; THERE ARE NO MAJOR DEFECTS WITH THIS SECTION OF PIPE

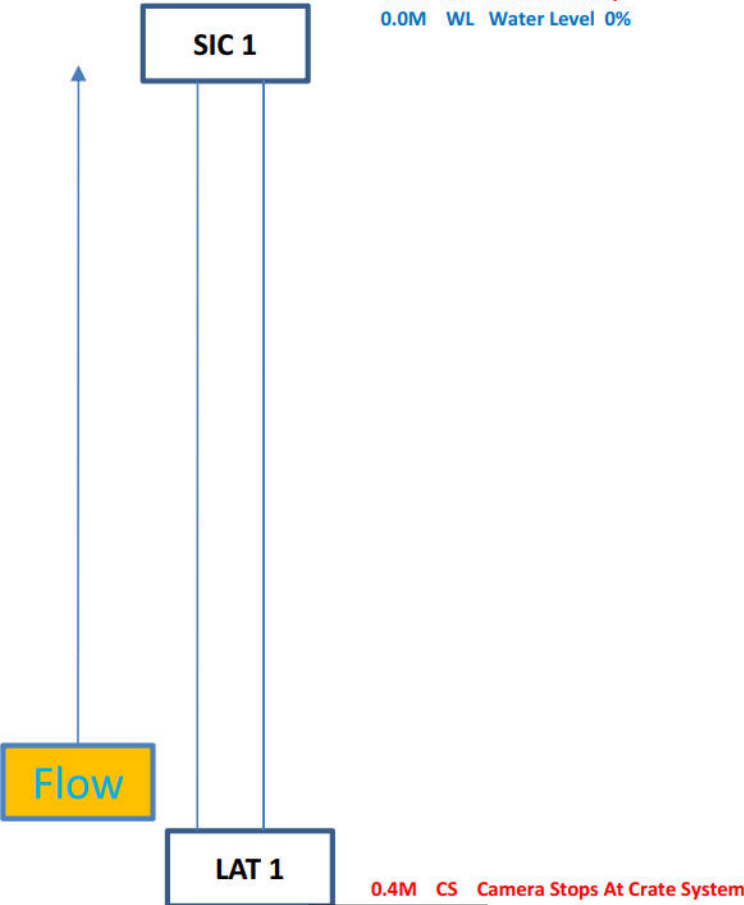
REM; THERE ARE NO MAJOR DEFECTS WITH THIS SECTION OF PIPE

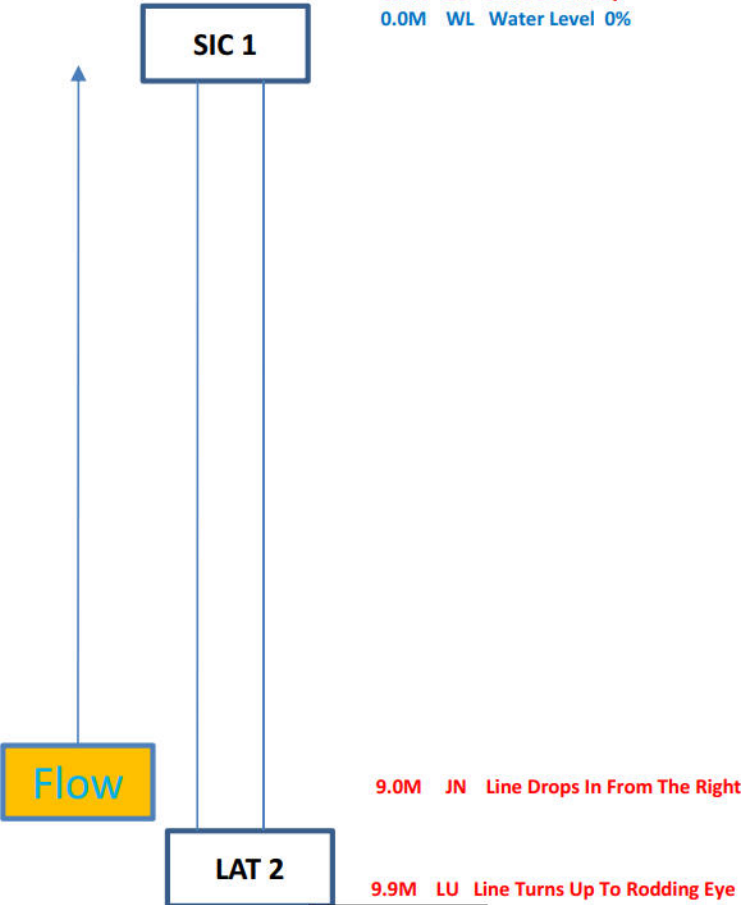
REM; THERE ARE NO MAJOR DEFECTS WITH THIS SECTION OF PIPE

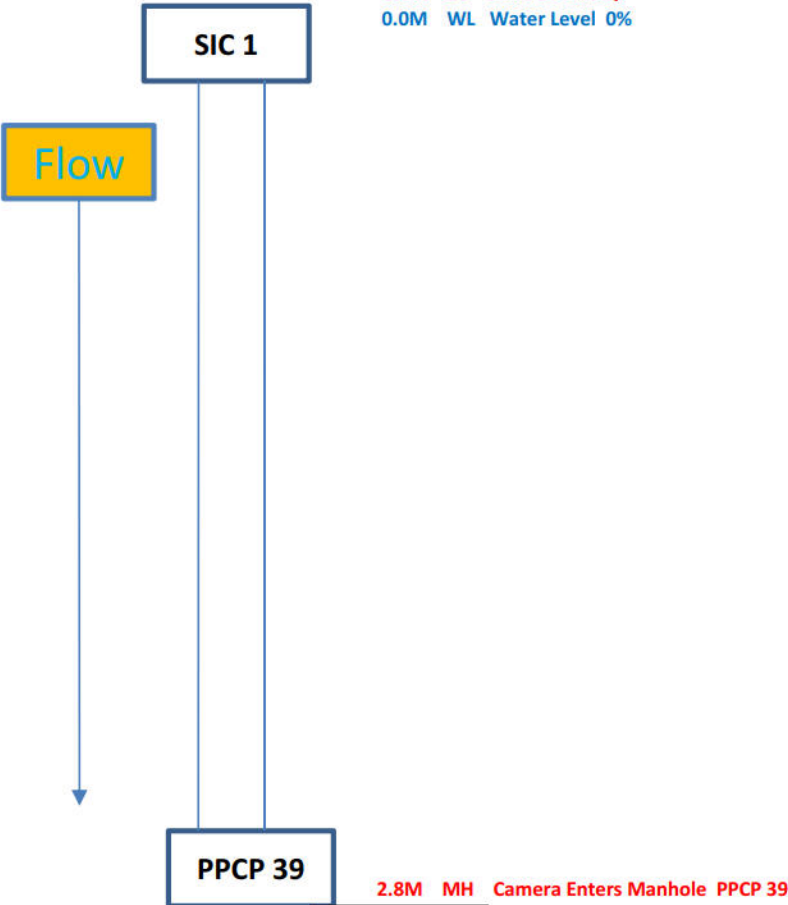
REM; THERE ARE NO MAJOR DEFECTS WITH THIS SECTION OF PIPE

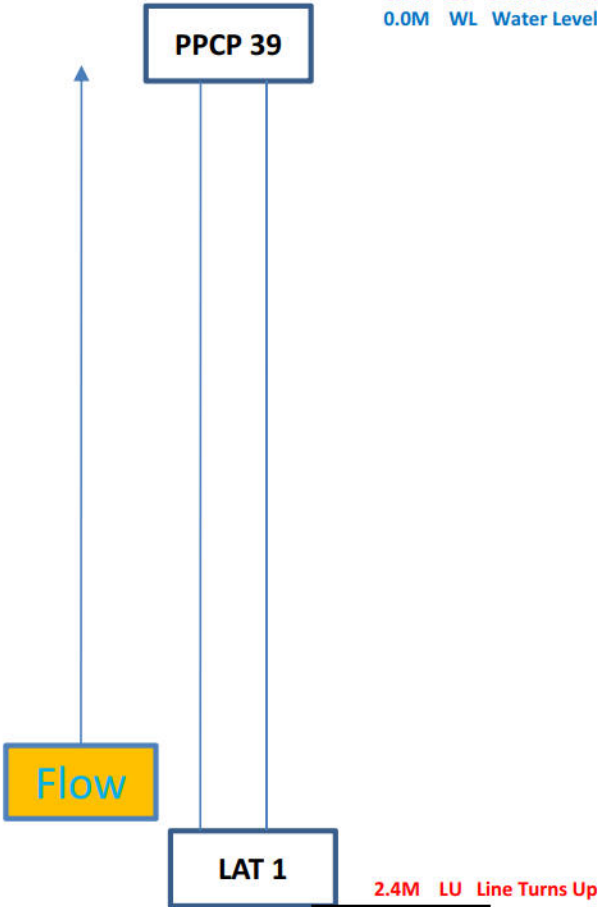
REM; THERE ARE NO MAJOR DEFECTS WITH THIS SECTION OF PIPE

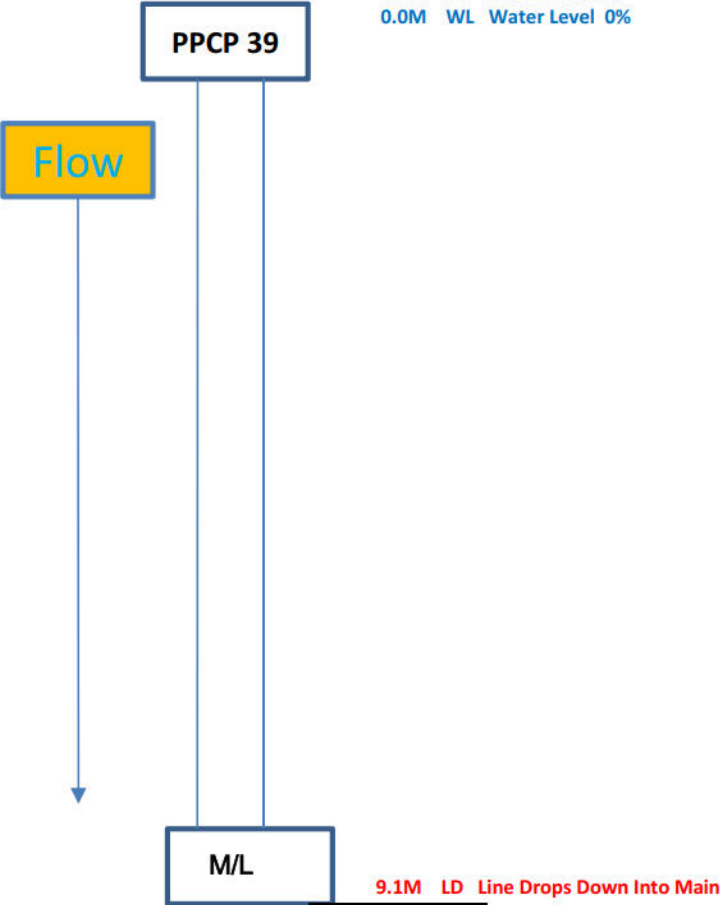
REM; THERE ARE NO MAJOR DEFECTS WITH THIS SECTION OF PIPE

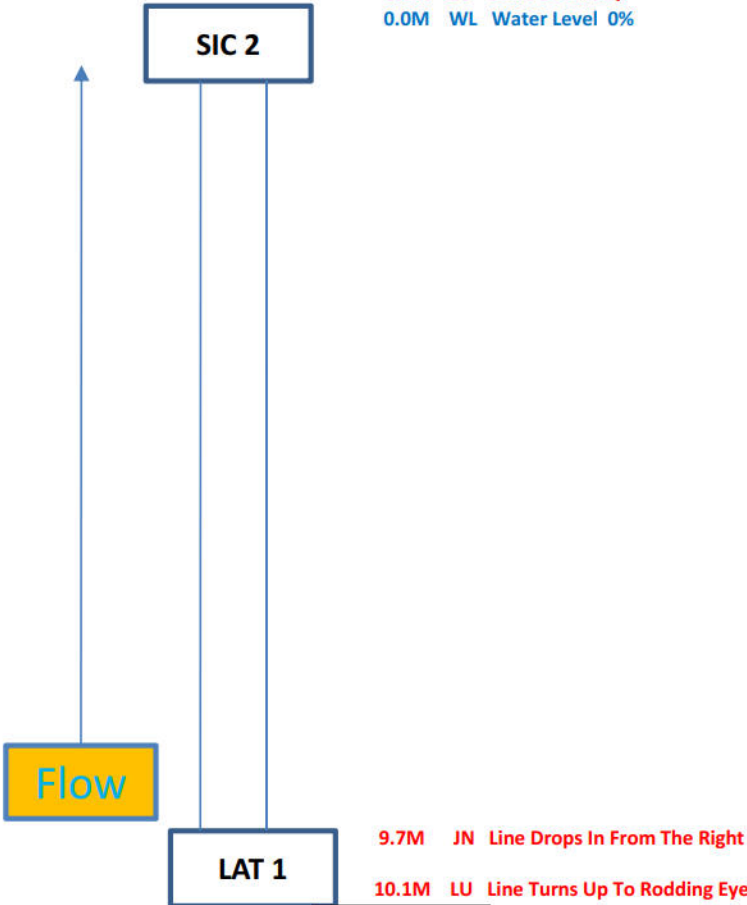
REM; THERE ARE NO MAJOR DEFECTS WITH THIS SECTION OF PIPE

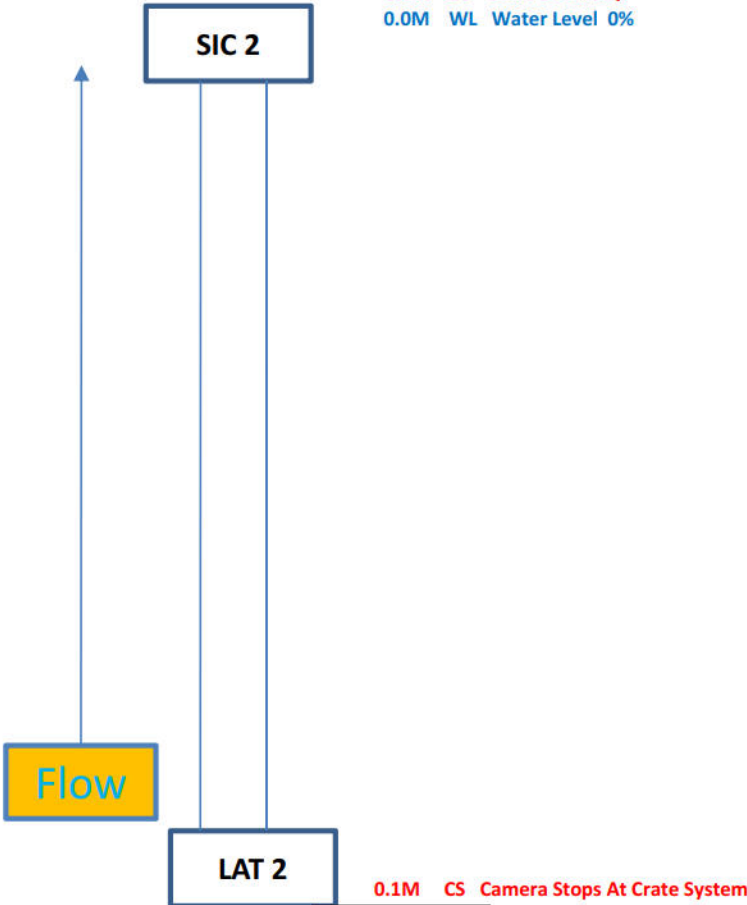
REM; THERE ARE NO MAJOR DEFECTS WITH THIS SECTION OF PIPE

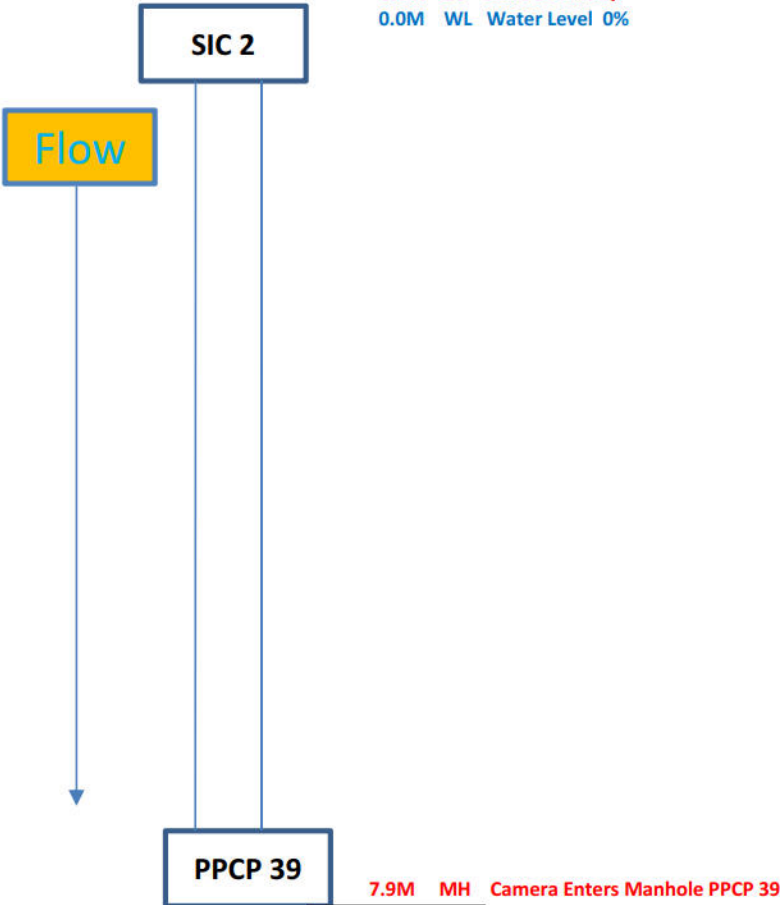
REM; THERE ARE NO MAJOR DEFECTS WITH THIS SECTION OF PIPE

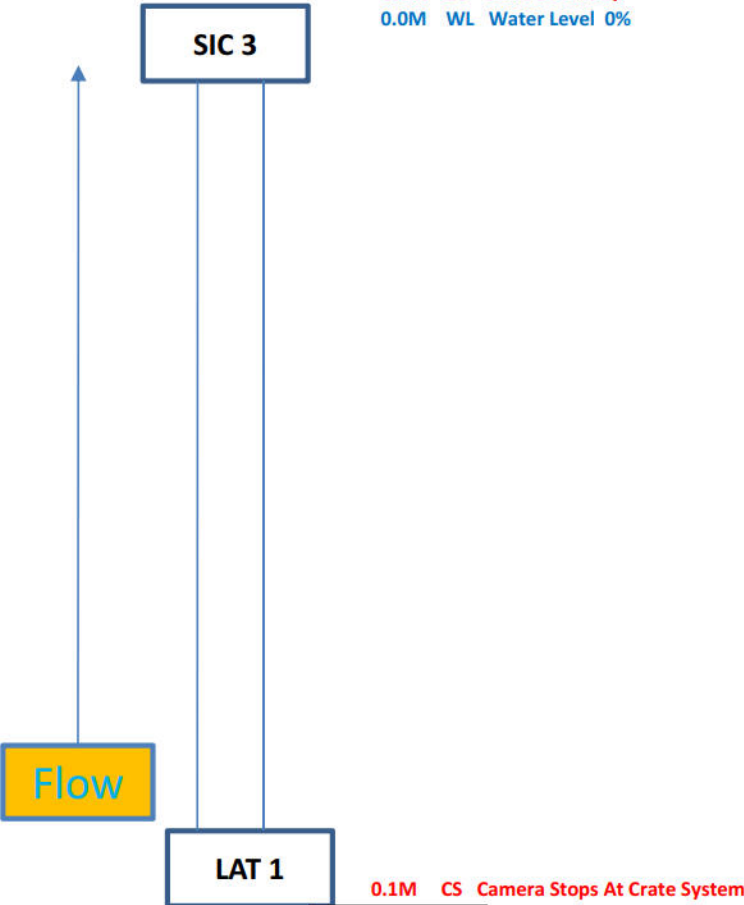
REM; THERE ARE NO MAJOR DEFECTS WITH THIS SECTION OF PIPE

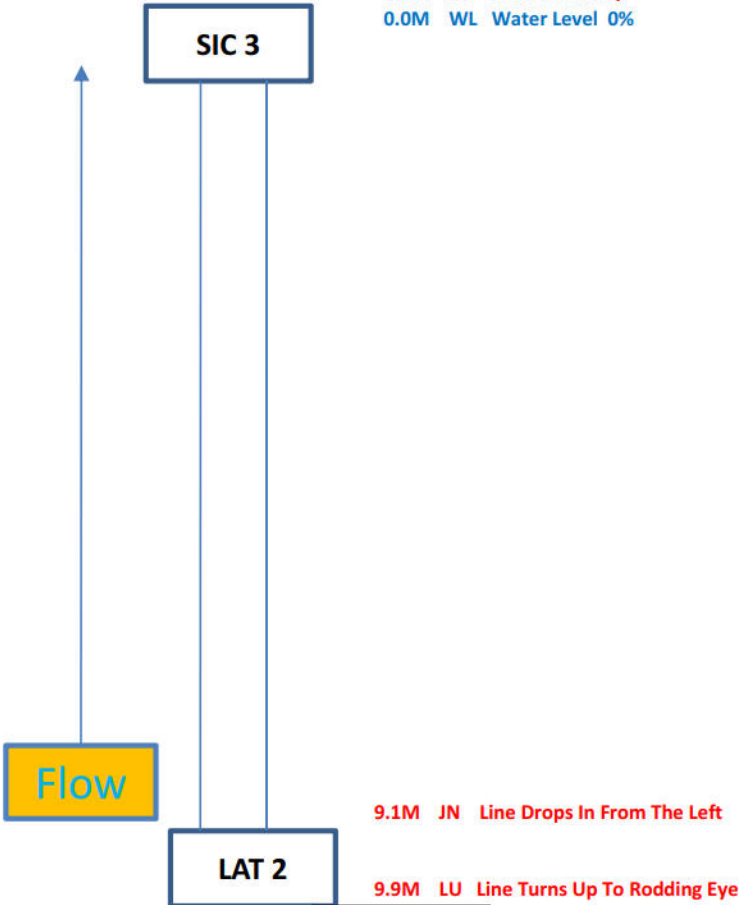
REM; THERE ARE NO MAJOR DEFECTS WITH THIS SECTION OF PIPE

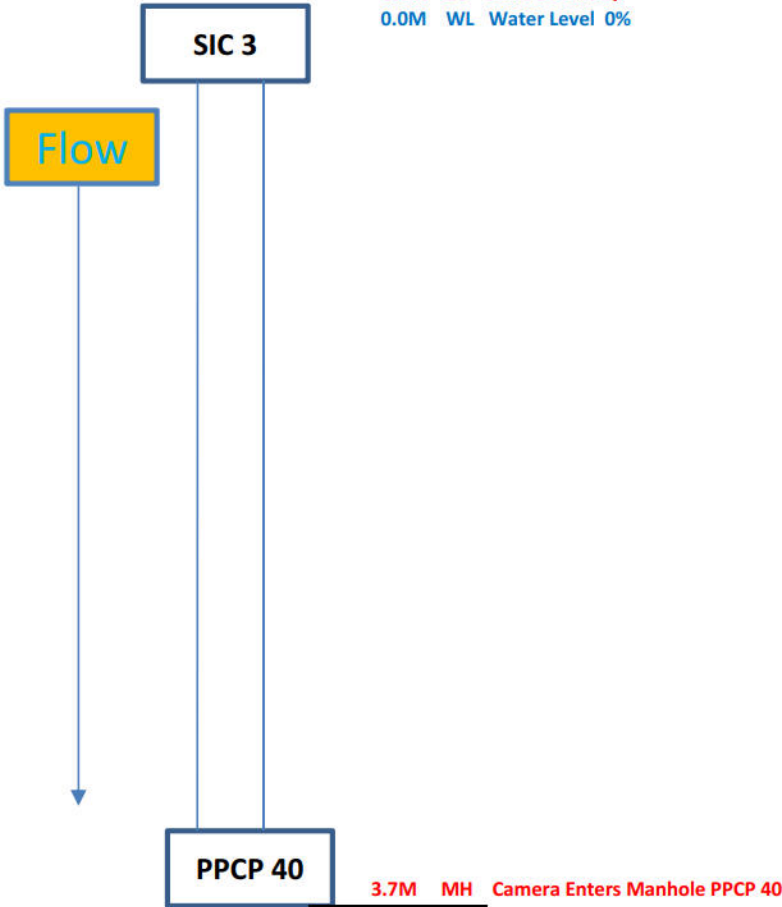
REM; THERE ARE NO MAJOR DEFECTS WITH THIS SECTION OF PIPE

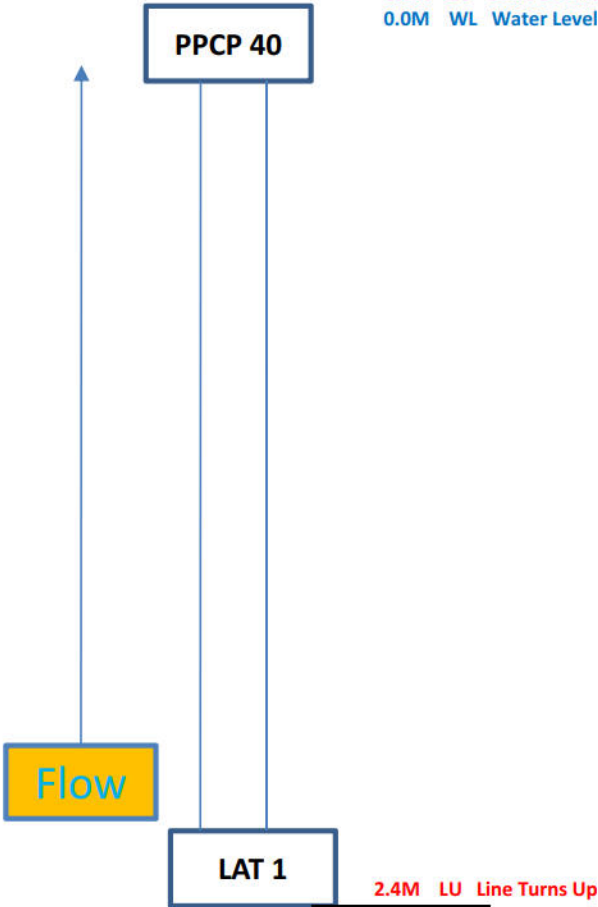
REM; THERE ARE NO MAJOR DEFECTS WITH THIS SECTION OF PIPE

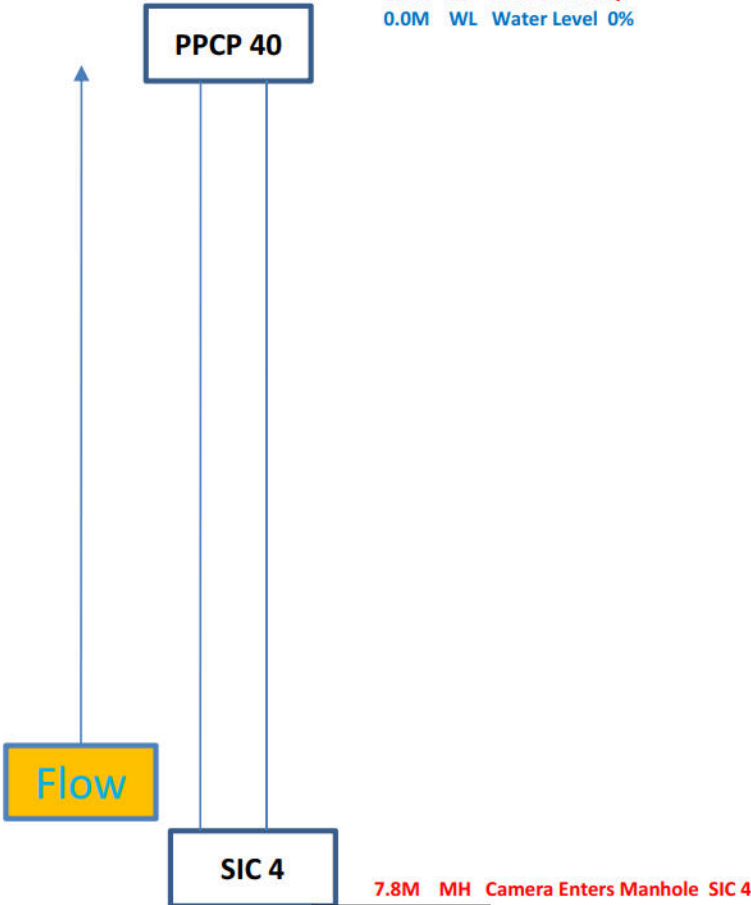
REM; THERE ARE NO MAJOR DEFECTS WITH THIS SECTION OF PIPE
