Inspection Report

| Site ; 468<br>Place ; LITTLEHAMPTON | | Division:<br>District:<br>Tape No: 1 | | Start MH: PPCP 30<br>End MH: LAT 1<br>Total Length: | |

## 468 Littlehampton - Defects

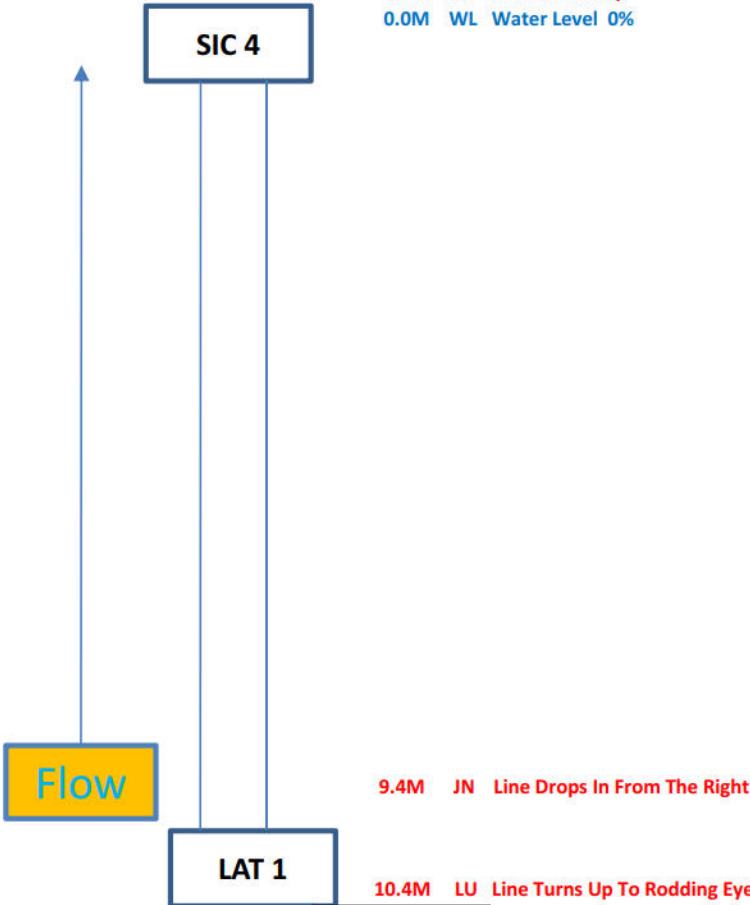
REM; THERE ARE NO MAJOR DEFECTS WITH THIS SECTION OF PIPE

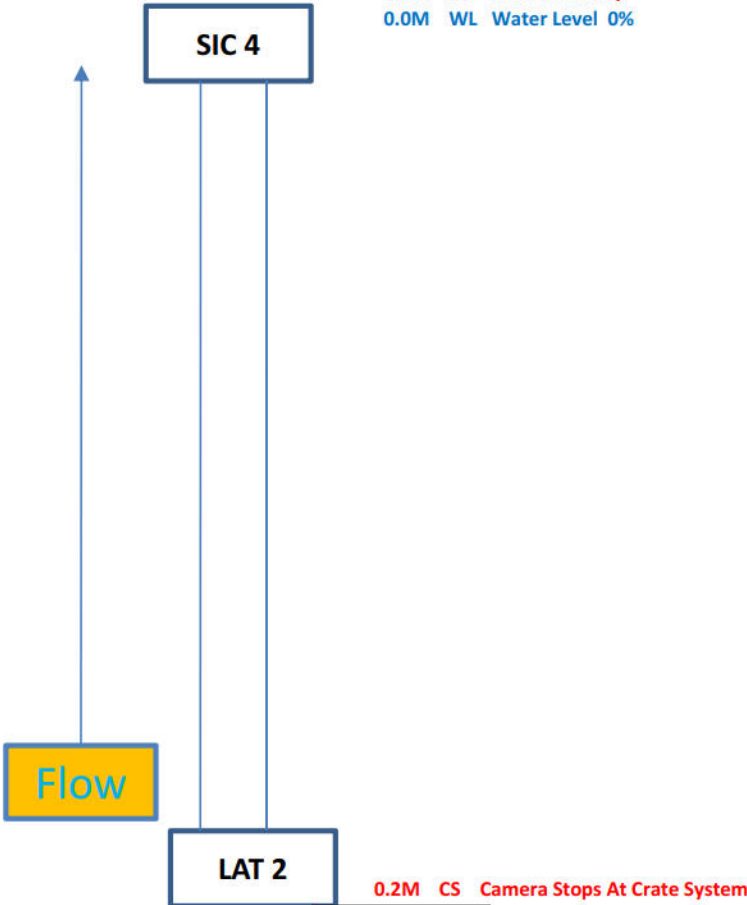
REM; THERE ARE NO MAJOR DEFECTS WITH THIS SECTION OF PIPE

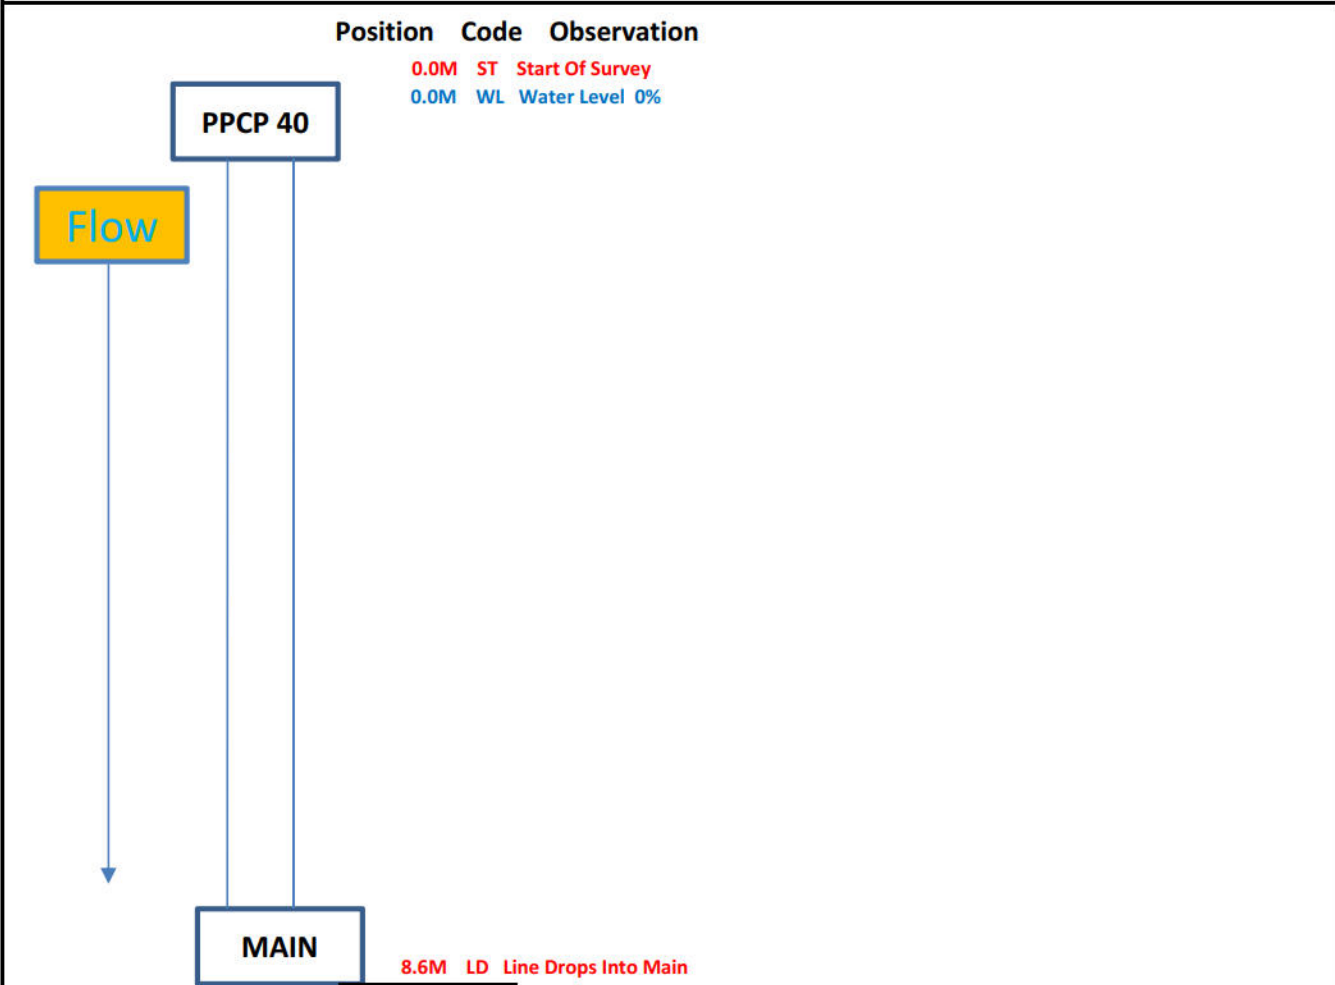
REM; THERE ARE NO MAJOR DEFECTS WITH THIS SECTION OF PIPE

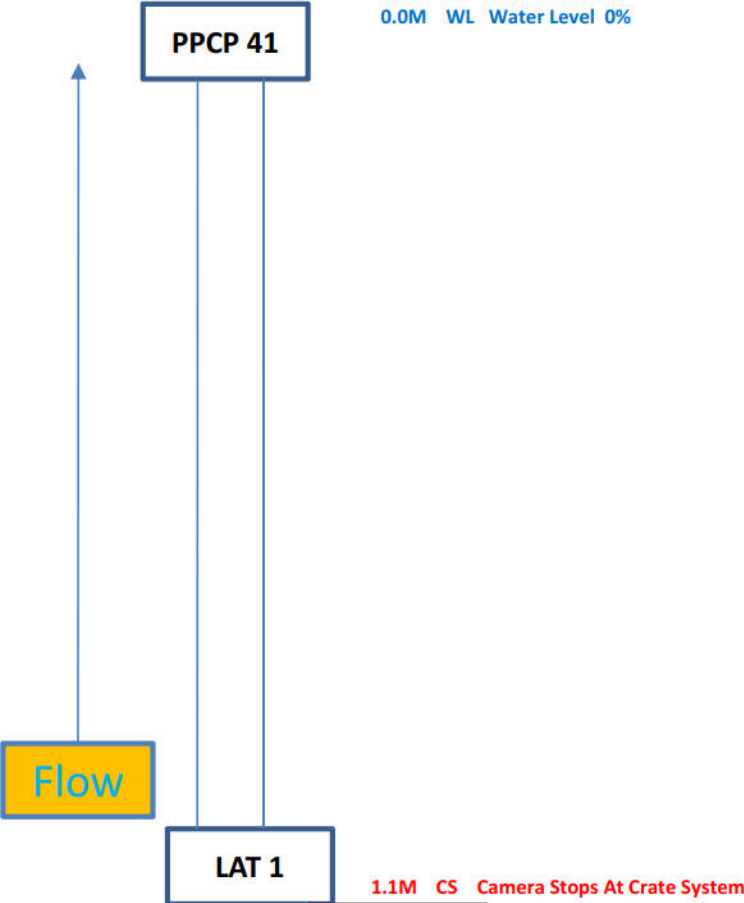
0.0M ST Start Of Survey  
0.0M WL Water Level 0%

REM; THERE ARE NO MAJOR DEFECTS WITH THIS SECTION OF PIPE

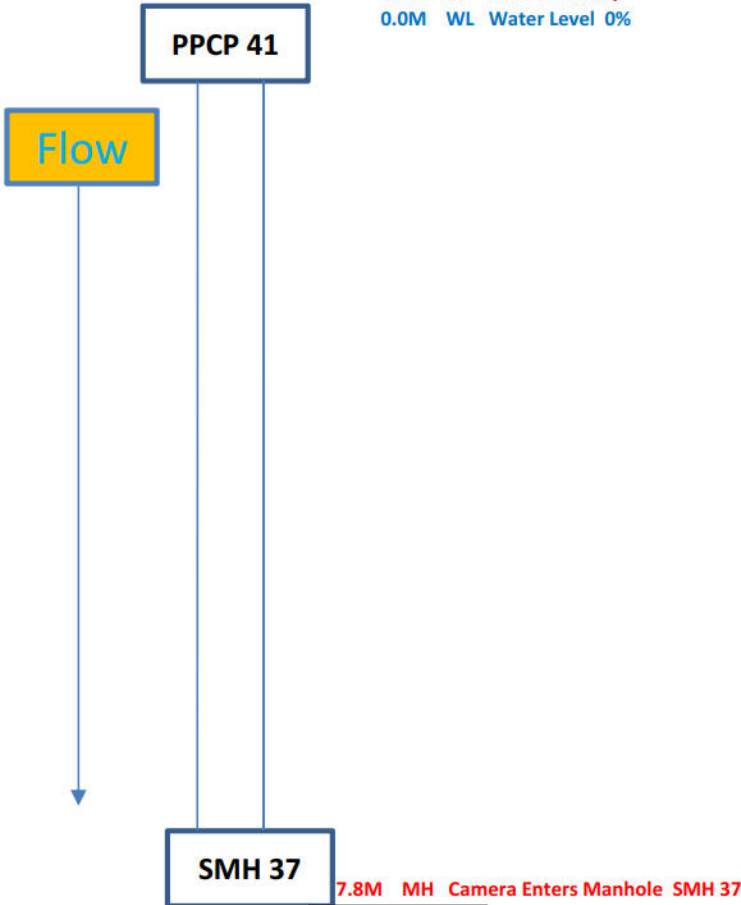
0.0M ST Start Of Survey  
0.0M WL Water Level 0%

REM; THERE ARE NO MAJOR DEFECTS WITH THIS SECTION OF PIPE

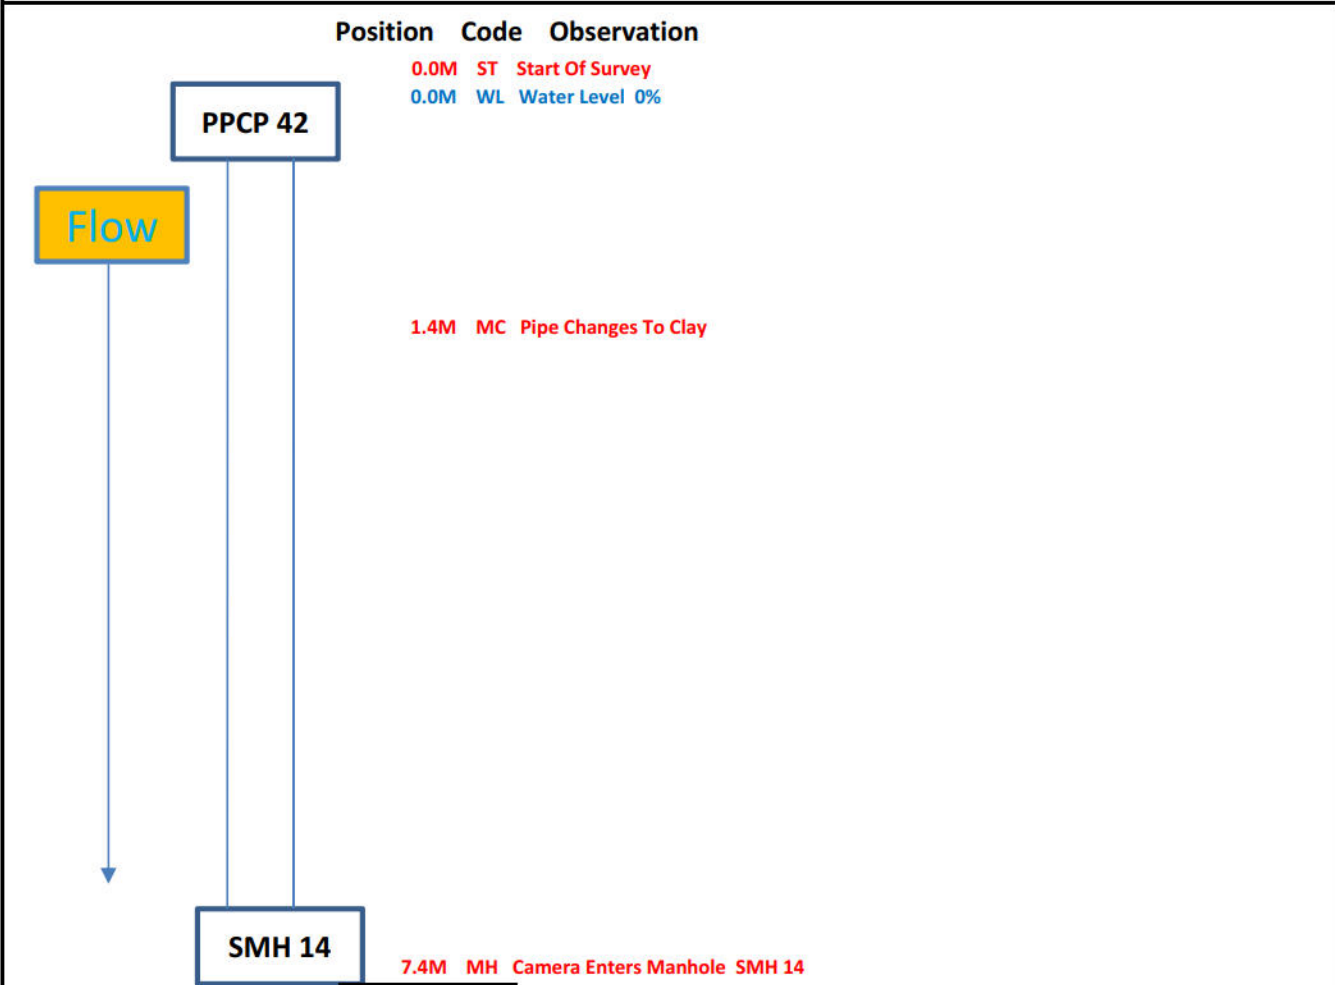
REM; THERE ARE NO MAJOR DEFECTS WITH THIS SECTION OF PIPE

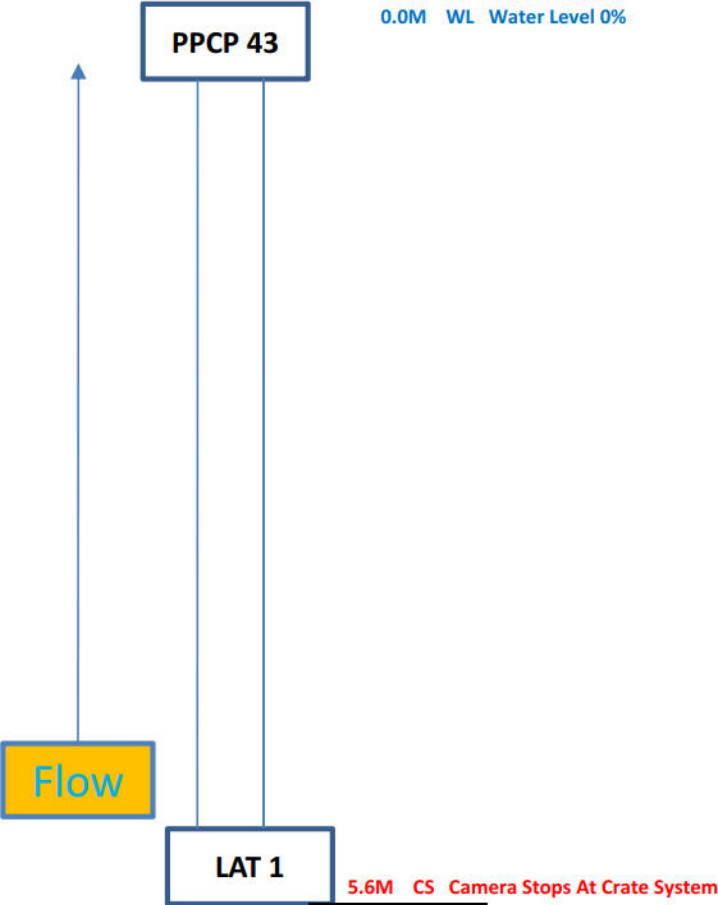
0.0M ST Start Of Survey  
0.0M WL Water Level 0%

REM; THERE ARE NO MAJOR DEFECTS WITH THIS SECTION OF PIPE

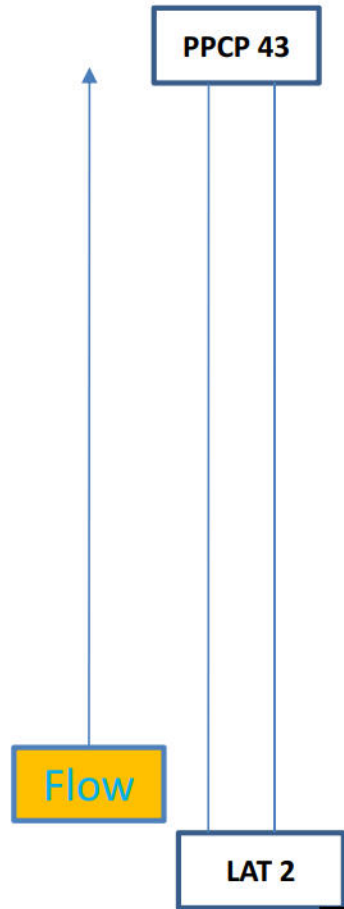
8.2M WL Water Level 0 %

10.1M LU Line Turns Up To Rodding Eye

REM; THERE ARE NO MAJOR DEFECTS WITH THIS SECTION OF PIPE

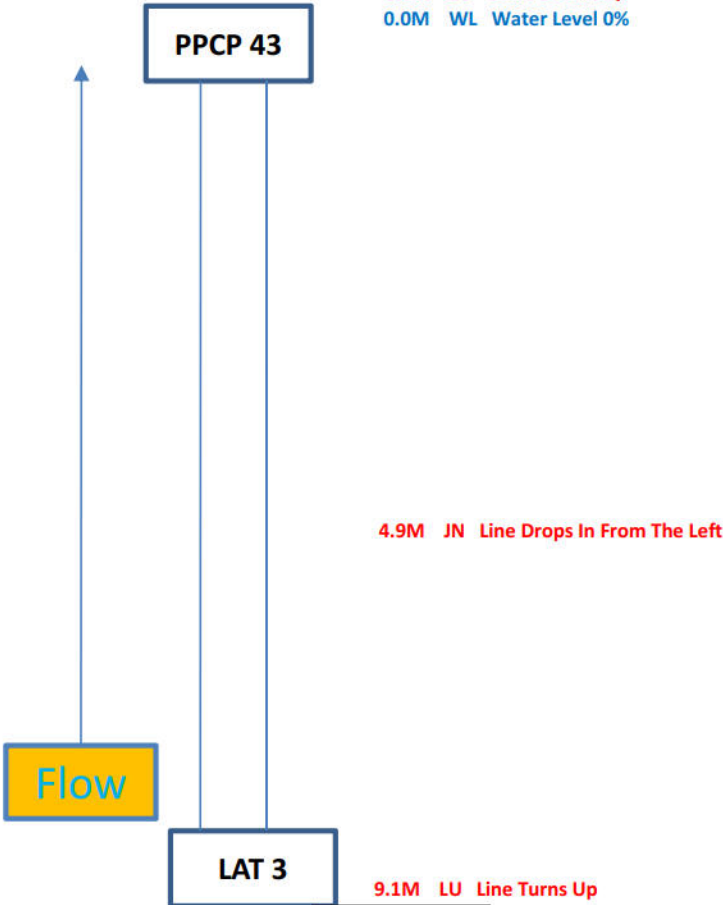
0.0M ST Start Of Survey  
0.0M WL Water Level 0%

REM; THERE ARE NO MAJOR DEFECTS WITH THIS SECTION OF PIPE

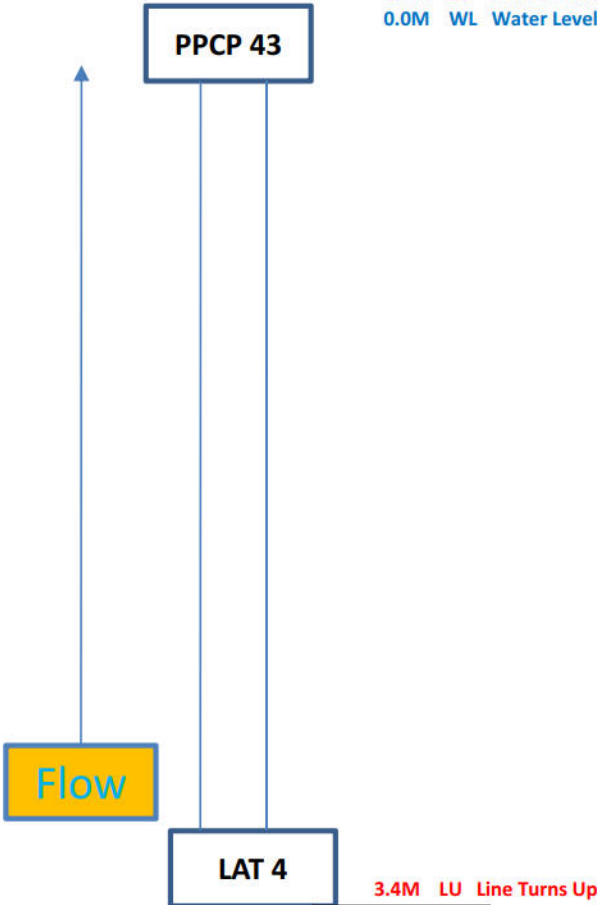
0.0M ST Start Of Survey  
0.0M WL Water Level 0%

REM; THERE ARE NO MAJOR DEFECTS WITH THIS SECTION OF PIPE

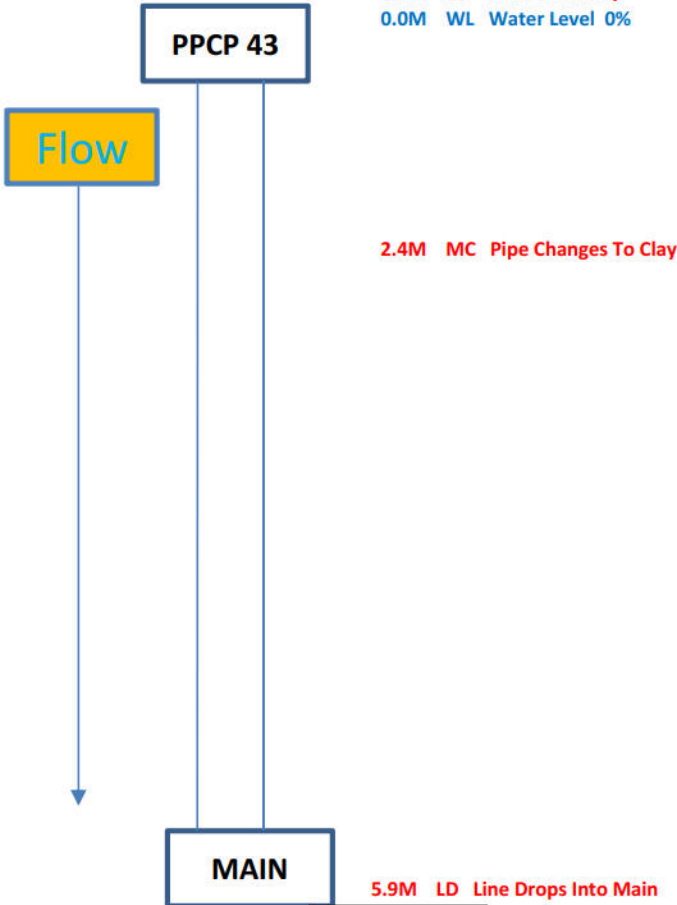
0.0M ST Start Of Survey  
0.0M WL Water Level 0%

REM; THERE ARE NO MAJOR DEFECTS WITH THIS SECTION OF PIPE

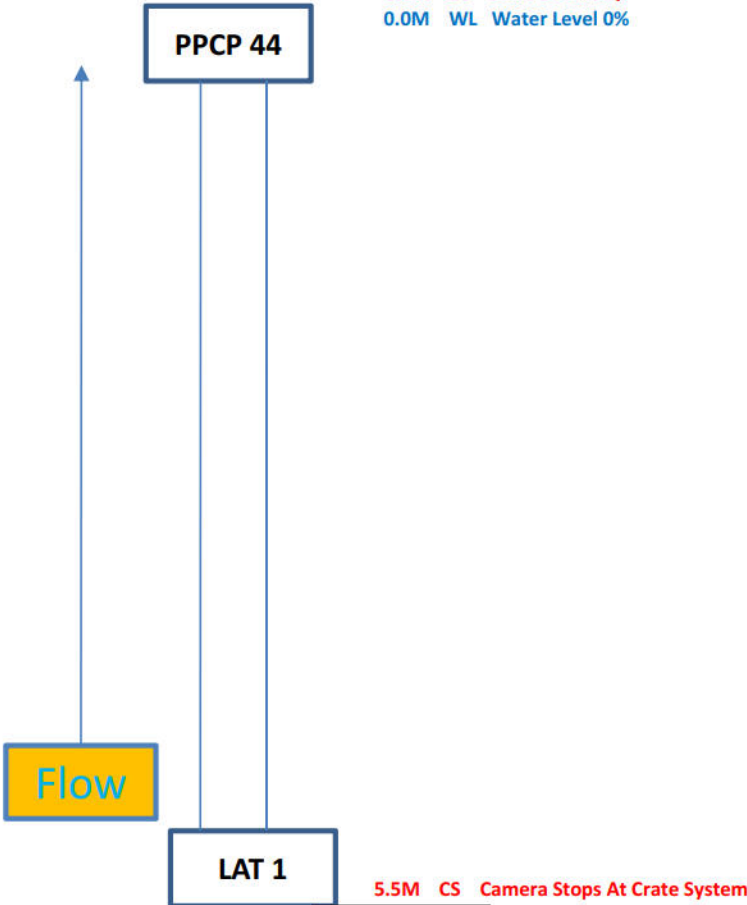
0.0M ST Start Of Survey  
0.0M WL Water Level 0%

REM; THERE ARE NO MAJOR DEFECTS WITH THIS SECTION OF PIPE

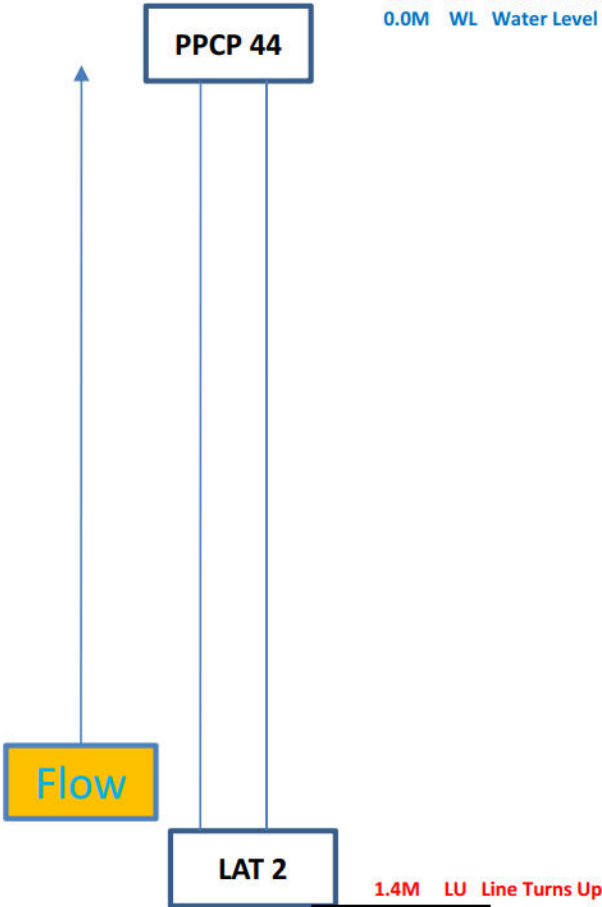
0.0M ST Start Of Survey  
0.0M WL Water Level 0%

REM; THERE ARE NO MAJOR DEFECTS WITH THIS SECTION OF PIPE

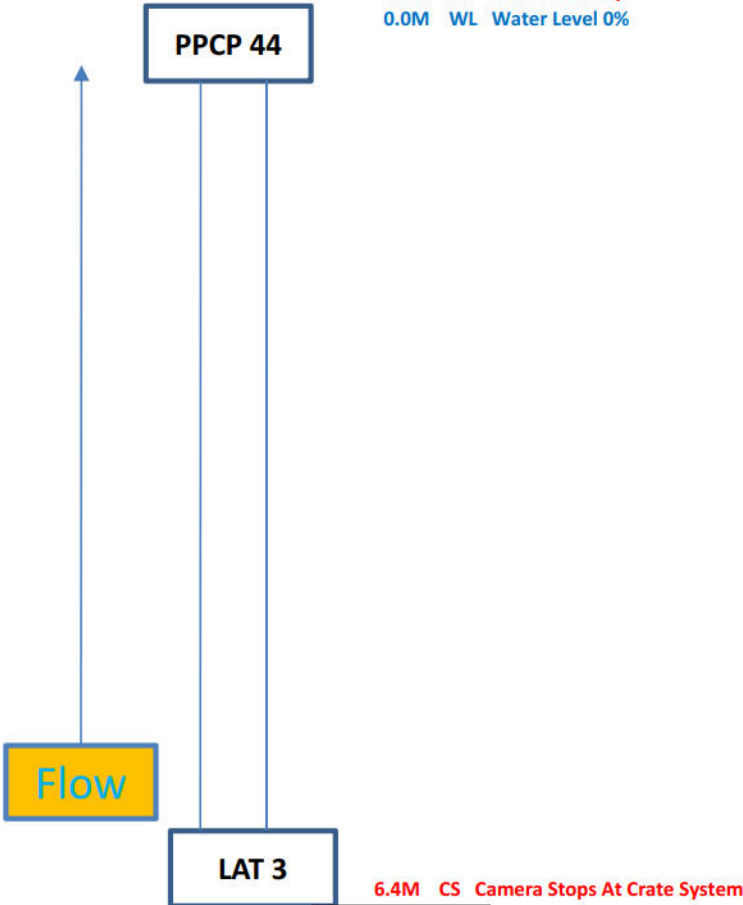
0.0M ST Start Of Survey  
0.0M WL Water Level 0%

REM; THERE ARE NO MAJOR DEFECTS WITH THIS SECTION OF PIPE

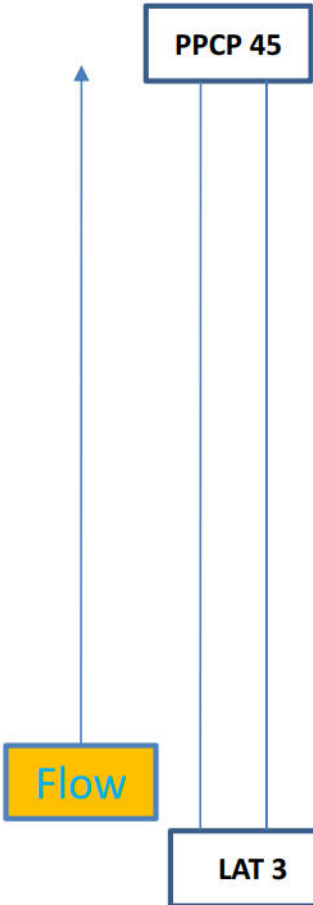
6.0M JN Line Drops In From The Left

10.4M LU Line Turns Up To Rodding Eye

REM; THERE ARE NO MAJOR DEFECTS WITH THIS SECTION OF PIPE

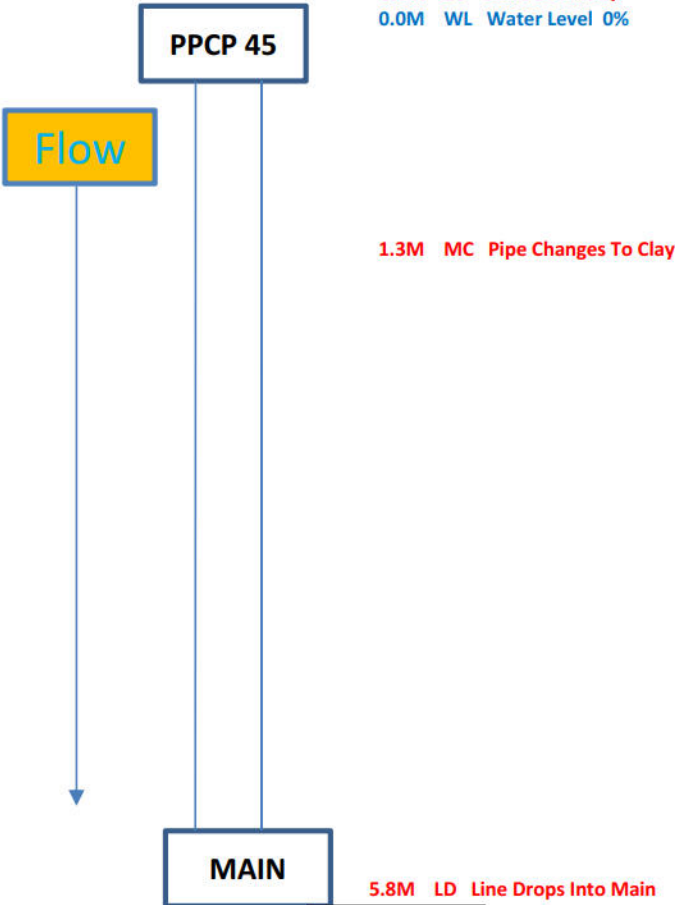
0.0M ST Start Of Survey  
0.0M WL Water Level 0%

REM; THERE ARE NO MAJOR DEFECTS IN THIS SECTION OF PIPE

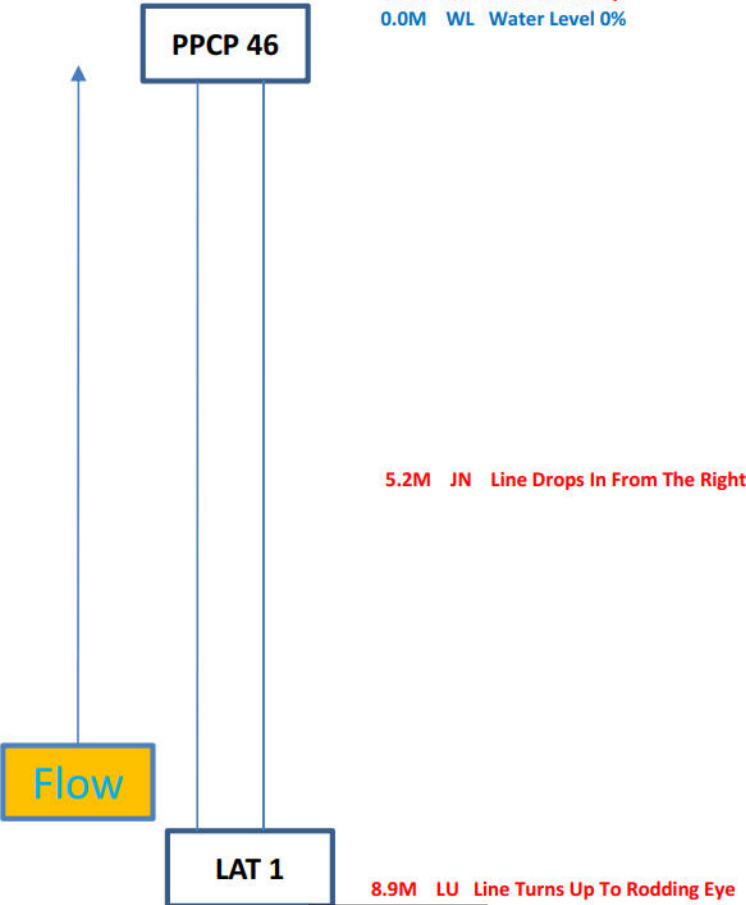
0.0M ST Start Of Survey  
0.0M WL Water Level 0%

REM; THERE ARE NO MAJOR DEFECTS WITH THIS SECTION OF PIPE

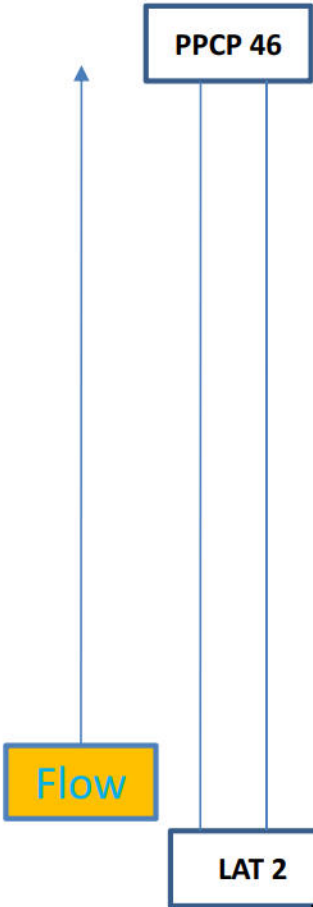
0.0M ST Start Of Survey  
0.0M WL Water Level 0%  
0.2M JN Line Drops In From The Left

6.9M JN Line Drops In From The Left  
7.1M LU Line Turns Up To Rodding Eye

REM; THERE ARE NO MAJOR DEFECTS WITH THIS SECTION OF PIPE

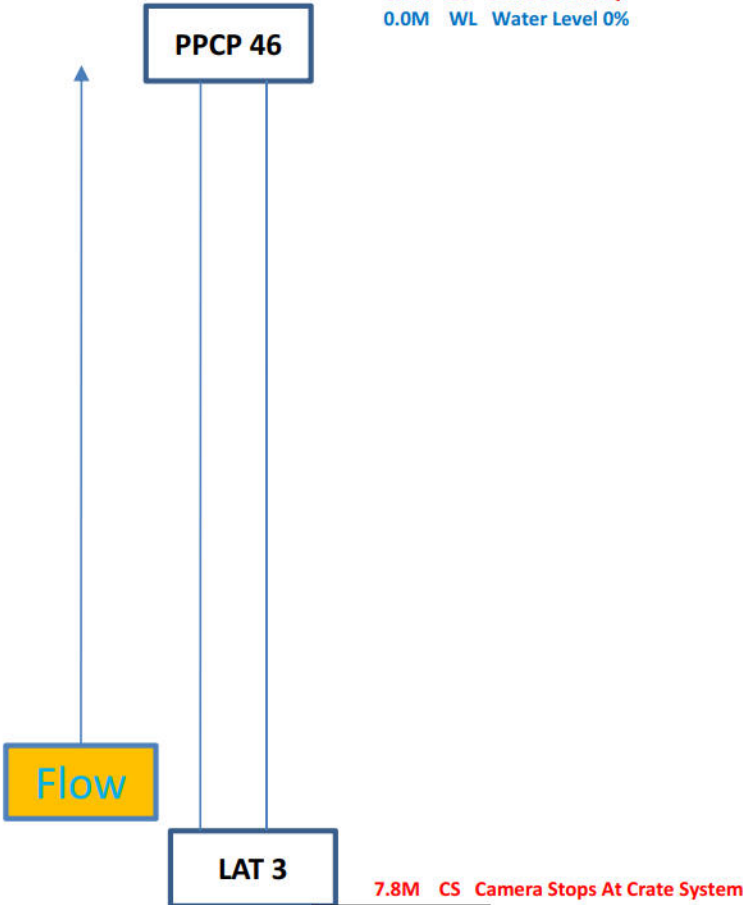
0.0M ST Start Of Survey  
0.0M WL Water Level 0%

REM; THERE ARE NO MAJOR DEFECTS WITH THIS SECTION OF PIPE

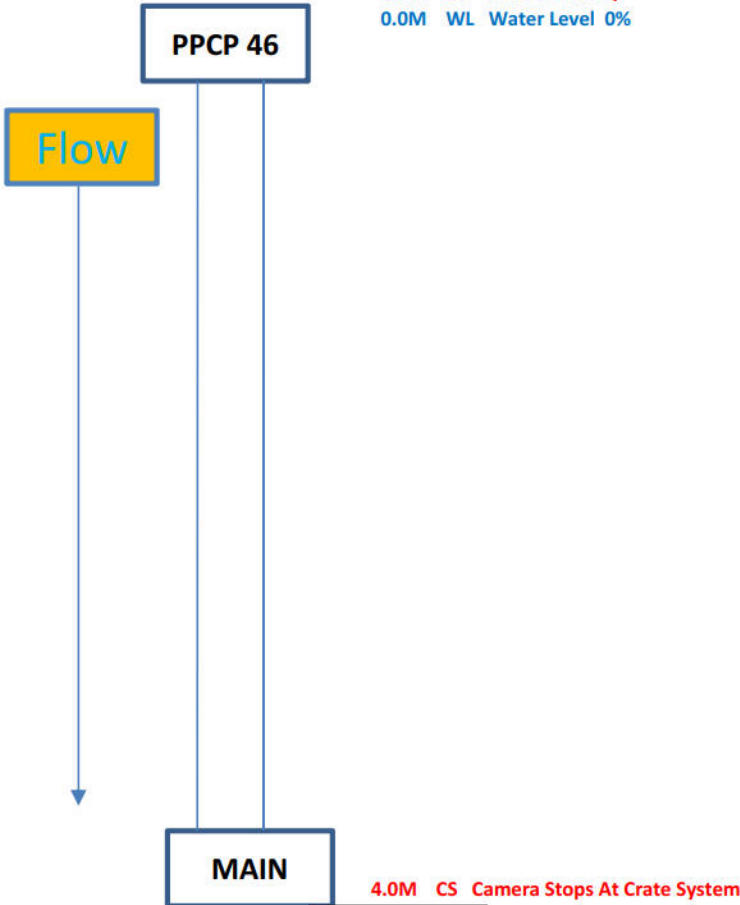
0.0M ST Start Of Survey  
0.0M WL Water Level 0%

REM; THERE ARE NO MAJOR DEFECTS WITH THIS SECTION OF PIPE

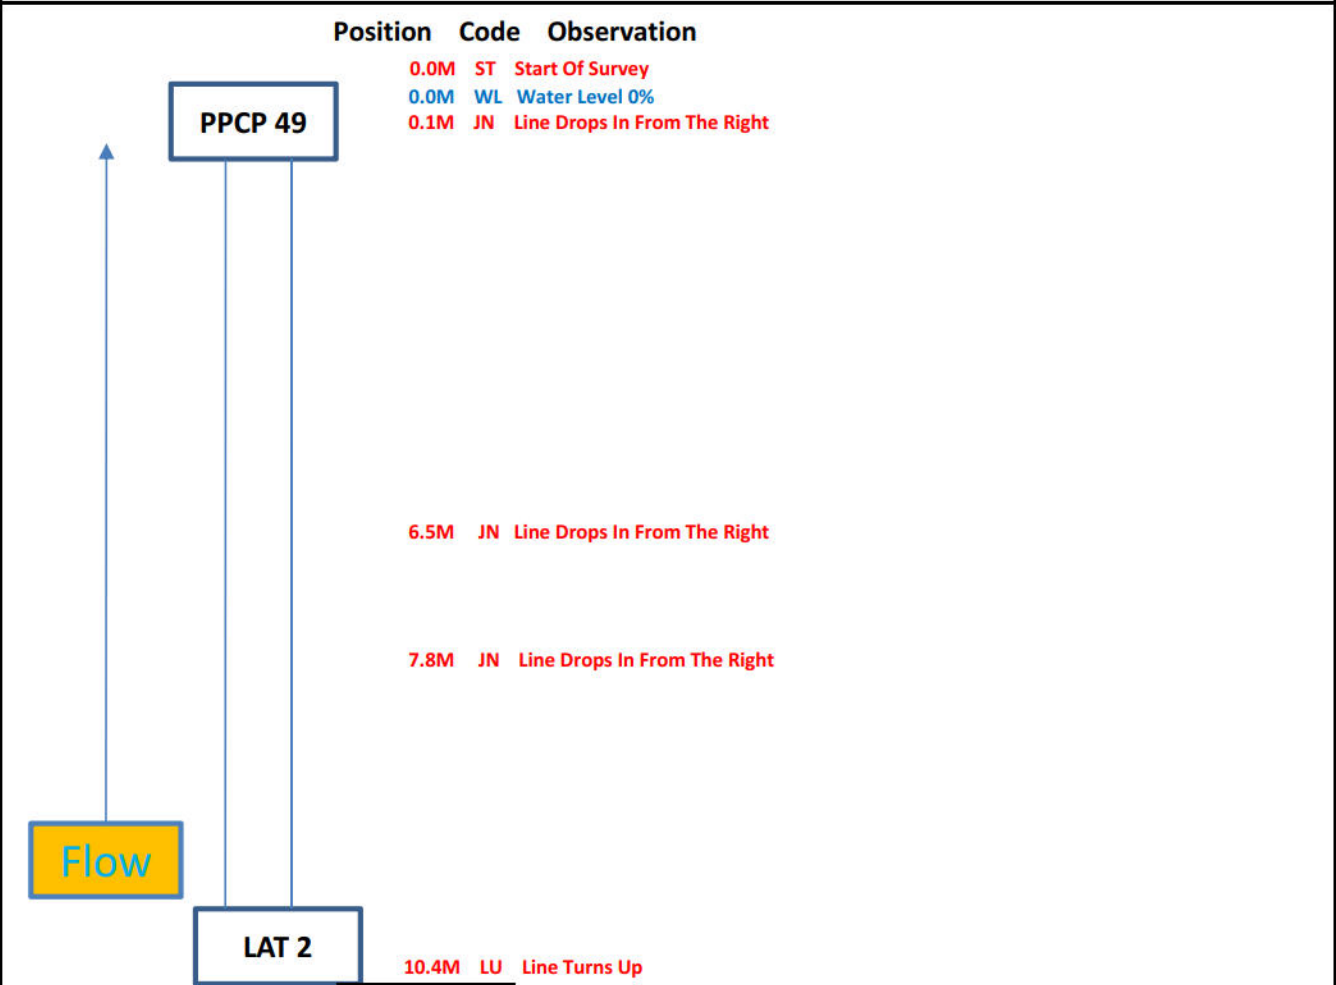
REM; THERE ARE NO MAJOR DEFECTS WITH THIS SECTION OF PIPE

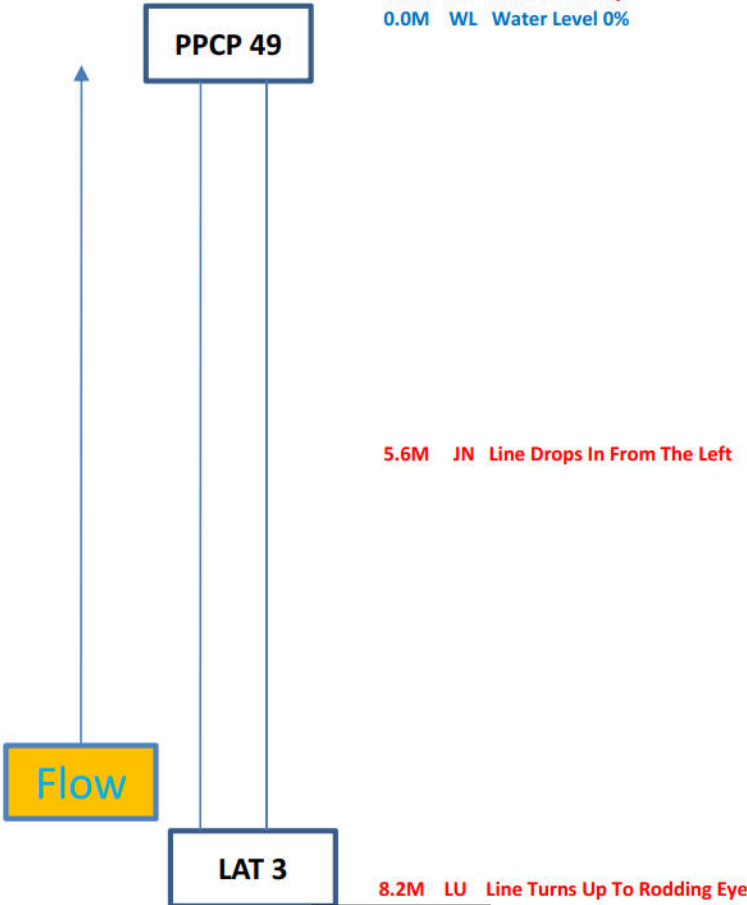
0.0M ST Start Of Survey  
0.0M WL Water Level 0%

REM; THERE ARE NO MAJOR DEFECTS WITH THIS SECTION OF PIPE

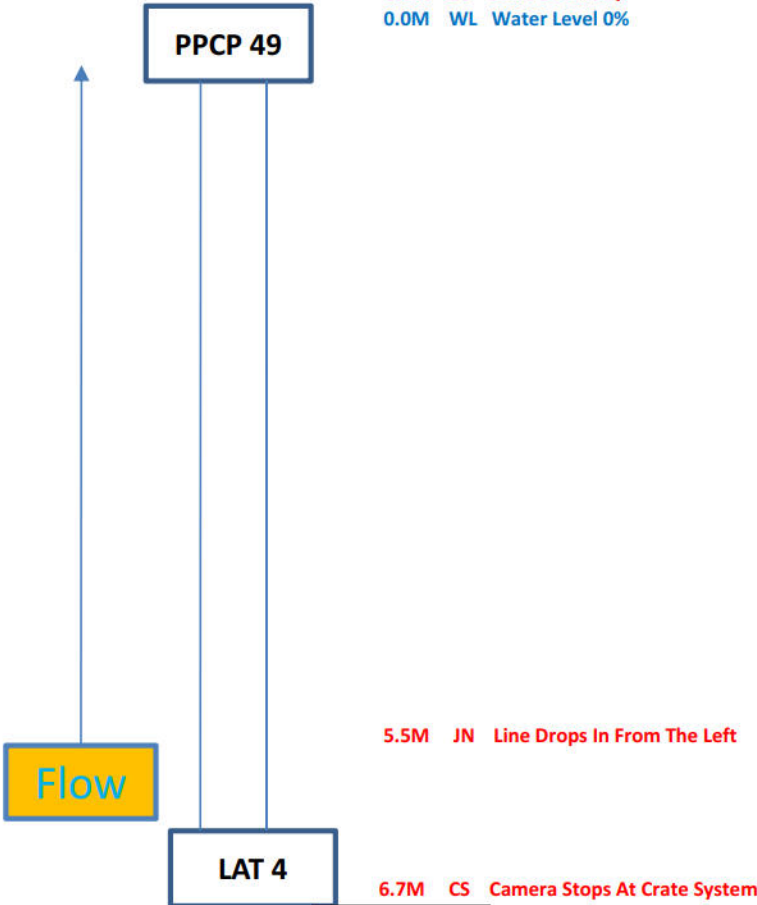
0.0M ST Start Of Survey  
0.0M WL Water Level 0%

REM; THERE ARE NO MAJOR DEFECTS WITH THIS SECTION OF PIPE

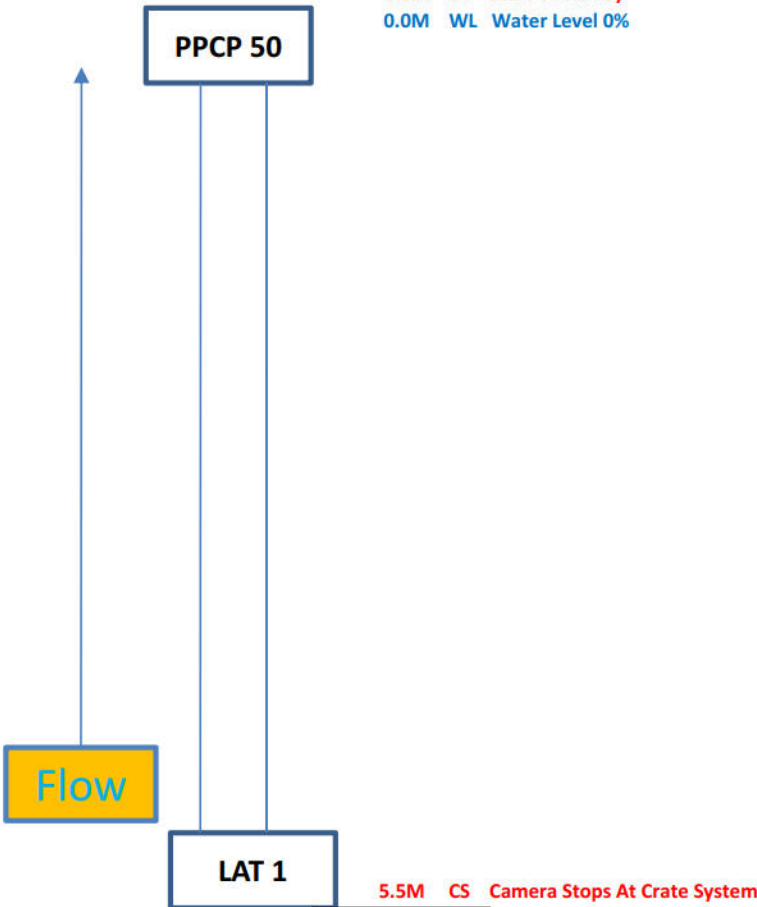
0.0M ST Start Of Survey  
0.0M WL Water Level 0%

REM; THERE ARE NO MAJOR DEFECTS WITH THIS SECTION OF PIPE

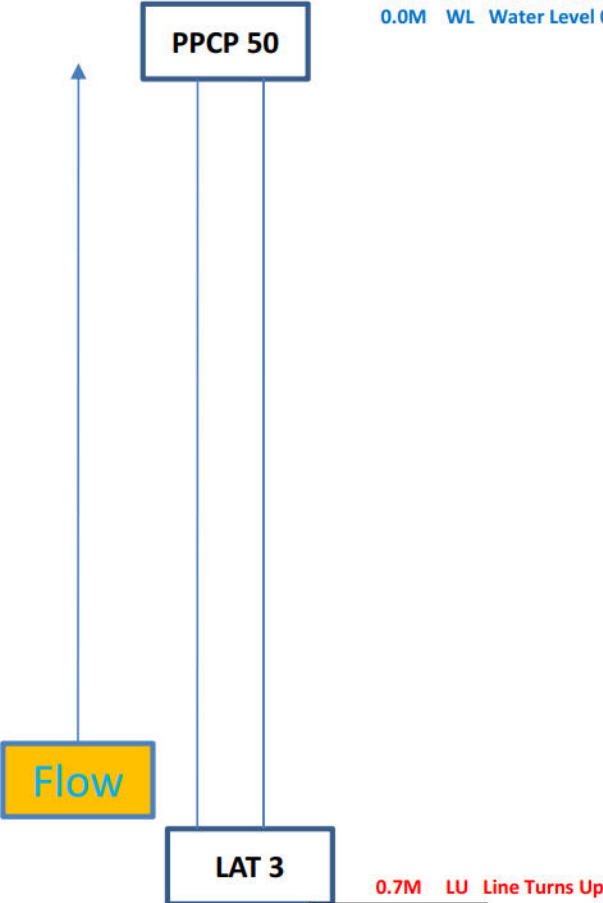
0.0M ST Start Of Survey  
0.0M WL Water Level 0%

REM; THERE ARE NO MAJOR DEFECTS WITH THIS SECTION OF PIPE

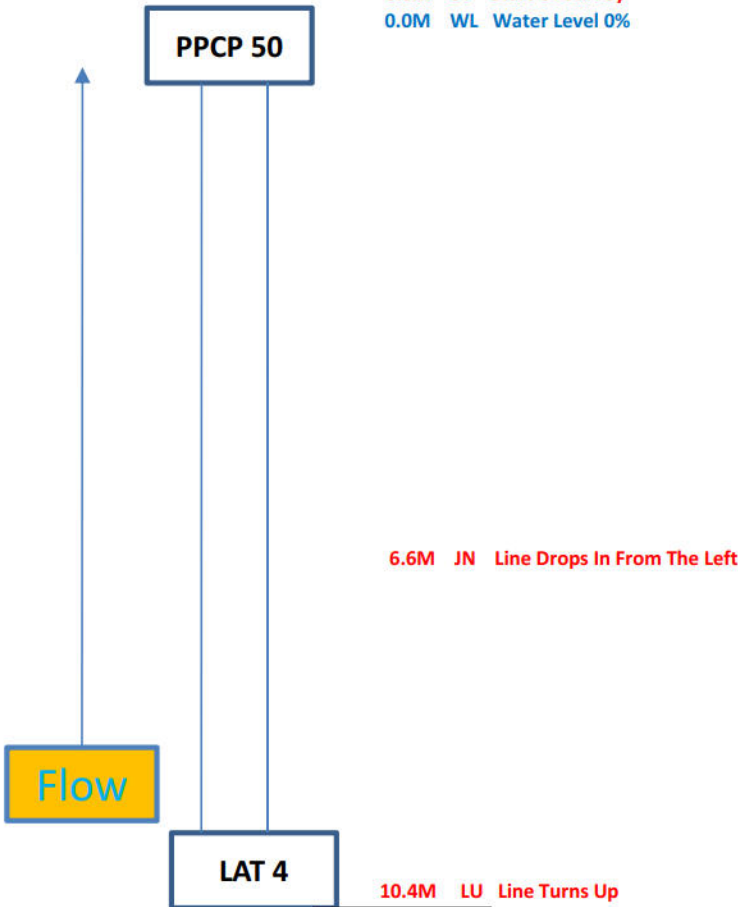
0.0M ST Start Of Survey  
0.0M WL Water Level 0%

REM; THERE ARE NO MAJOR DEFECTS WITH THIS SECTION OF PIPE

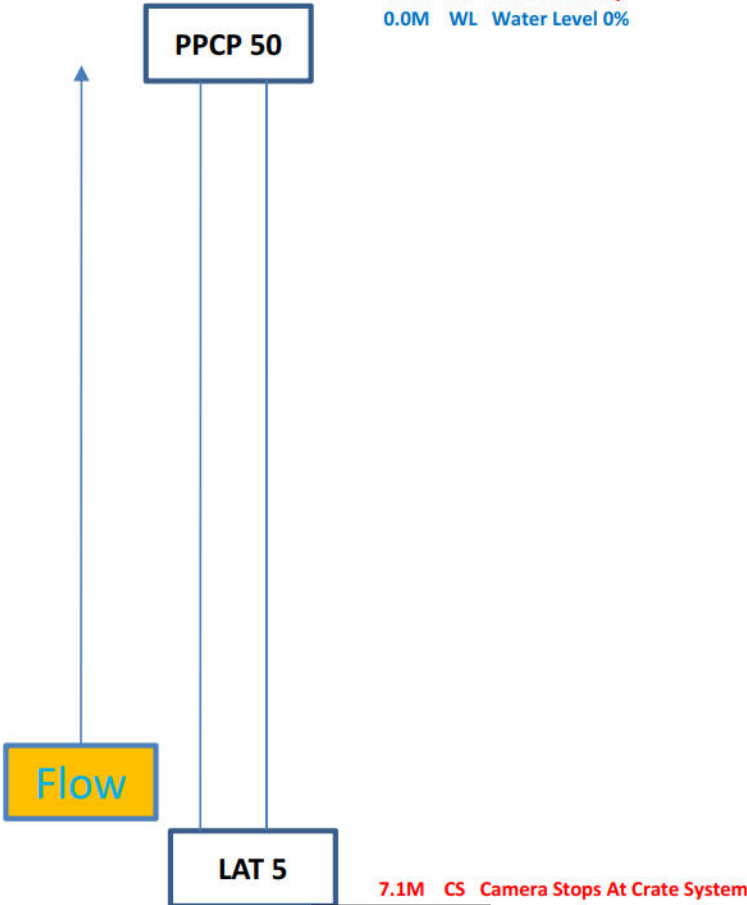
0.0M ST Start Of Survey

0.0M WL Water Level 0%

REM; THERE ARE NO MAJOR DEFECTS WITH THIS SECTION OF PIPE

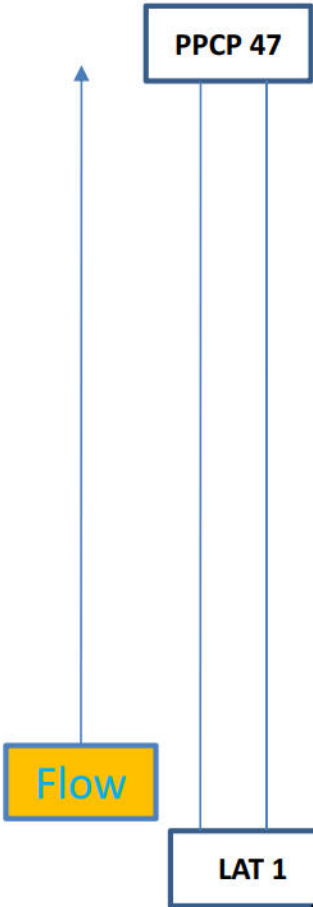
0.0M ST Start Of Survey  
0.0M WL Water Level 0%

1.0M JN Line Drops In From The Right

10.0M JN Line Drops In From The Right  
10.6M LU Line Turns Up

REM; THERE ARE NO MAJOR DEFECTS WITH THIS SECTION OF PIPE

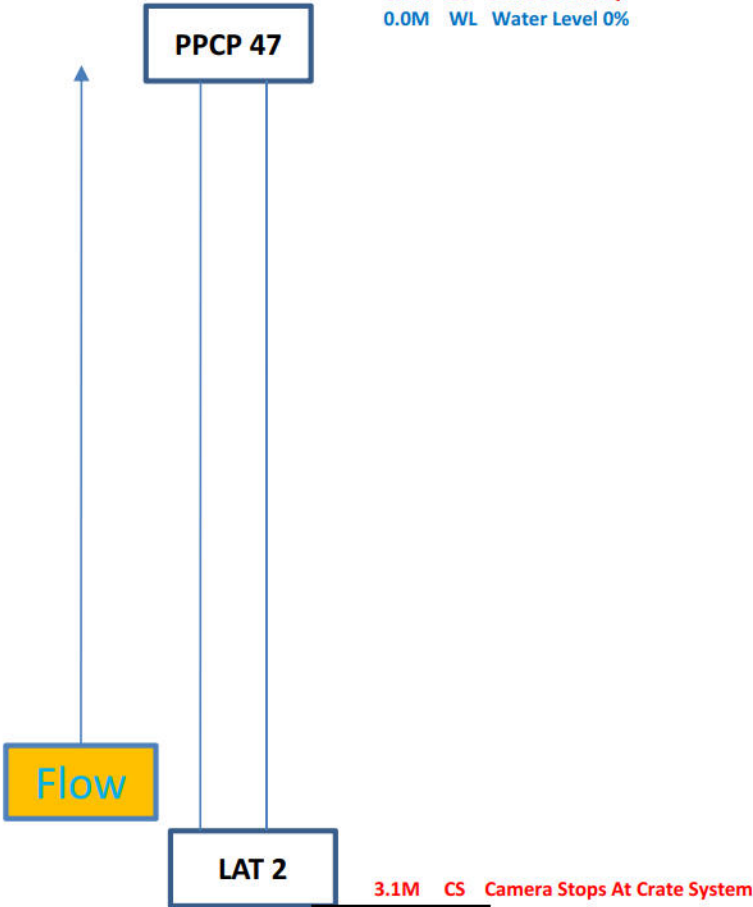
0.0M ST Start Of Survey  
0.0M WL Water Level 0%

REM; THERE ARE NO MAJOR DEFECTS WITH THIS SECTION OF PIPE

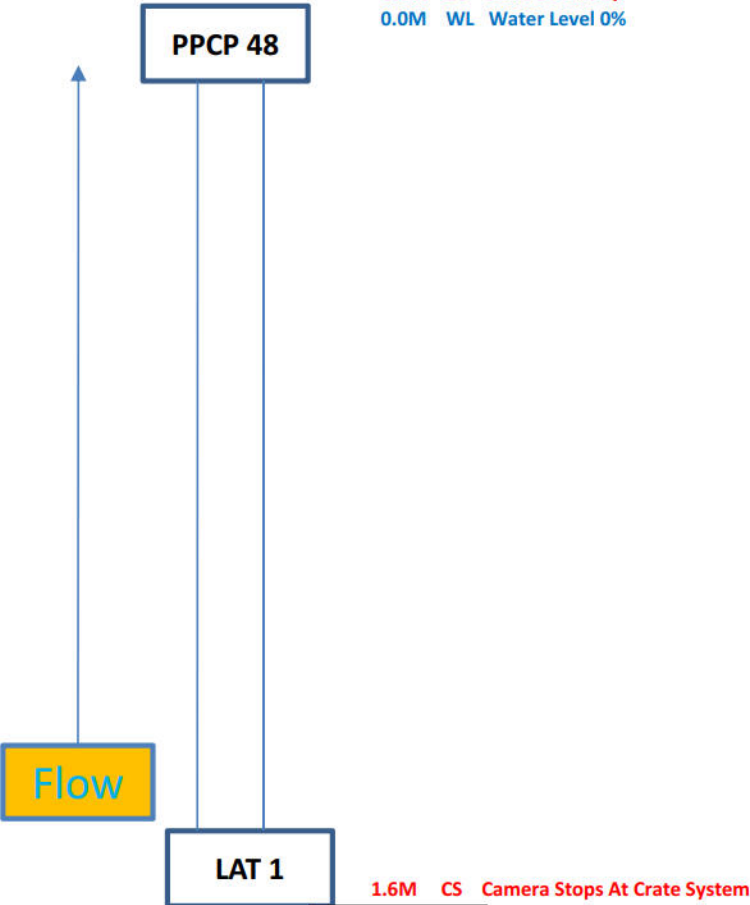
0.0M ST Start Of Survey  
0.0M WL Water Level 0%

REM; THERE ARE NO MAJOR DEFECTS WITH THIS SECTION OF PIPE

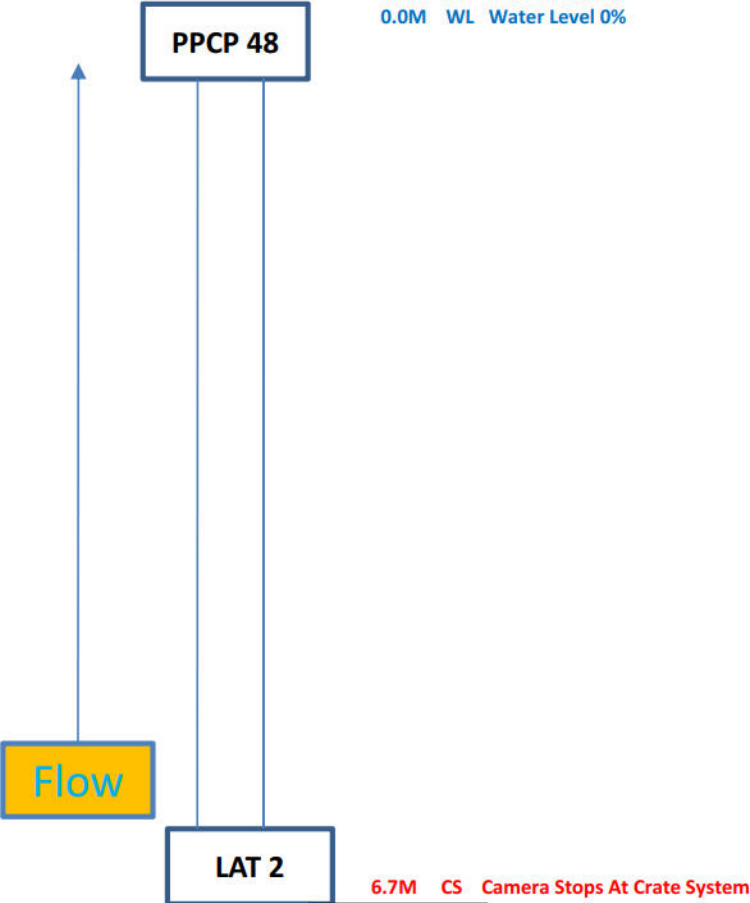
0.0M ST Start Of Survey  
0.0M WL Water Level 0%

REM; THERE ARE NO MAJOR DEFECTS WITH THIS SECTION OF PIPE

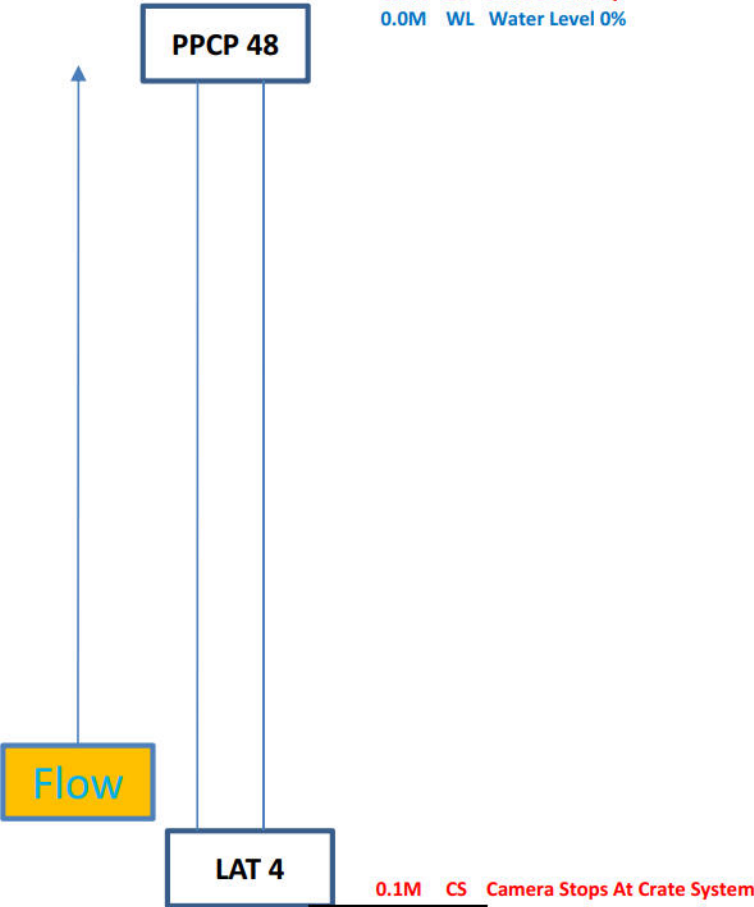
0.0M ST Start Of Survey  
0.0M WL Water Level 0%

REM; THERE ARE NO MAJOR DEFECTS WITH THIS SECTION OF PIPE

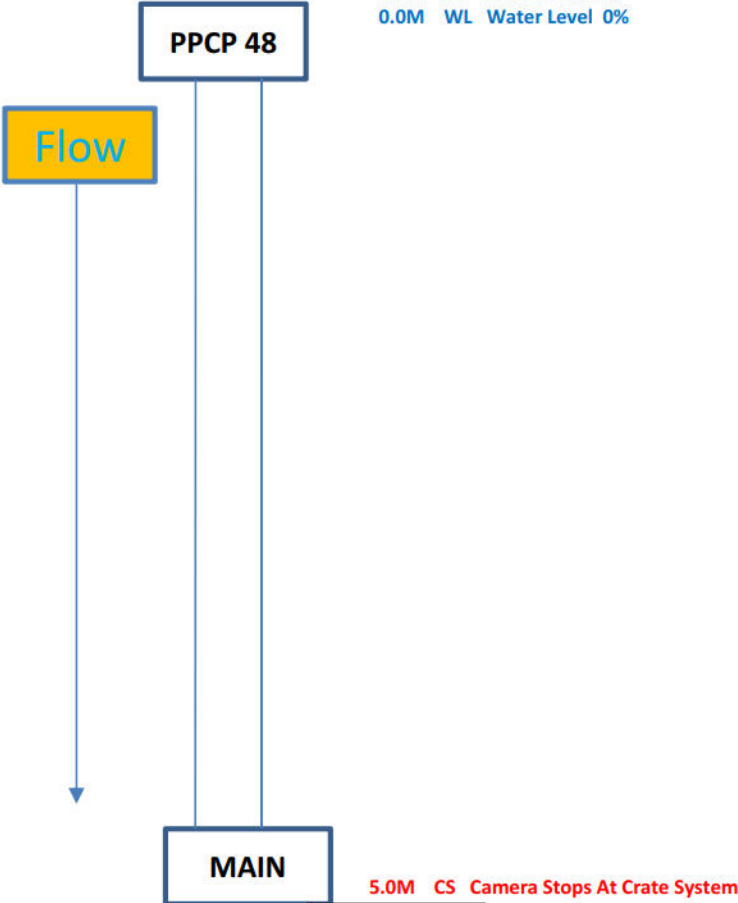
0.0M ST Start Of Survey  
0.0M WL Water Level 0%

REM; THERE ARE NO MAJOR DEFECTS WITH THIS SECTION OF PIPE
