**VERIFICATION REPORT**  
**for BLOCK A (SOIL COVER SYSTEMS) &**  
**ALL PLOTS (GROUND GAS) AT**  
**CORNFIELD CLOSE, LITTLEHAMPTON,**  
**WEST SUSSEX, BN17 6LD**  
**on behalf of**  
**THAKEHAM CLIENT LTD**

| <b>Date:</b> | <b>03/08/2021</b> |
| <b>Reference:</b> | <b>GE18103/VR/BLOCK A (Soil) &amp; All Plots (Gas)/AUG21</b> |

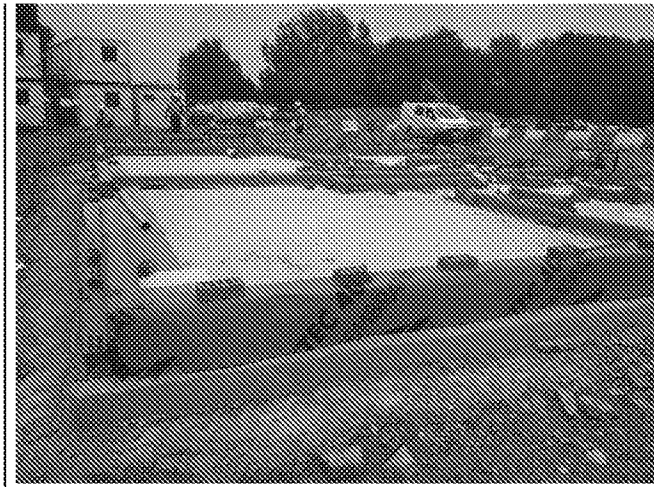
Area - incomplete

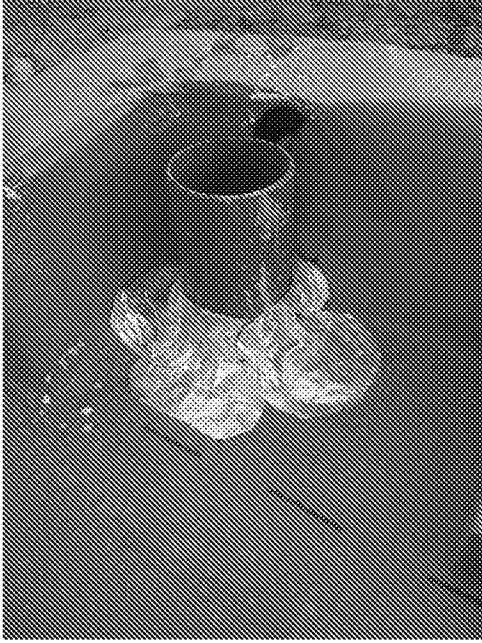
Alum tape around service duct

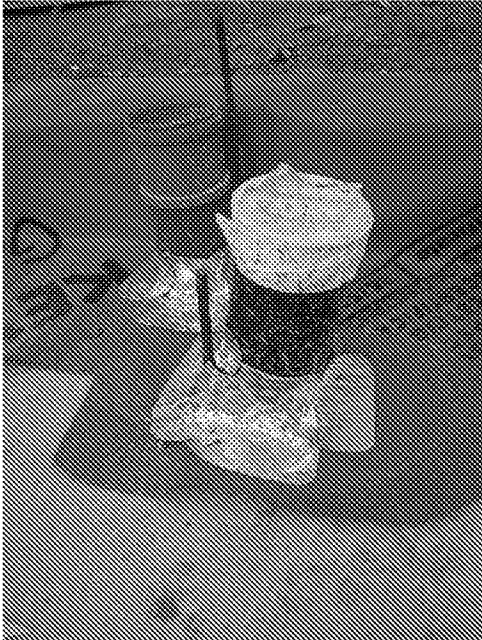
Foil tape around service duct

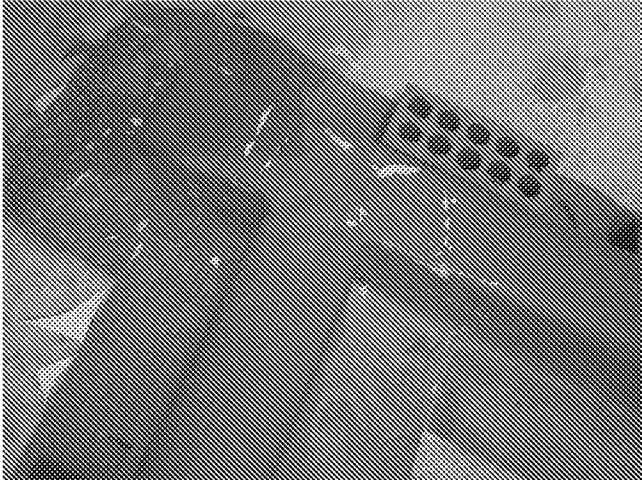
| | Joint sealed with no gaps or voids |

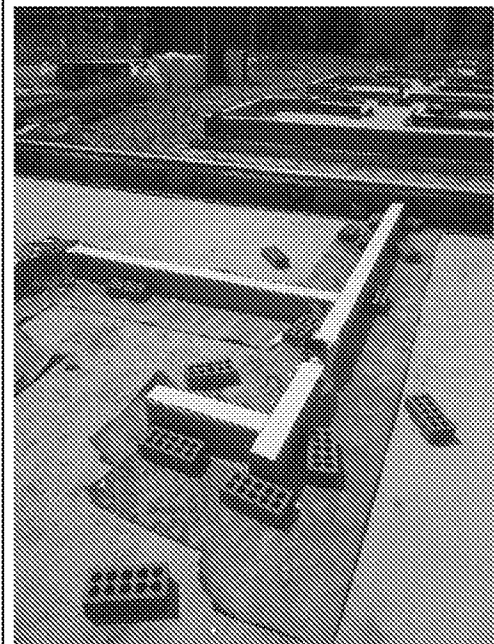
Plot 10 services

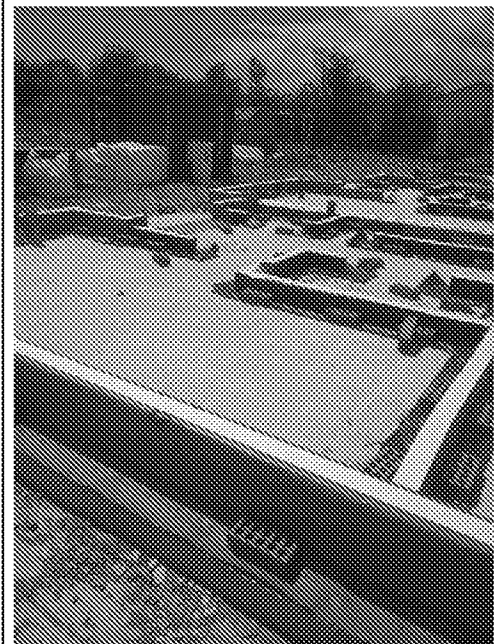
Plot 11 services

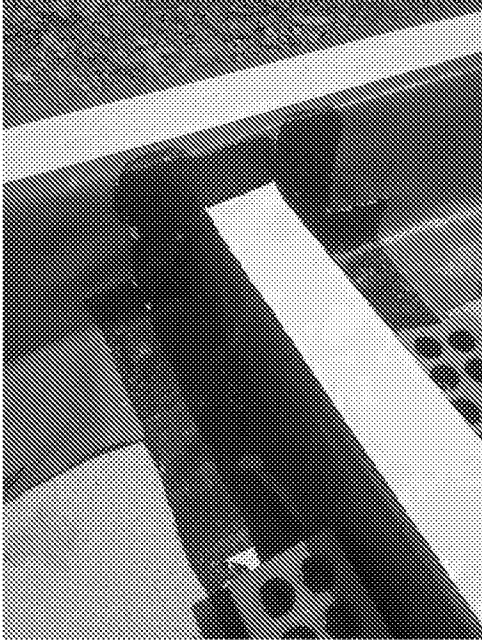
Plot 12 overview

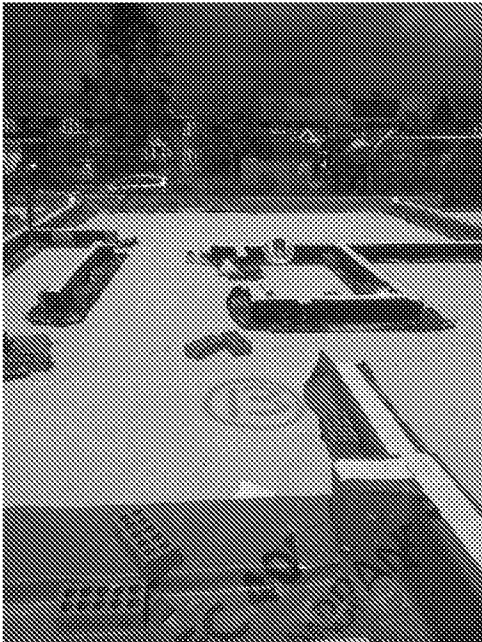
Plot 12 seal

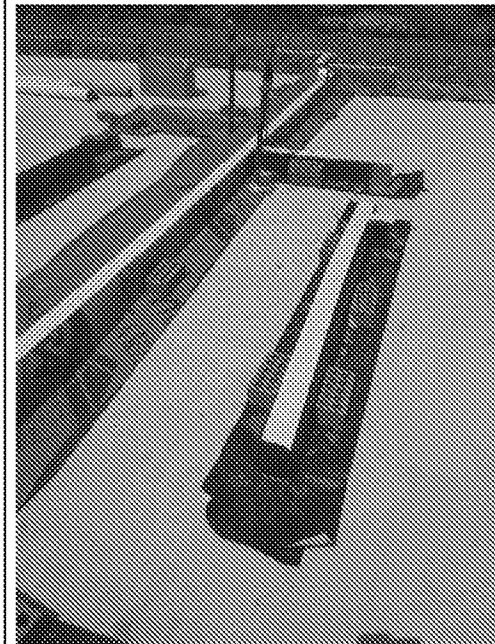
Plot 13 corner

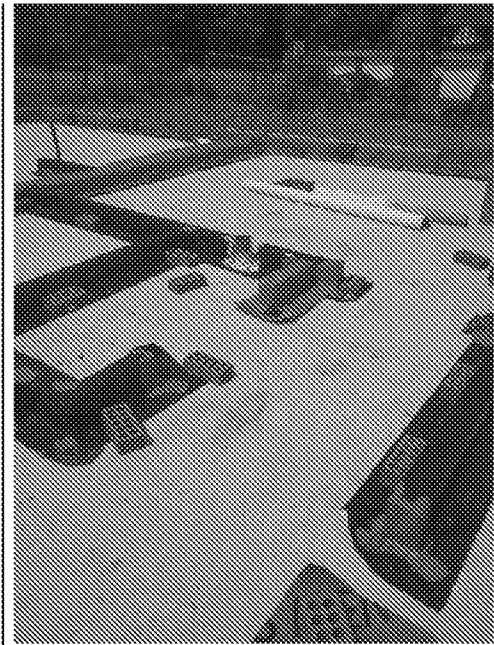
Plot 13 detail

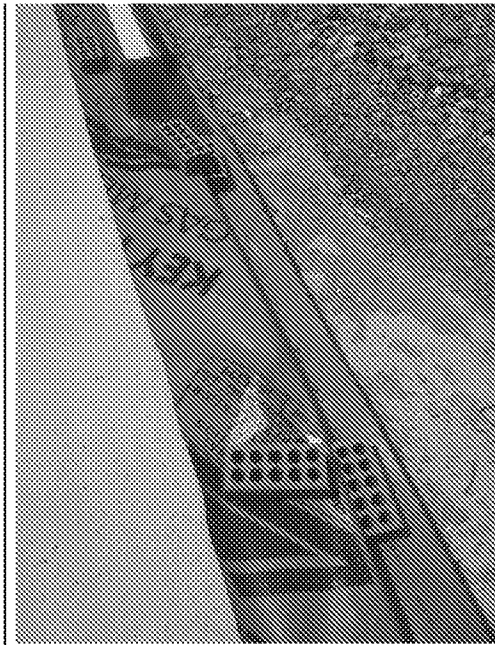
Plot 14 services

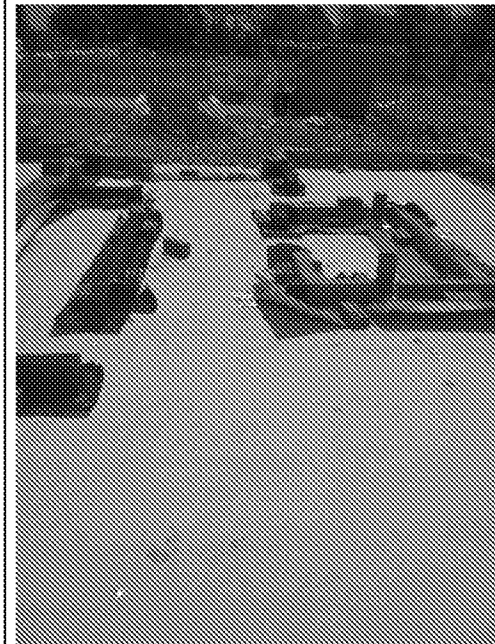
Plot 14 doorway

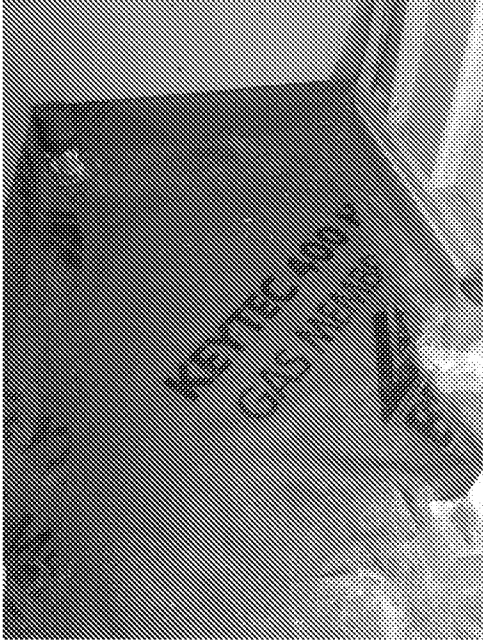
| | <p>Plot 1 services</p> |

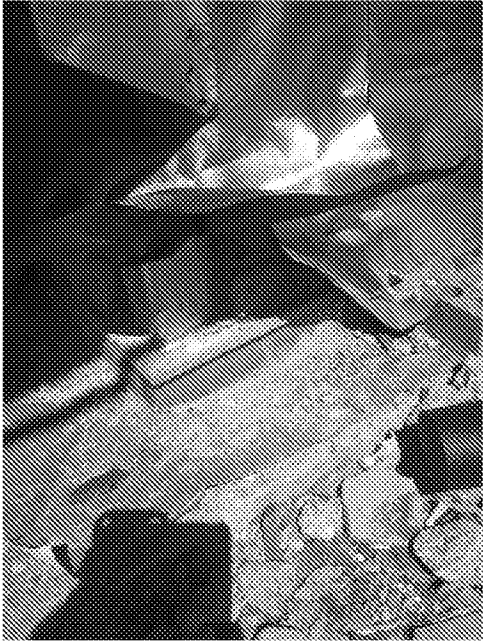
| | <p>Plot 1steel</p> |

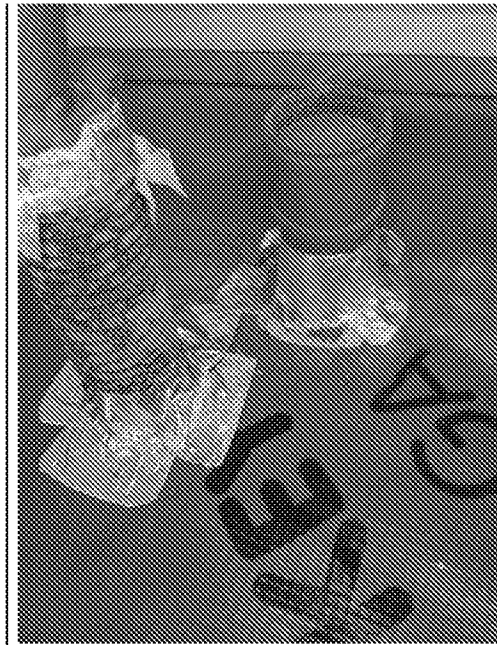
Plot 2 services

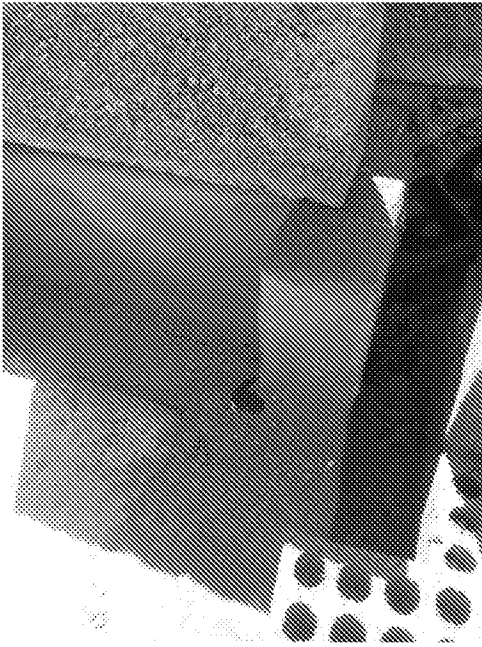
Block A corner

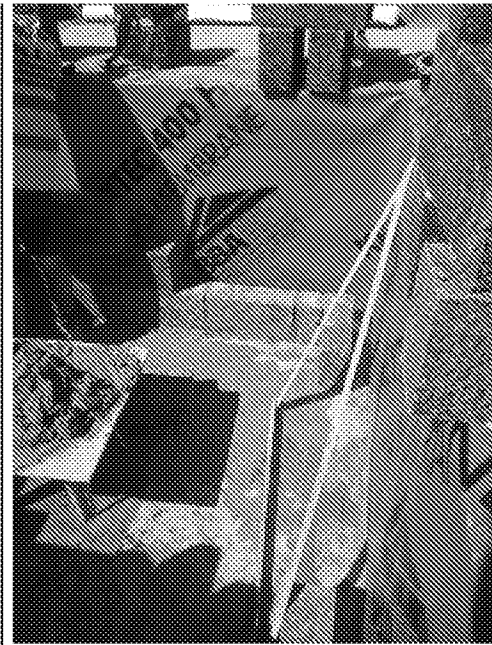
Block B overview

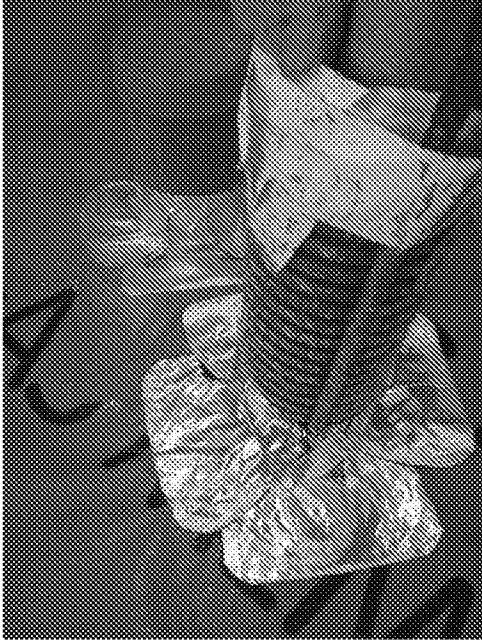
Plot 3 services

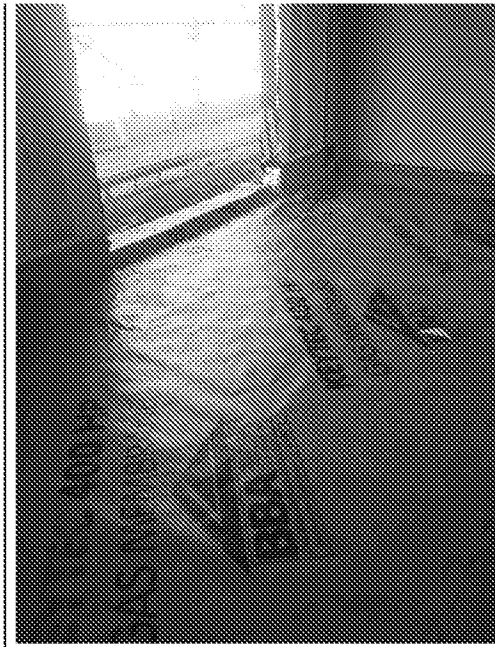
Plot 3 overview

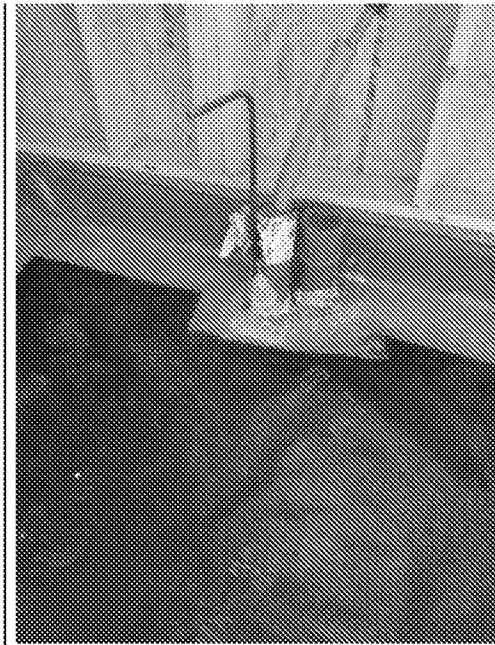
| 1.7 Service seals | Services sealed with double sided tape and membrane. All in good condition. |

Plot 4 - service seal

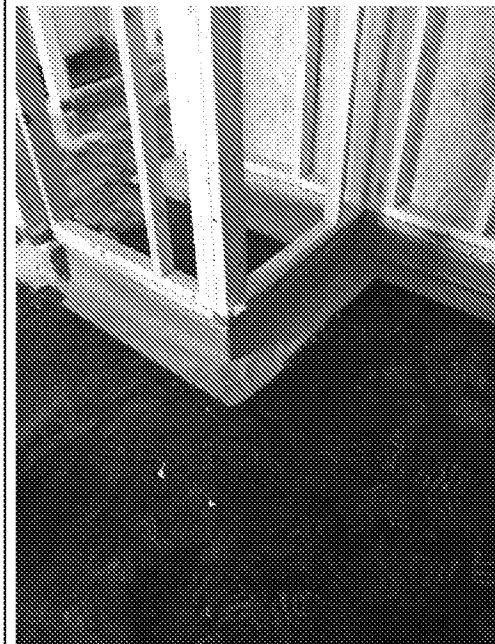
Plot 4 - join between wall and floor

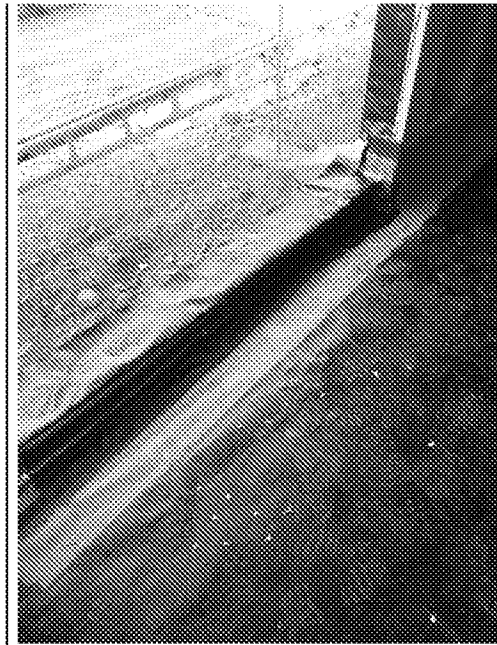
Plot 4 - Threshold

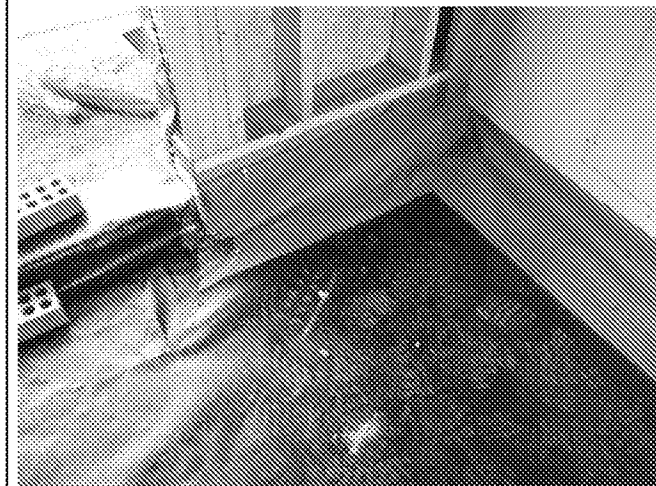
Plot 5 -Threshold corner detail

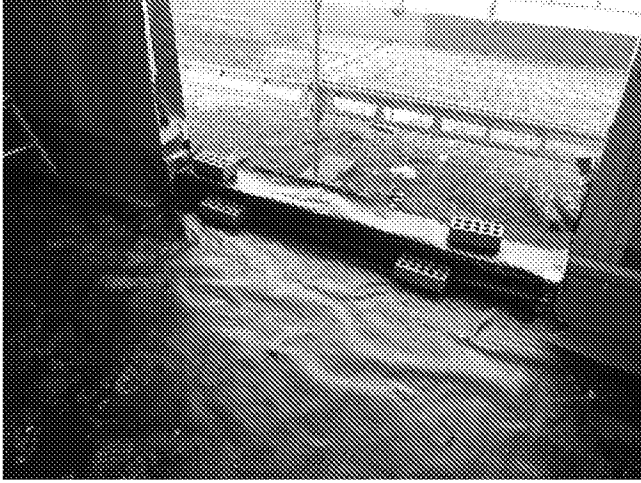
Plot 5 - Threshold

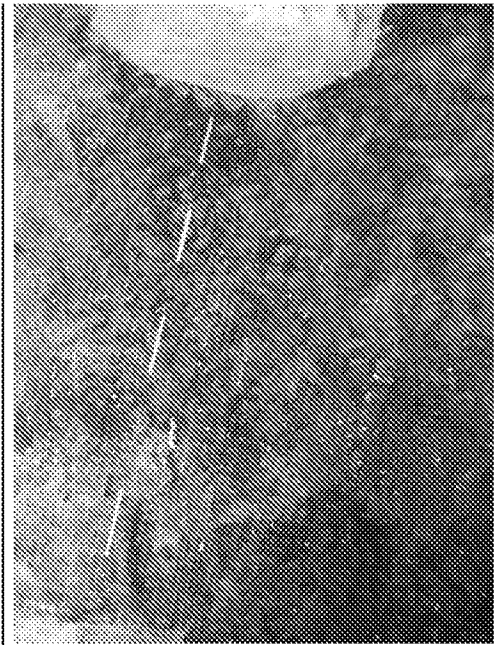
Plot 7 joins

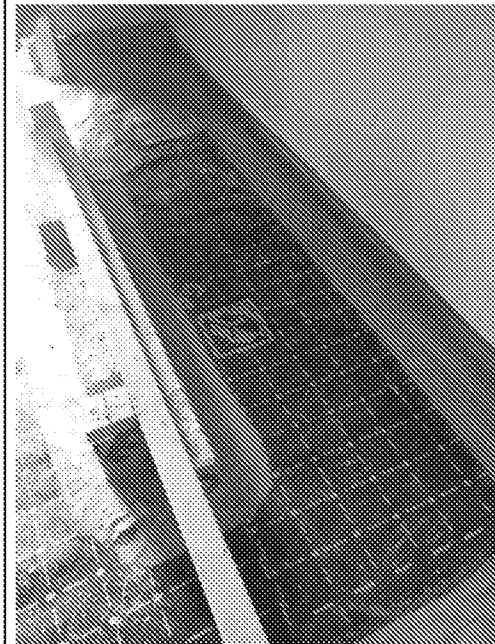
Plot 8 under stairs

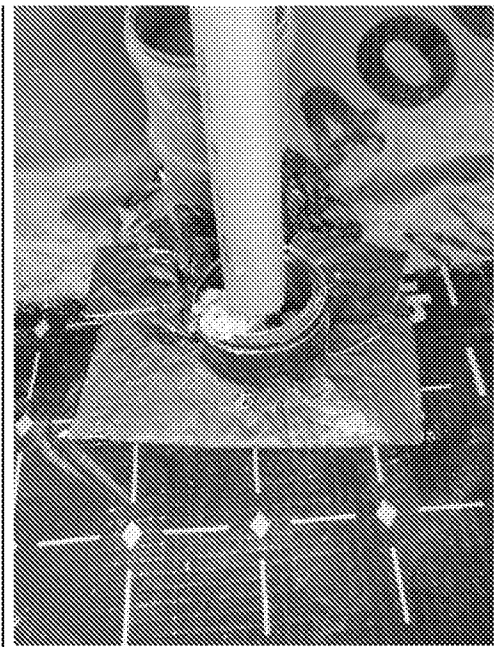
Plot 9 service seal

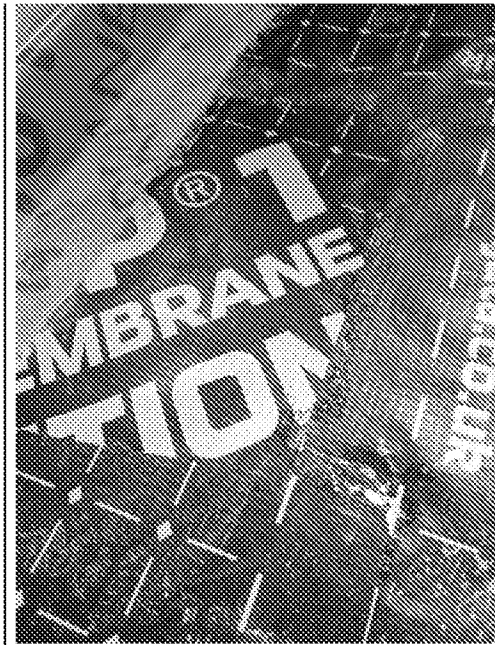
Pot 10 membrane joins

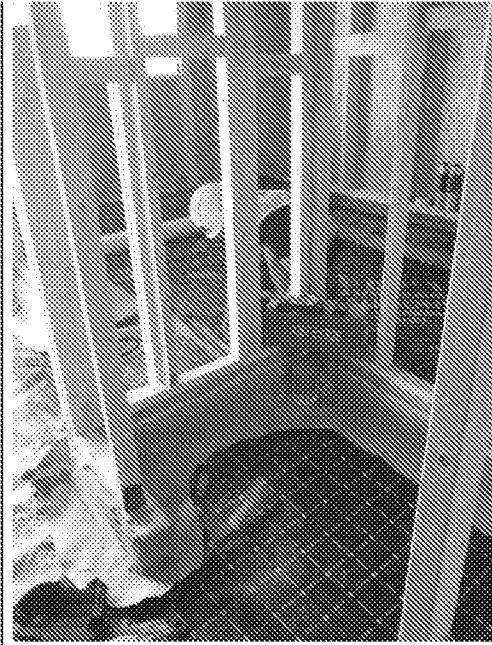
Plot 11 in progress

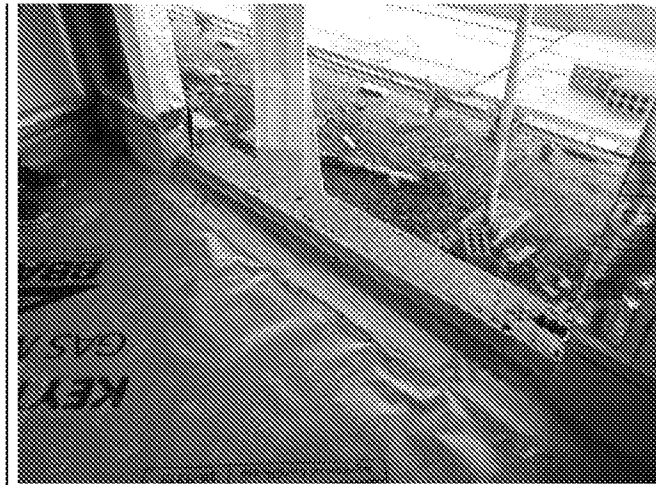
Plot 12 - Threshold

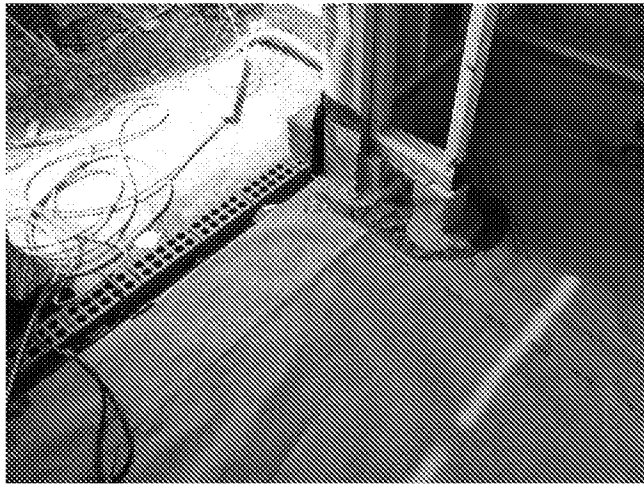
Plot 13 - Threshold

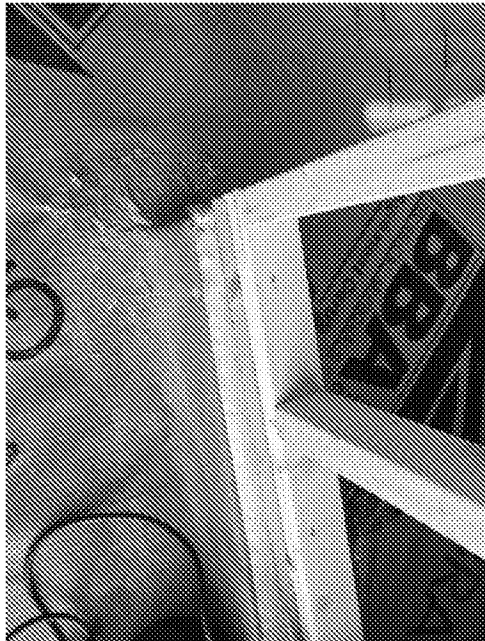
Plot 13 - Corner detail

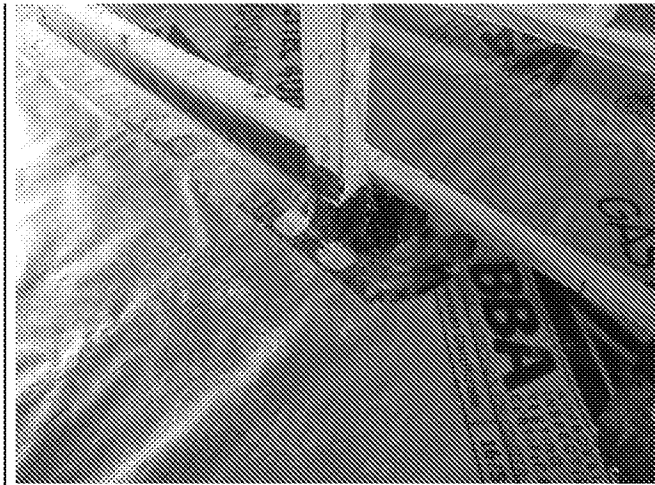
Plot 13 - Patching

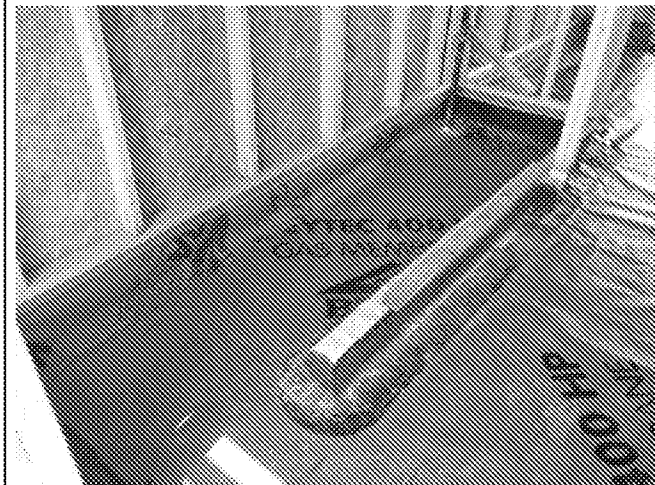
Plot 13 - Under stairs

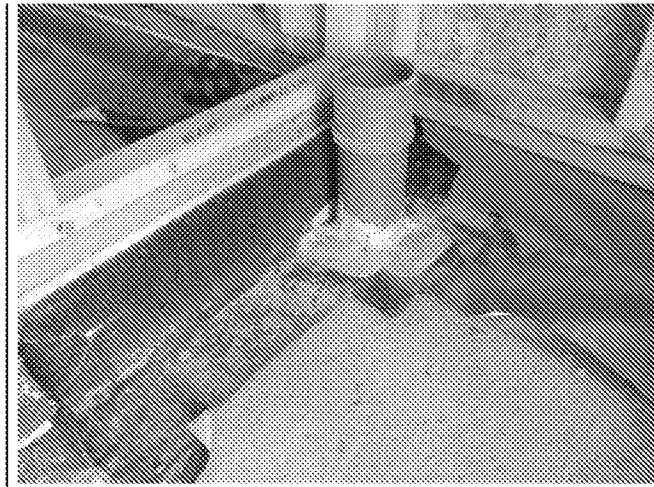
Plot 15 - Services sealed

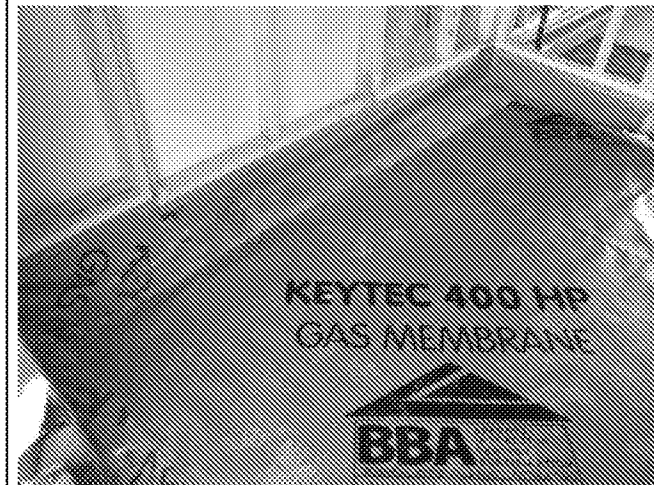
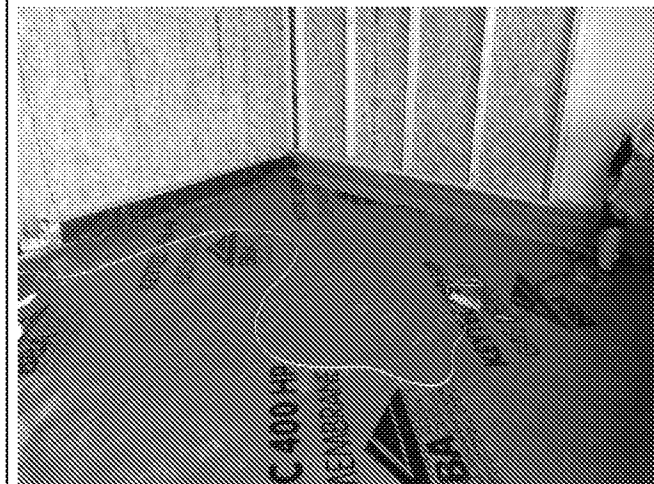
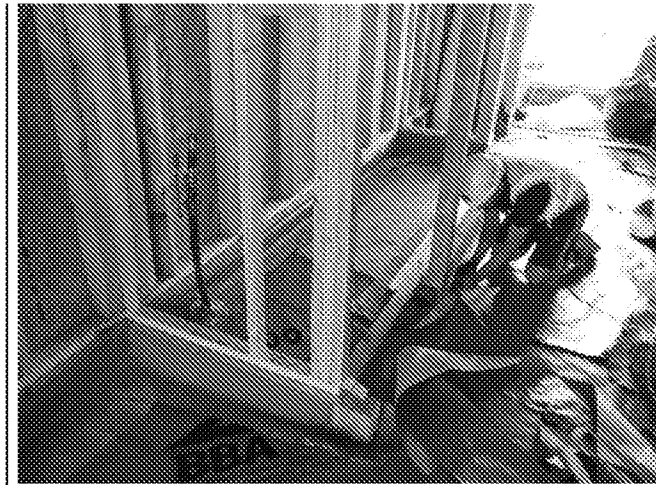
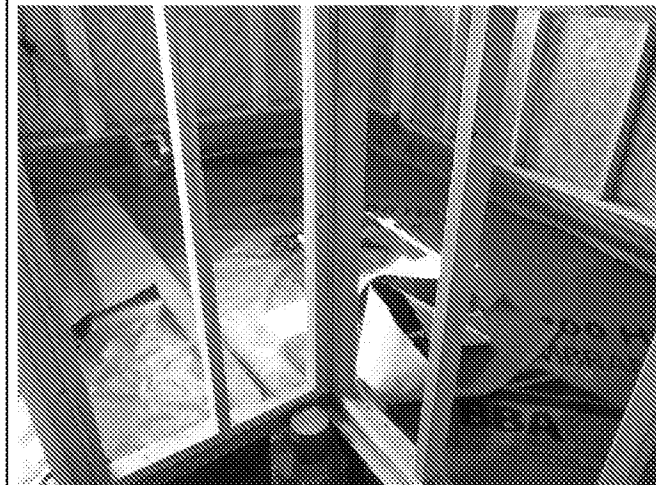
Plot 14 in progress

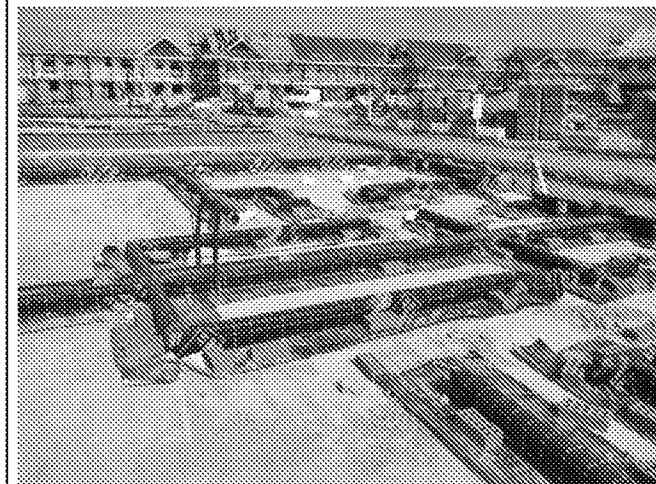
Plot 20-21(Phase 4) - View across plots

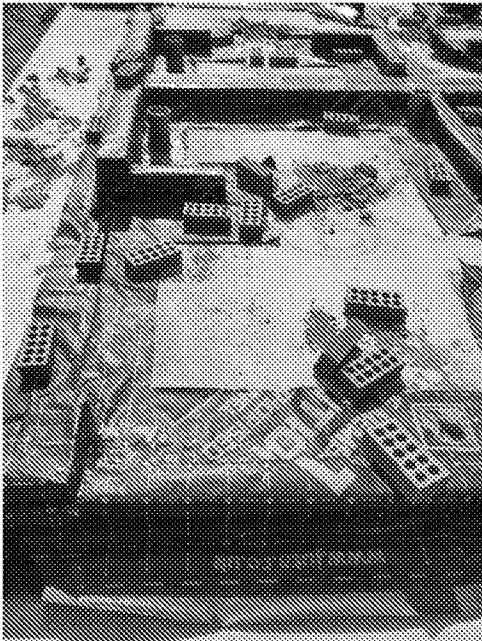
Plot 20-21(Phase 4) - walls and doorway

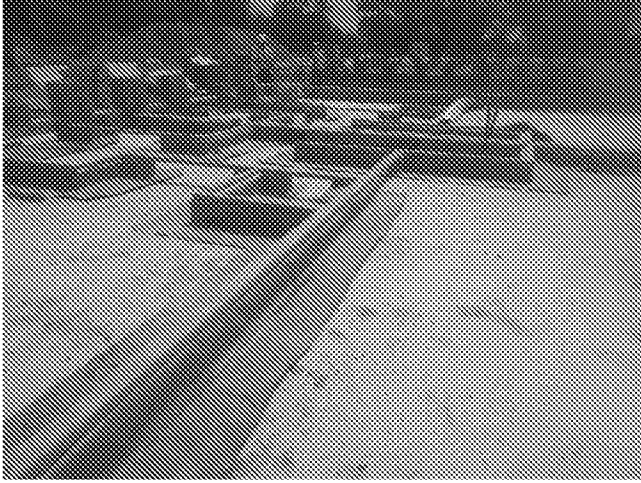
Plots 36-37. View across plots.

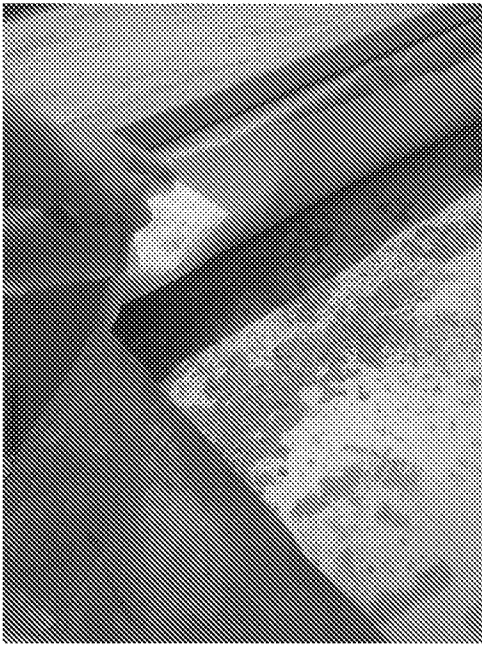
Plots 36-37. Example of underside of membrane.

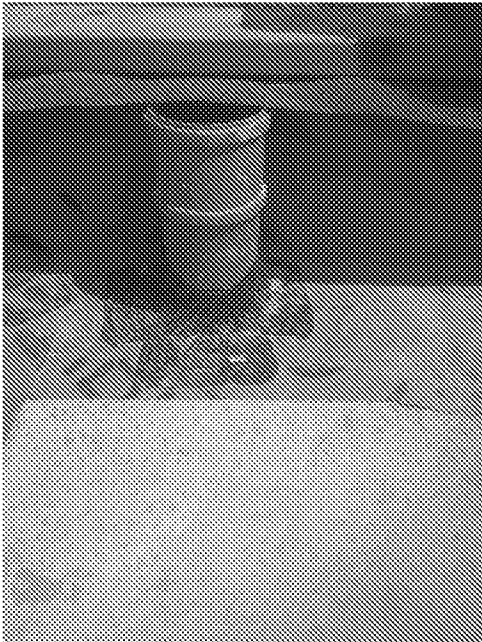
Plots 38-39. Service seal using butyl tape.

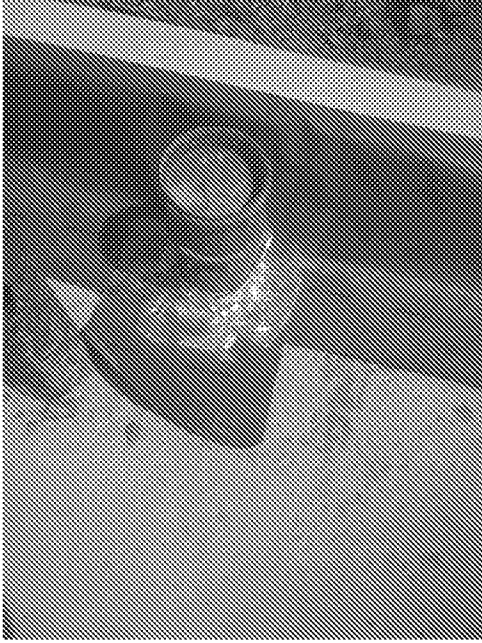
Plot 40-41. Servicing seal.

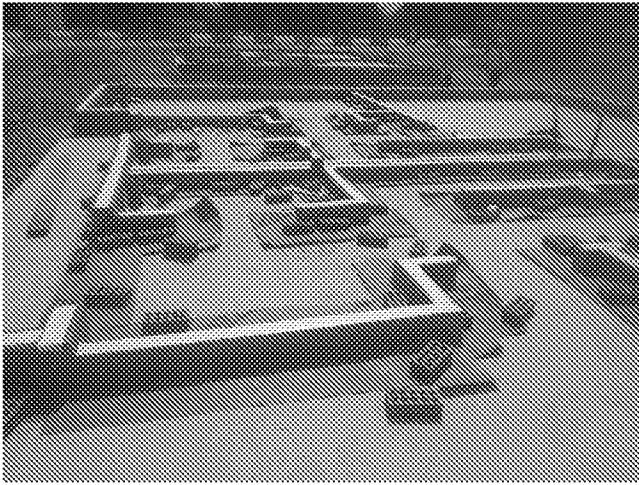
Plots 40-41. View across Plots showing butyl tape laid out for fixture of wooden frame.

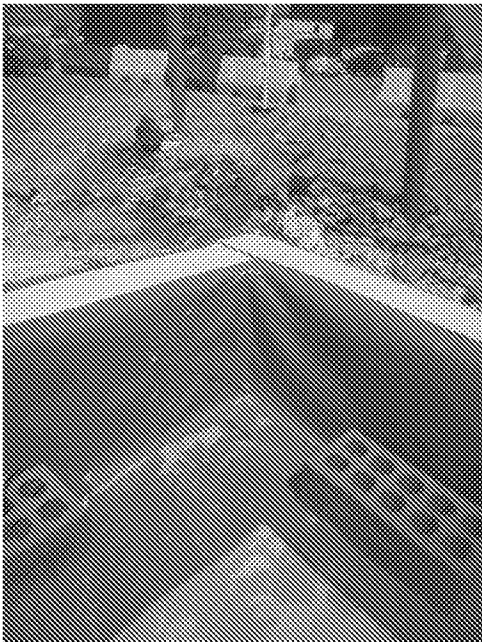
Plots 40-41. Corner detail.

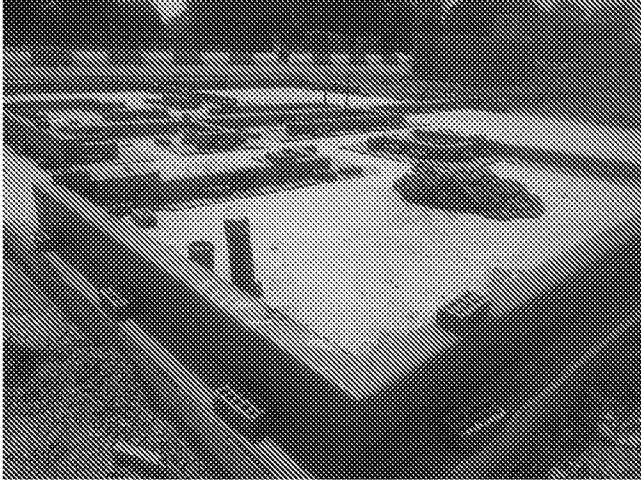
Plots 42-43. View across plots.

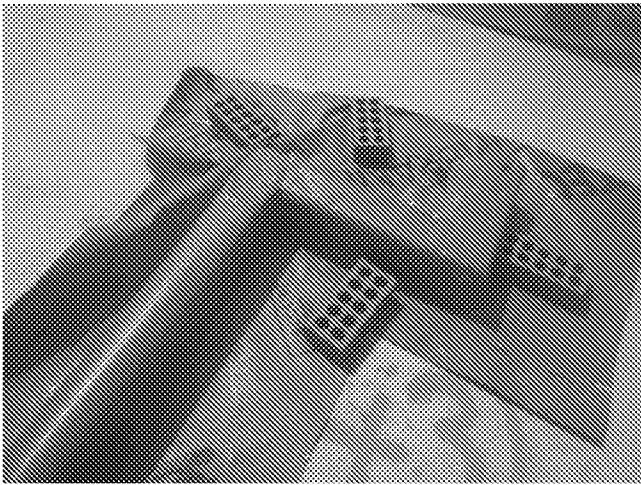
Plots 42-43. Corner detail.

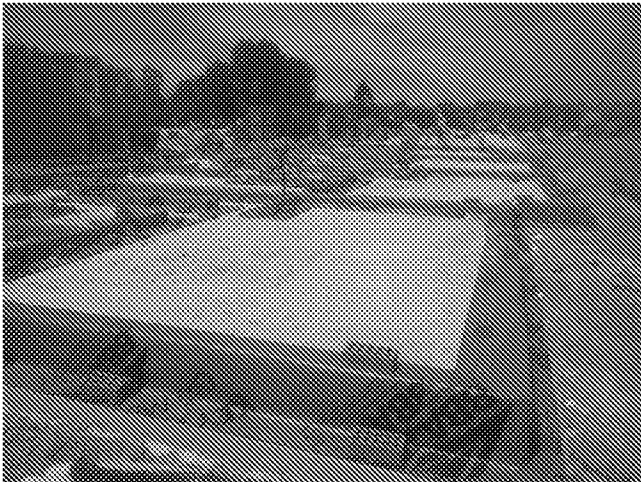
Plots 24-27. View across plots.

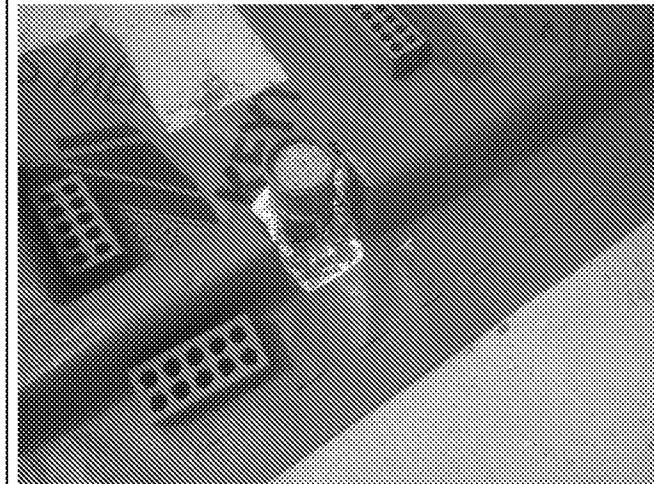
Plots 24-27. Service seal.

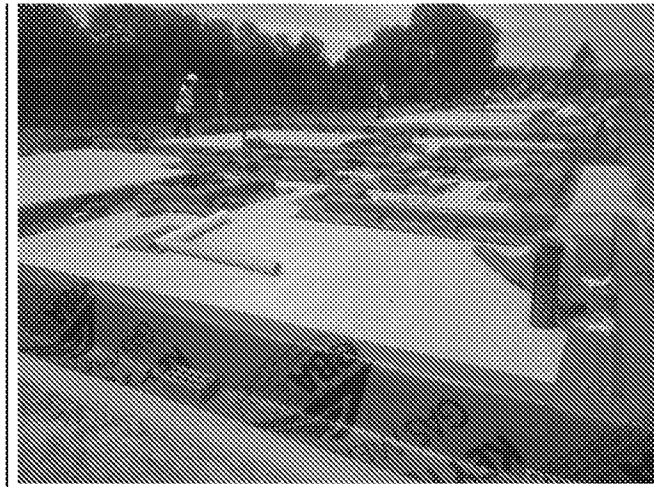
Plots 22-23. View across plots.

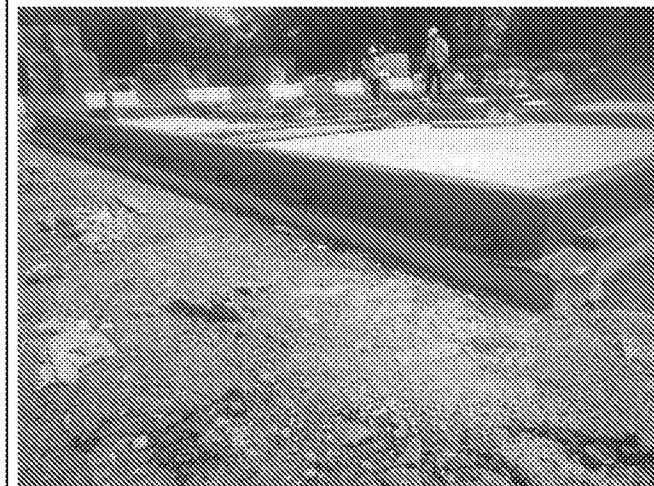
Plots 22-23. Lapping over external wall.

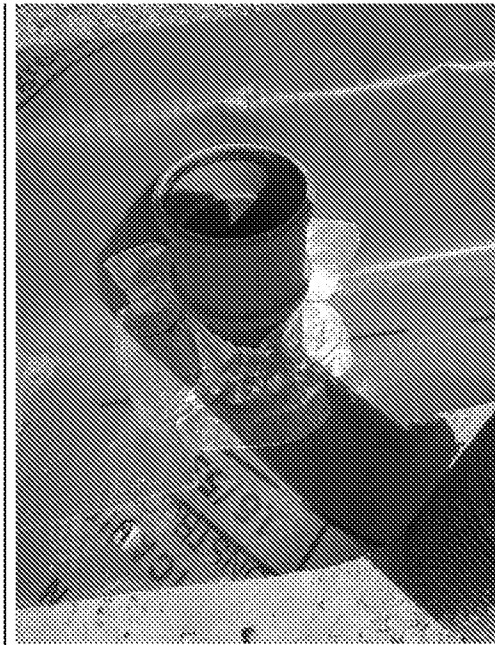
Plot 23 services

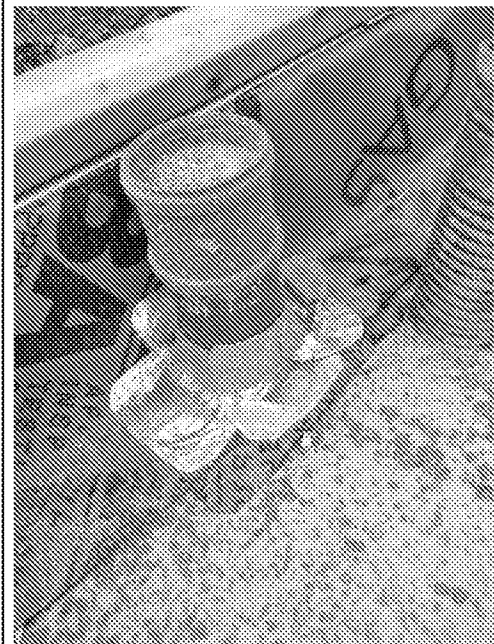
Plot 24 services

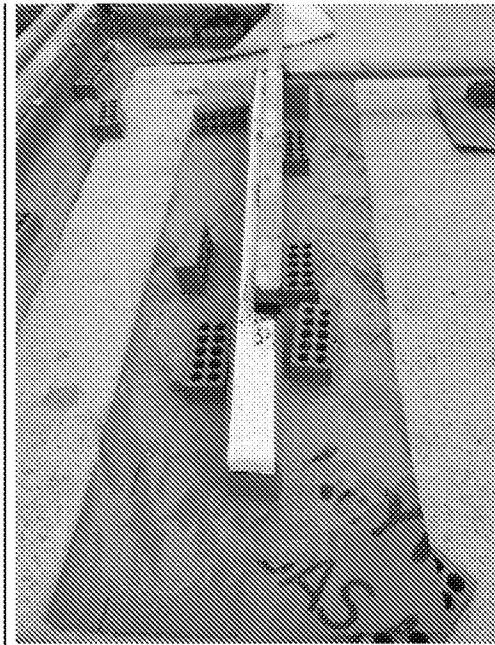
Plot 24 tape for timber frame

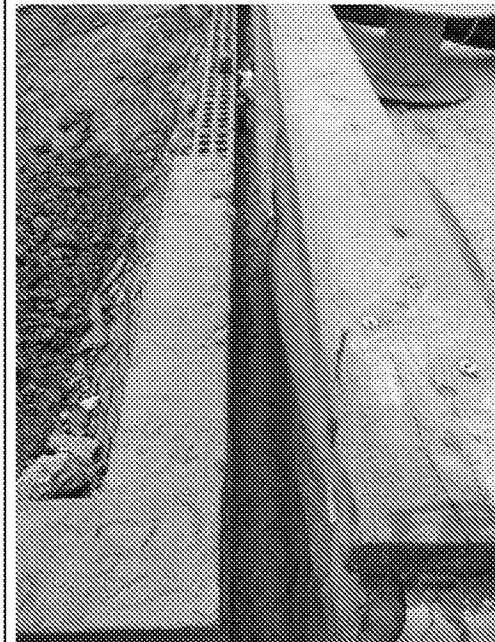
Plot 24 cavity
