| Project Name | Cornfield Close |
| Project No. | GE18103 |
| Client | Thakeham Homes |

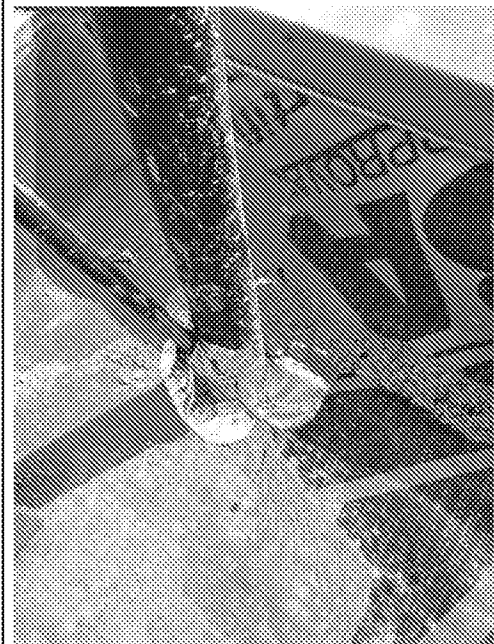
Plot 27 service

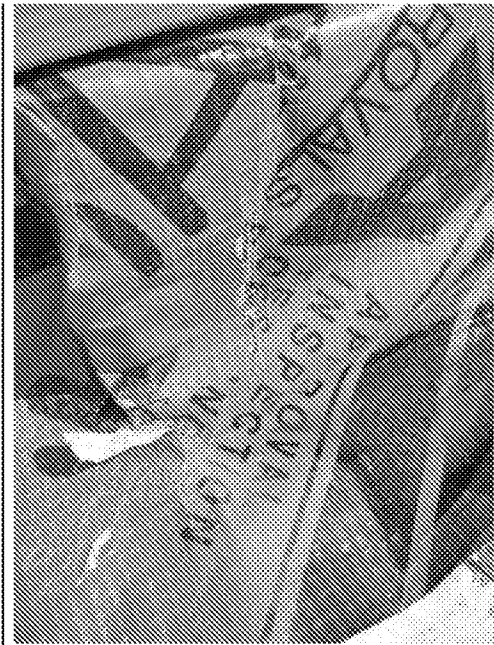
Plot 27 damage

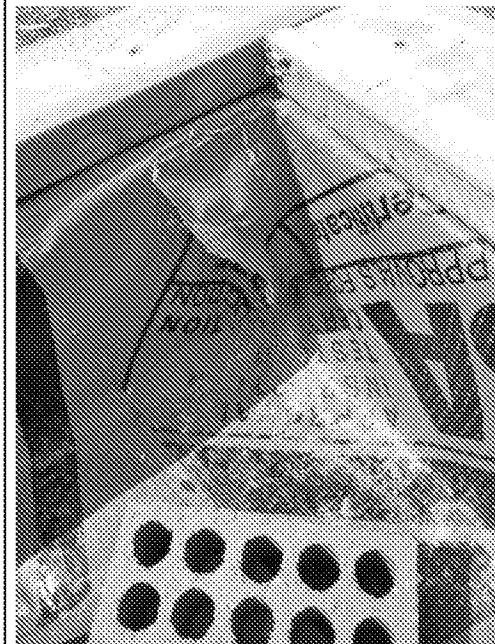
Plot 28 corner needs sealing

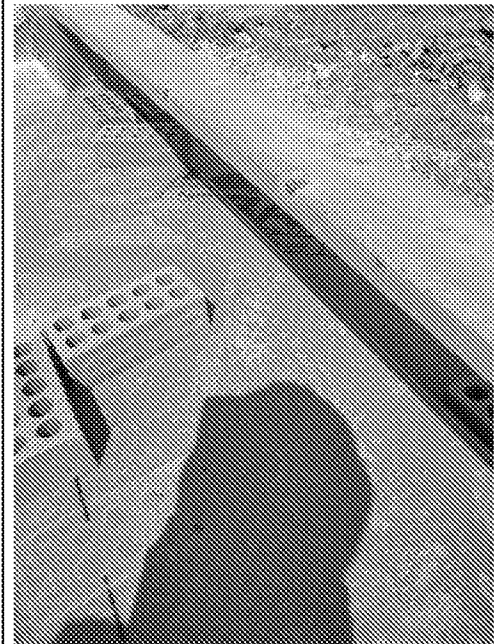
Plot 29 threshold

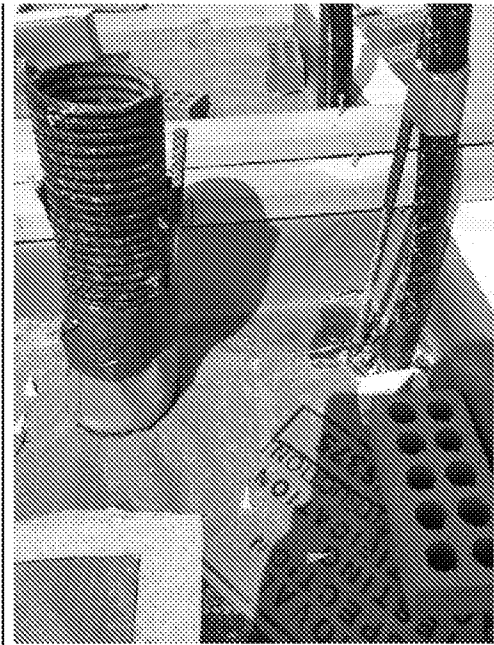
Plot 29 services

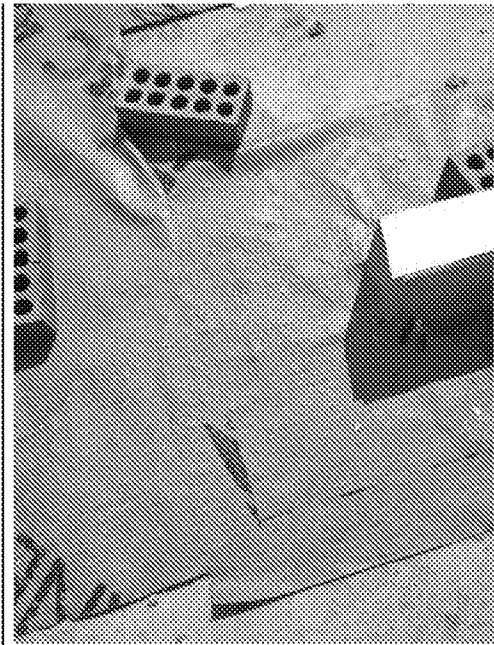
Plot 30 joins

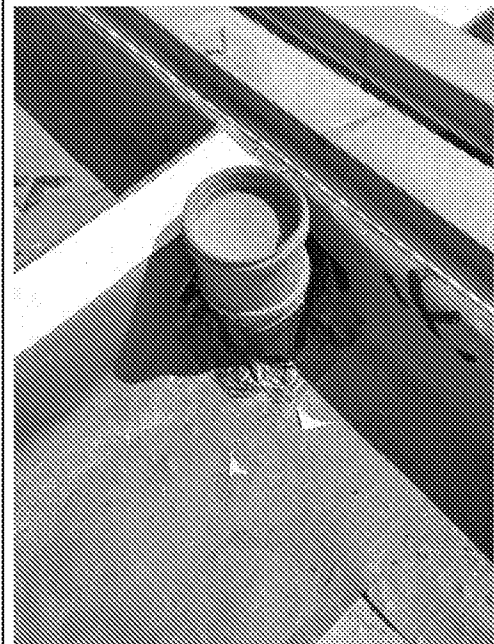
Plot 30 services

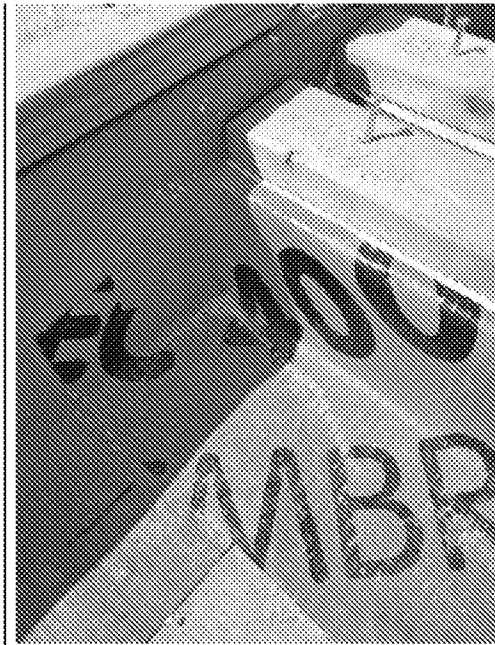
Plot 30 corner

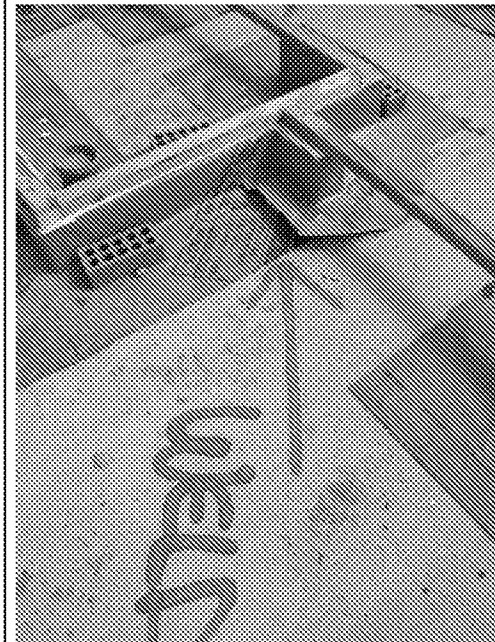
Plot 31 seal needs attention

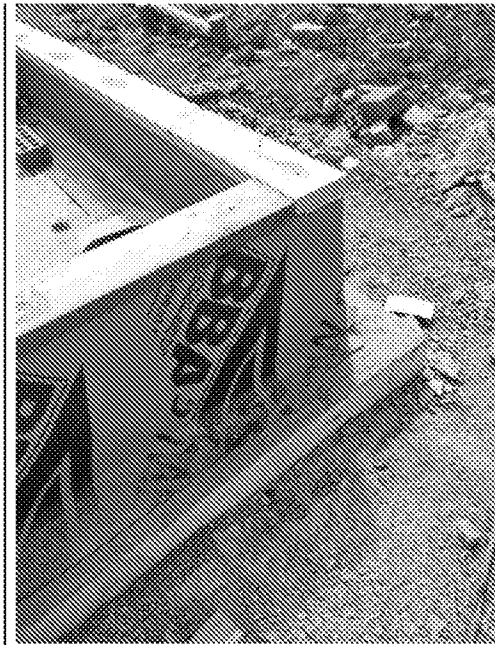
Plot 31 edge detail

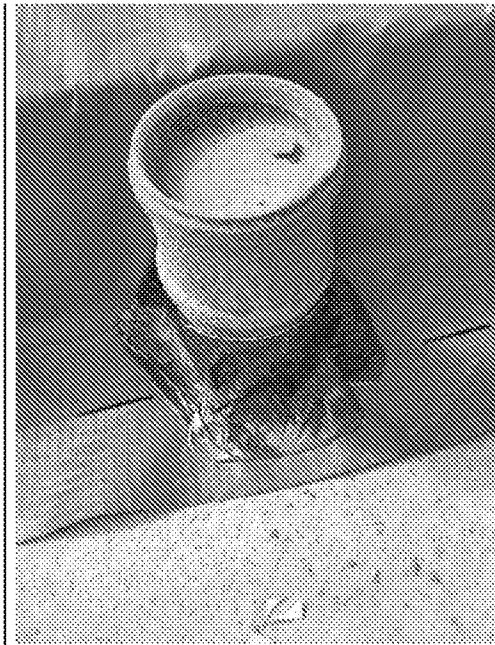
Plot 32 service

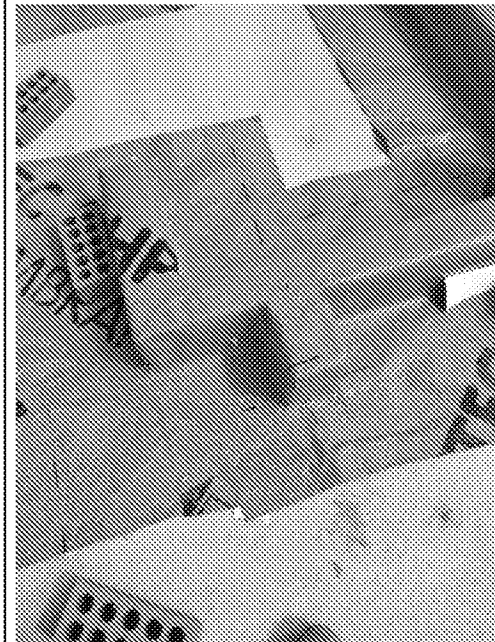
Plot 32 corner

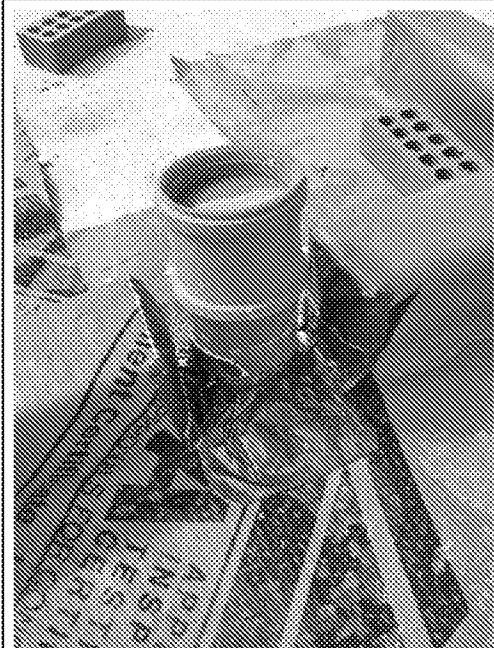
Plot 33 service

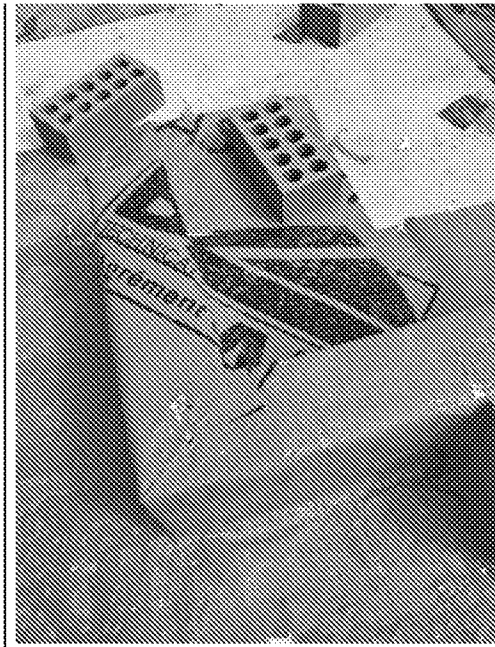
Plot 33 corner

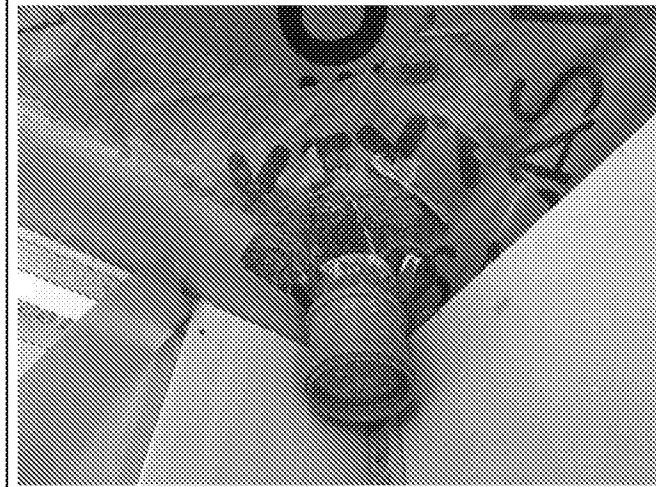
Plot 36 Service seal

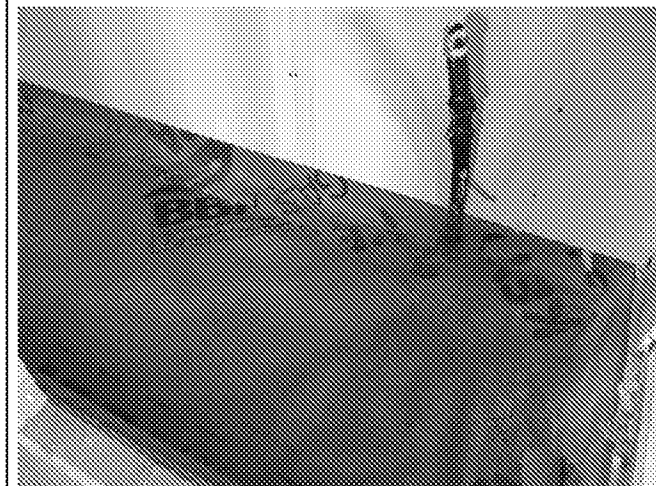
Plot 36 Under stairs

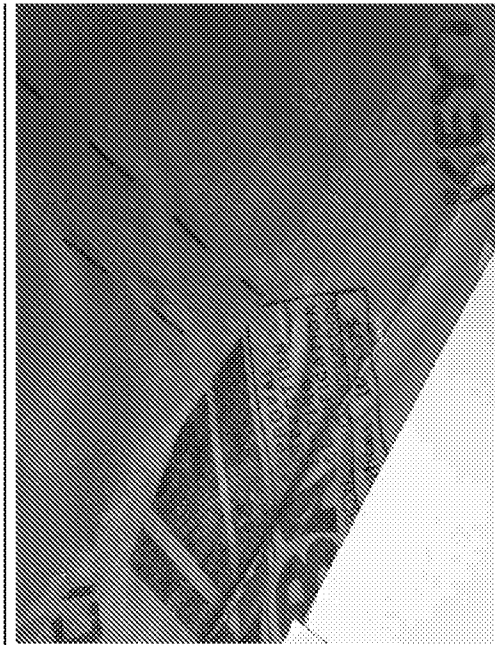
Plot 36 Joins

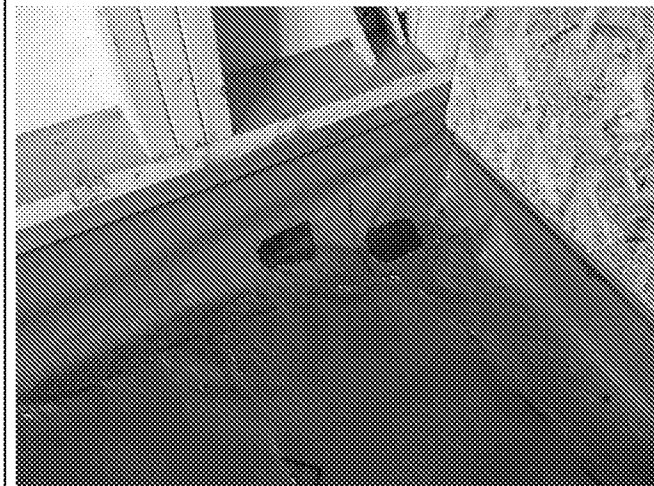
Plot 36 Patch repairs

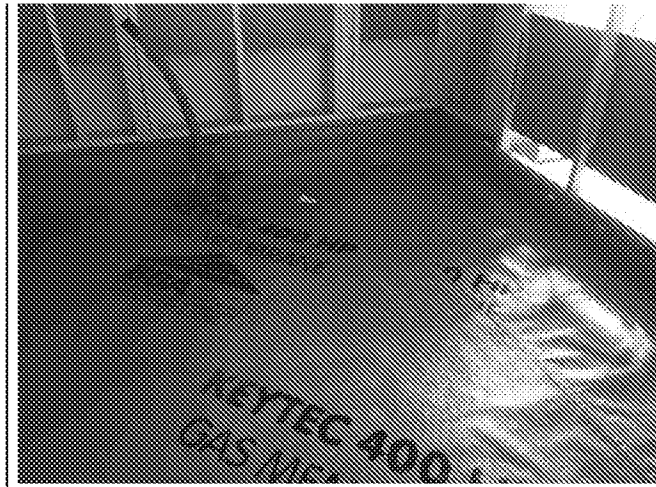
Plot 36 Front room

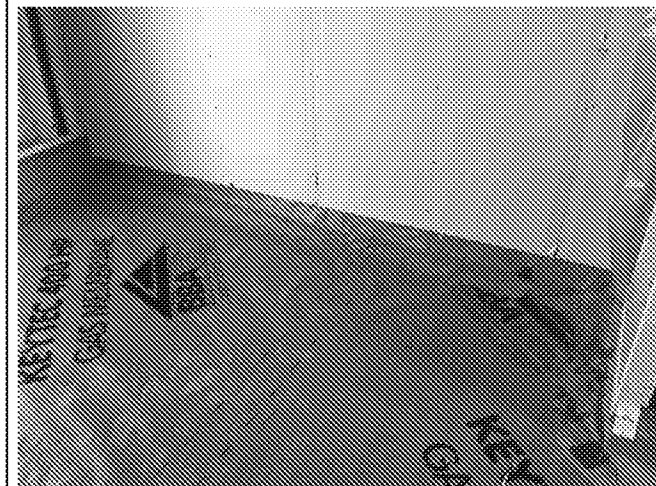
Plot 37 Joins and a patch repair

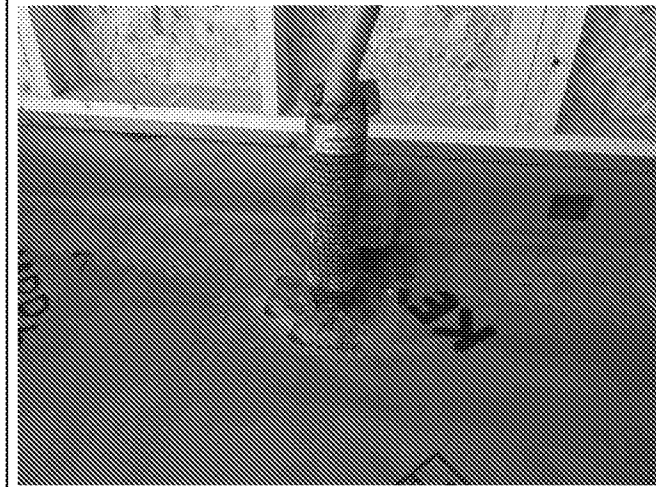
Plot 37 Service seal

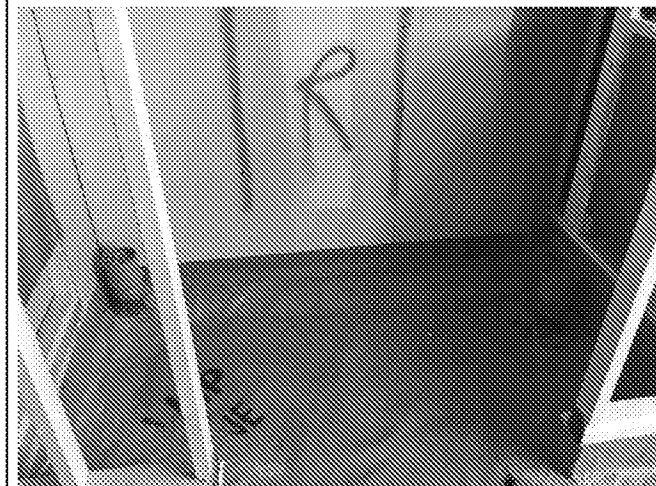
Plot 37 Front room

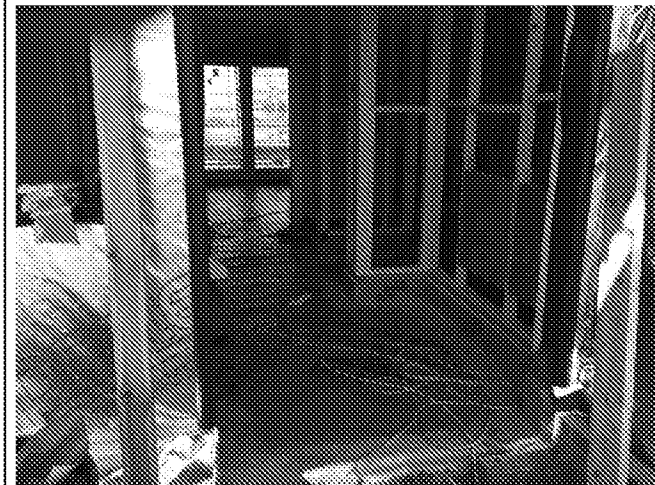
Plot 39 in progress

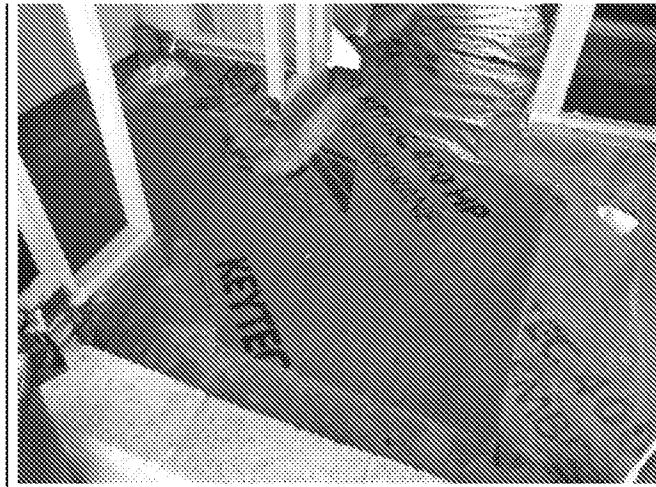
Plot 40 - floors sealed

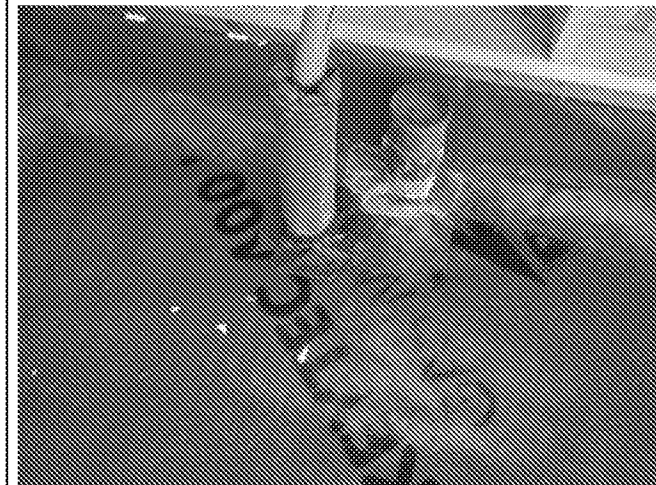
Plot 40 - example of service seal

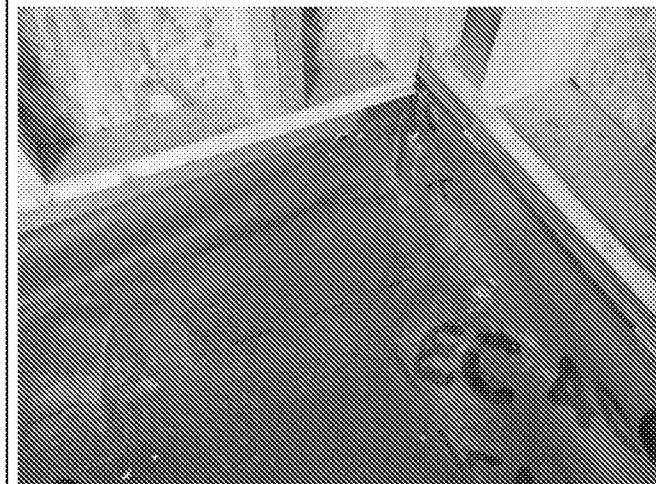
Plot 40 - Corner detail

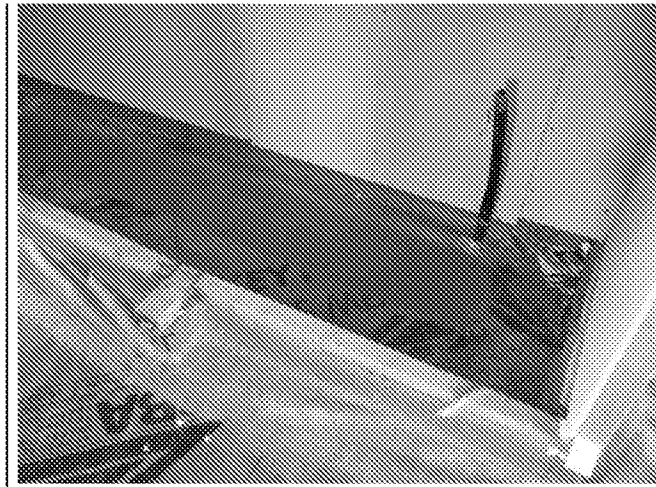
Plot 40 - under stairs

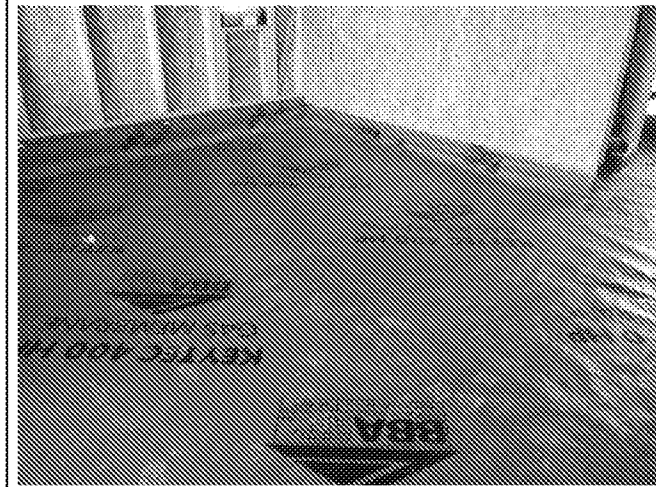
Plot 40 - floors sealed

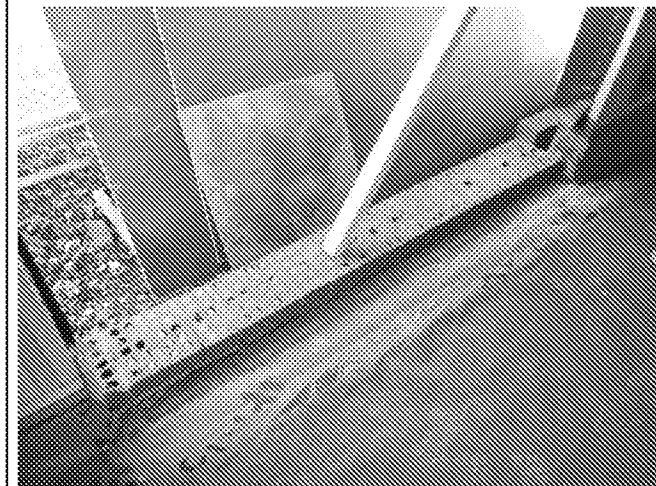
Plot 40 - Threshold

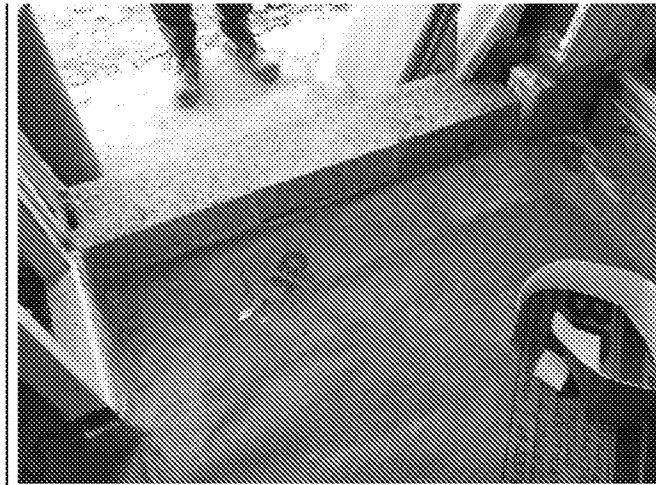
Plot 41 - Threshold

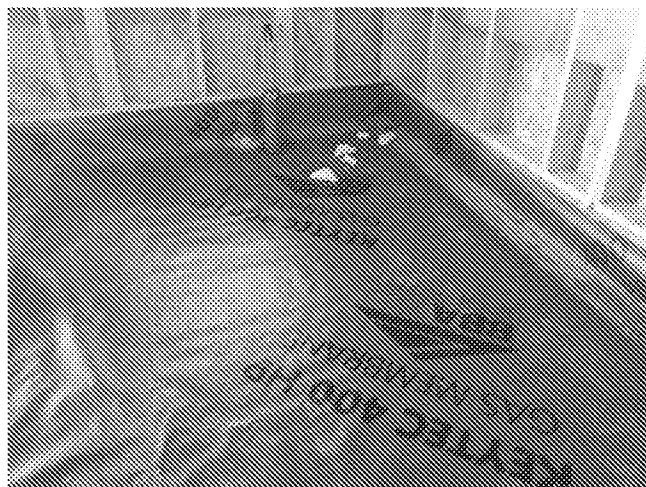
Plot 41 - Floor and services sealed

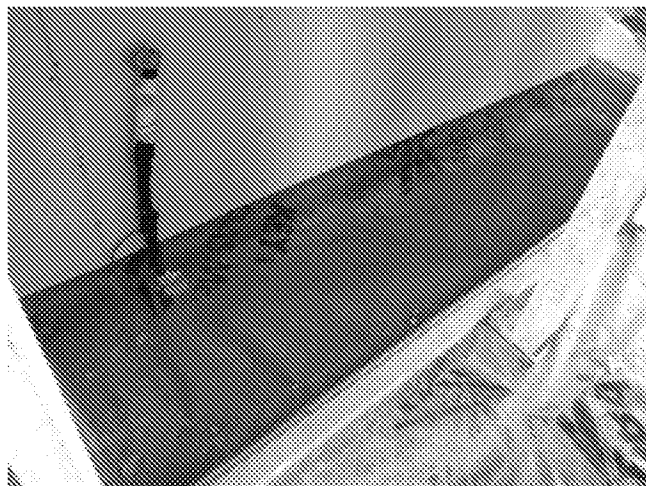
Plot 41 - under stairs sealed

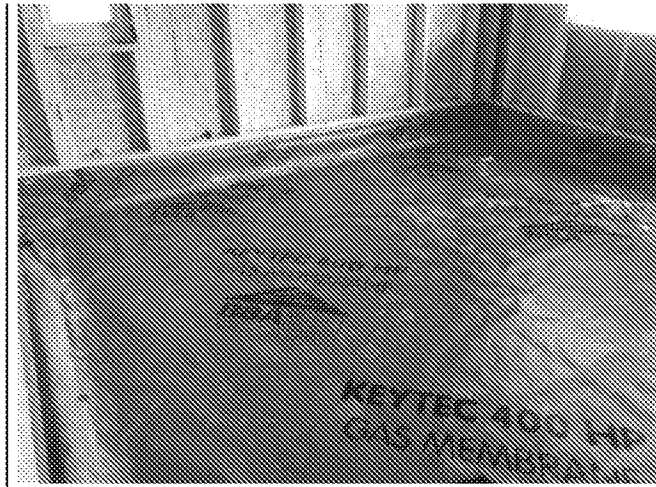
Plot 41 - floors sealed

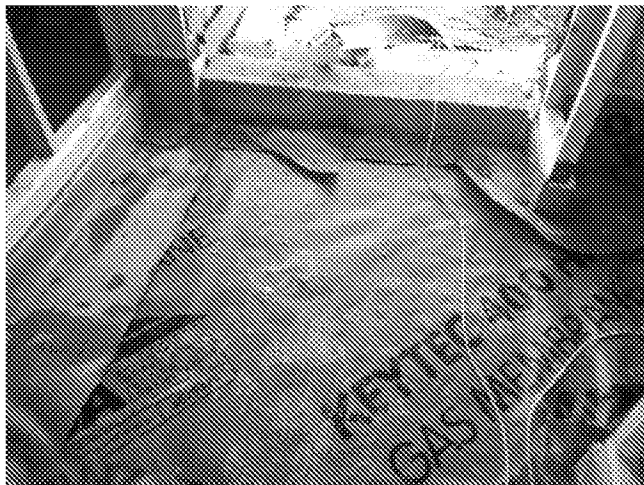
Plot 42 - Floor in progress

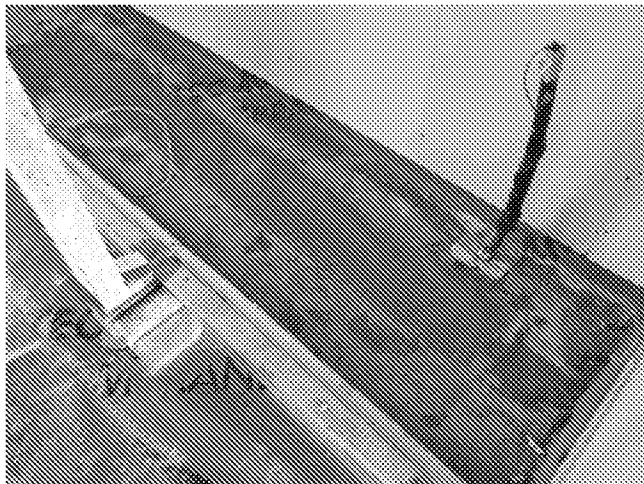
Plot 42 - under stairs sealed

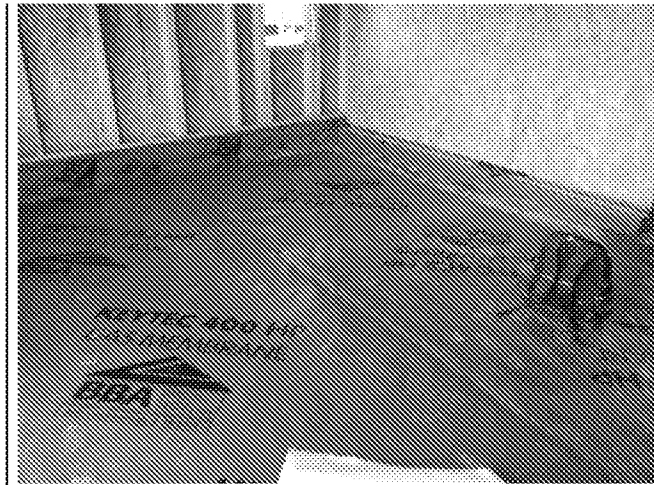
Plot 42 - floors sealed

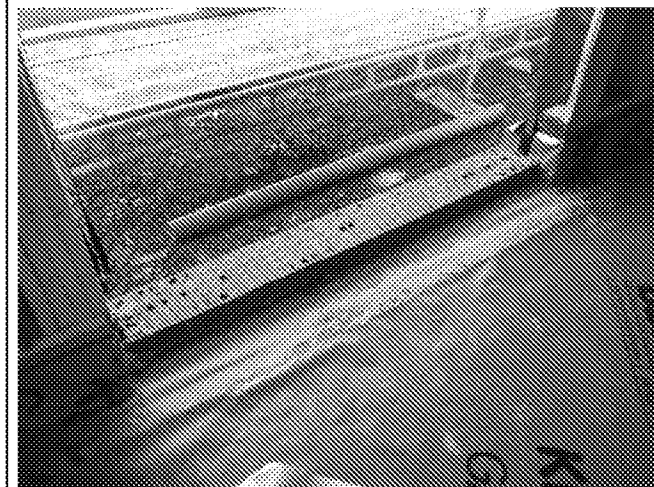
Plot 42 - Threshold sealed

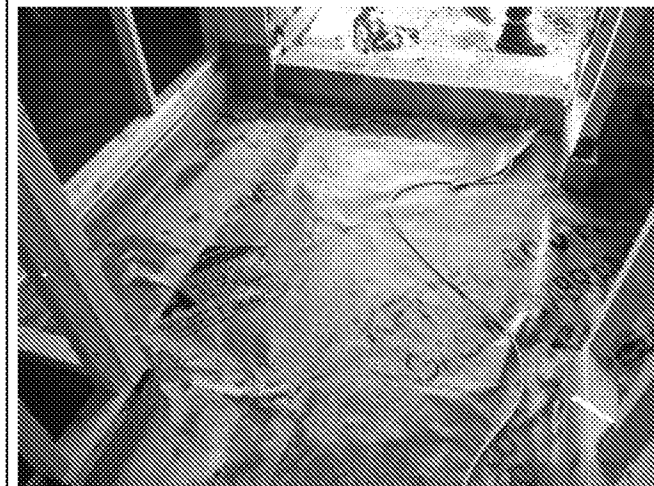
Plot 42 - Floor completed during visit

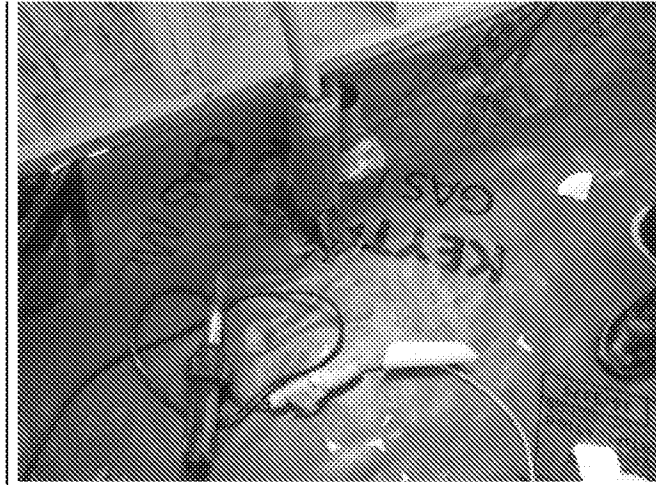
Plot 42 - service seals completed during inspection

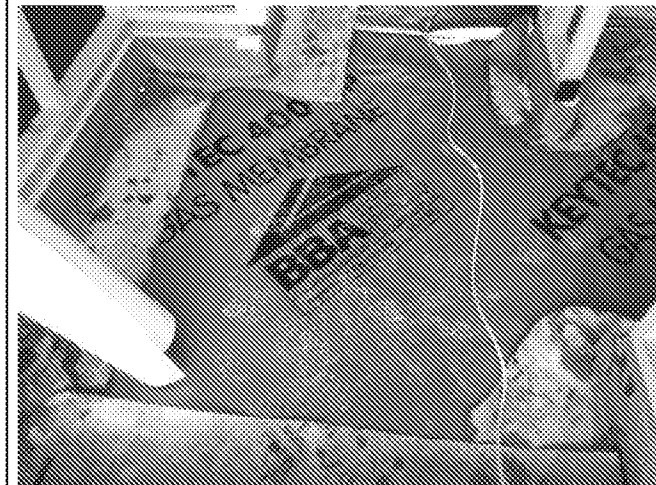
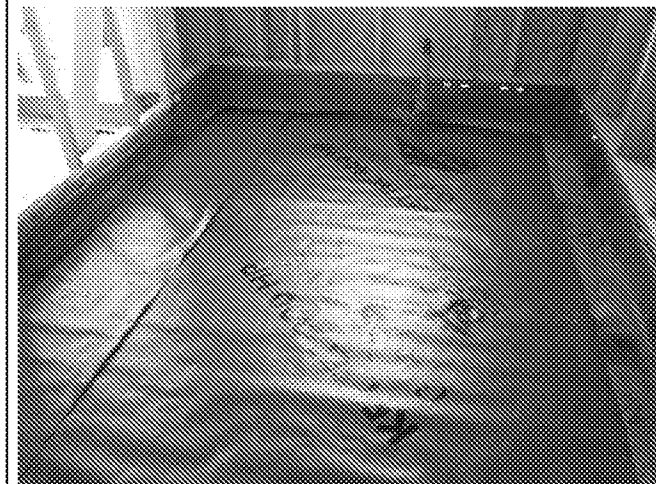
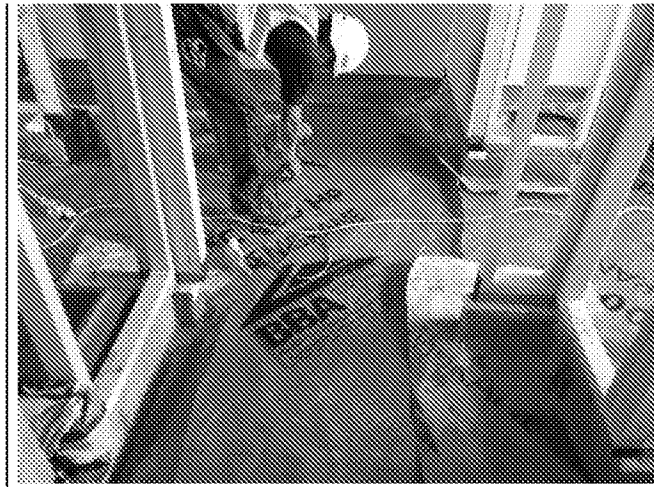
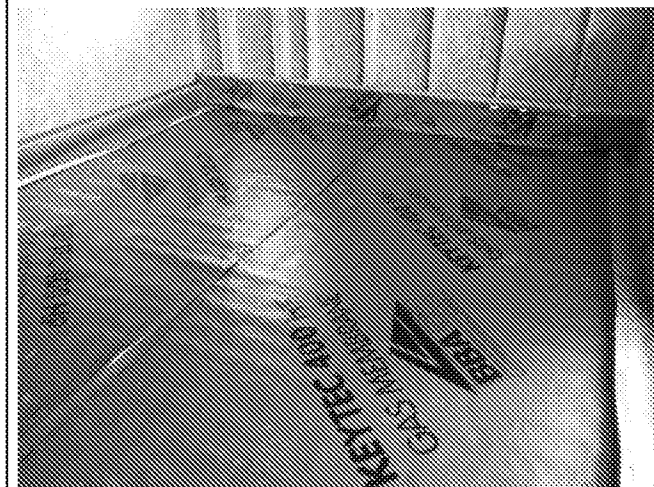
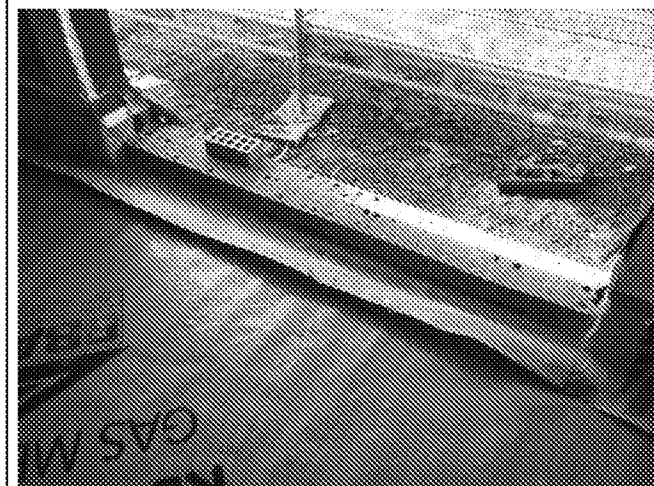
Plot 43 - in progress

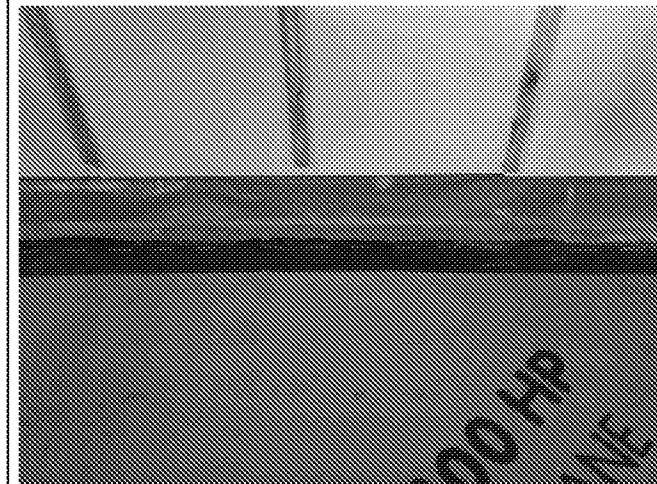
Plot 34 detail extra membrane to protect threshold beneath

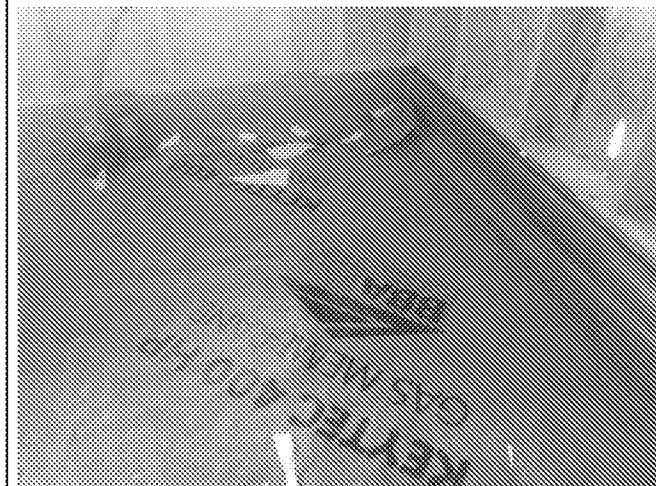
Plot 31 - Floor and service seals

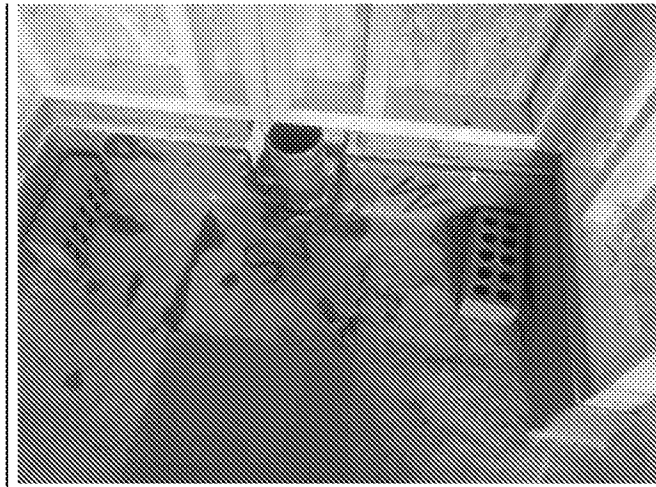
Plot 31 - Service seals. Bricks to hold membrane in shape

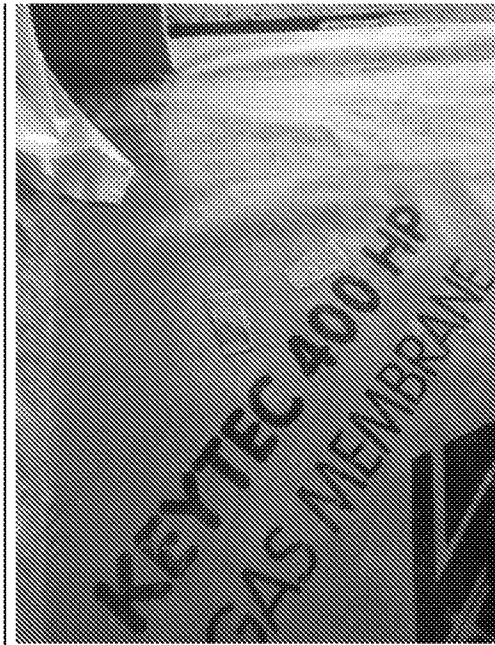
Plot 29 - Patching after removal of debris under membrane

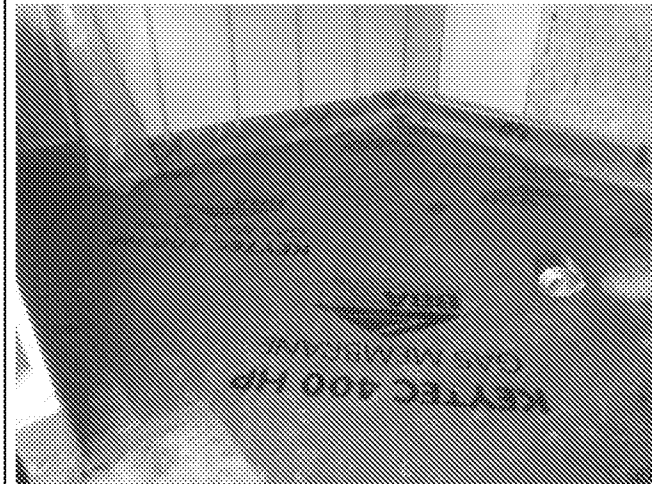
Plot 29 - Floor with some patching

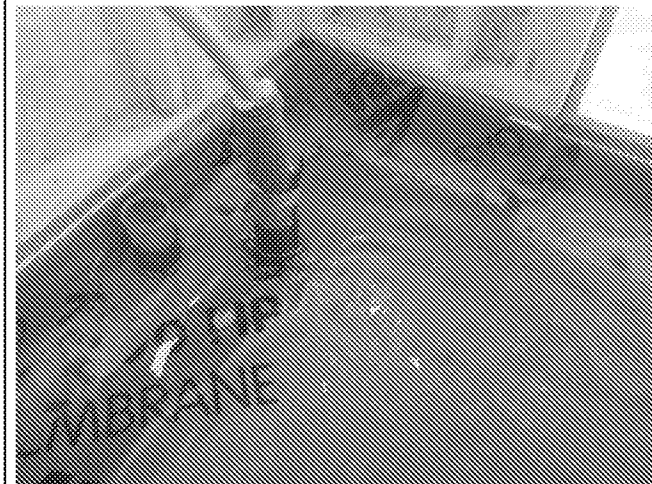
Plot 28 - Service seals

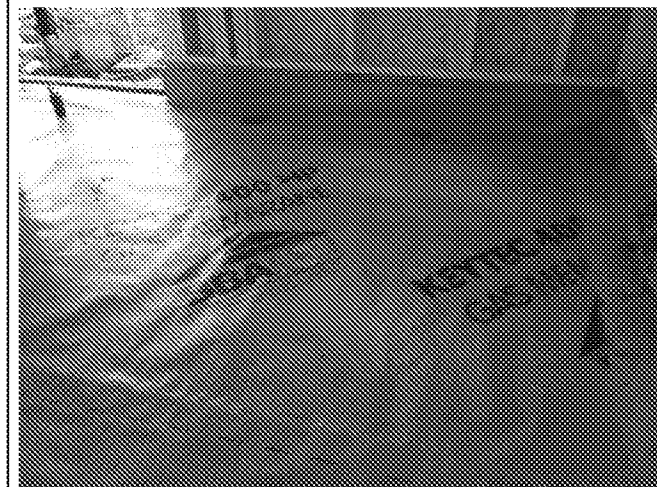
| 1.1 Condition of sub-grade and underside of membrane | Underside of membrane unable to be inspected as fully sealed. Gravel removed from some areas of subgrade and membrane subsequently patched up in Plots 28 and 30. |

Plot 28 - Floor with patching after removal of debris from under membrane

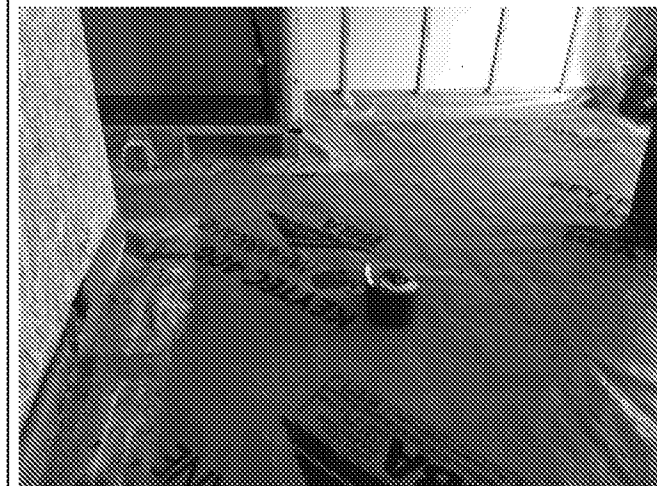
Pot 28 - Floor with some patching

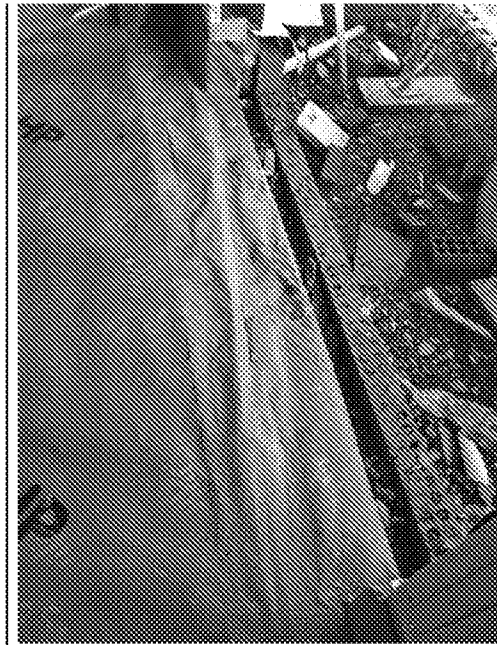
Plot 28 - Threshold with some patching

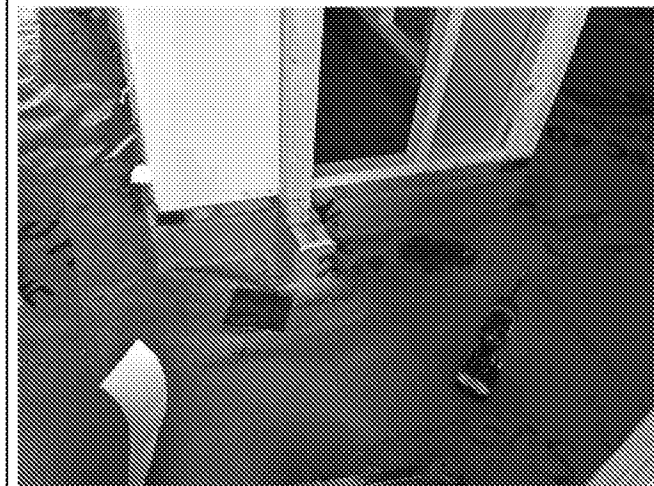
Plot 28 - Floor with patching after removal of debris from under membrane

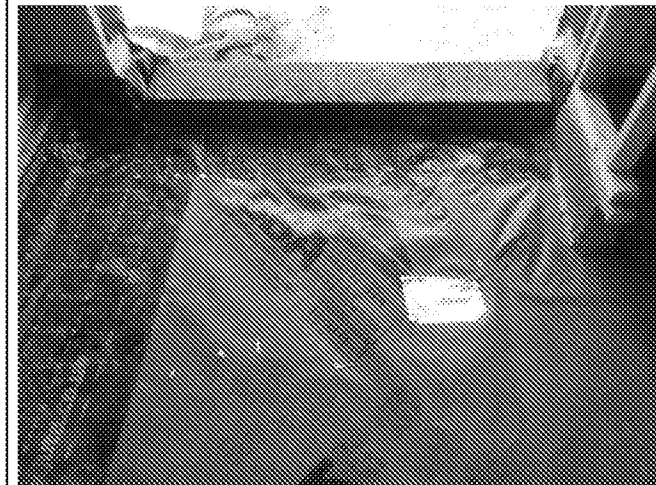
Plot 18 - Patching

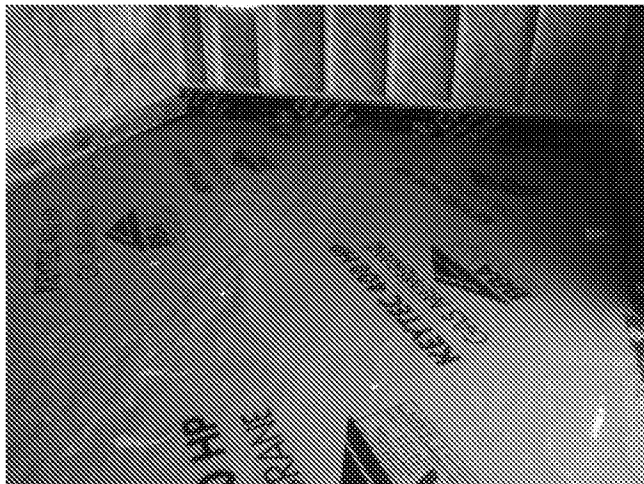
Plot 19 - Floor

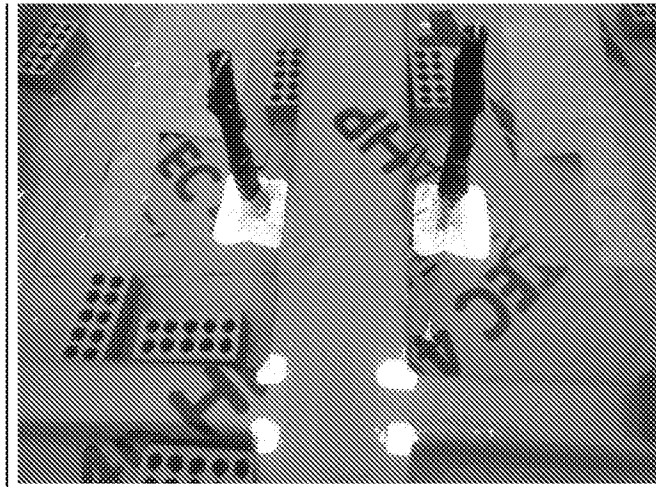
Plot 50-51 service seals

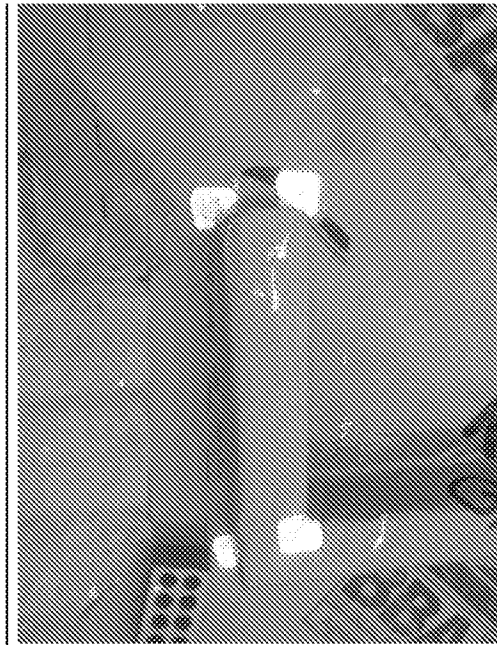
Plot 52-53 perimeter corner detail

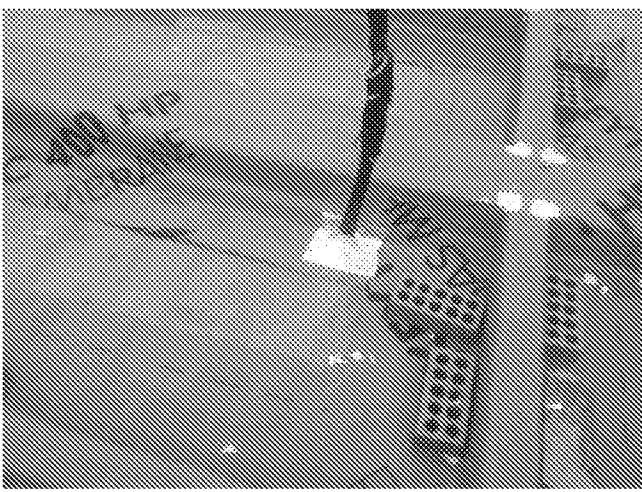
| | <p>Plot 52-53 perimeter services sealed</p> |

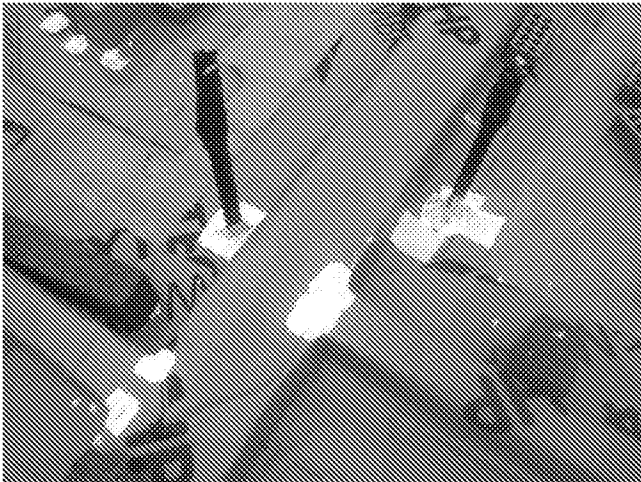
Plot 58-59 perimeter service seal

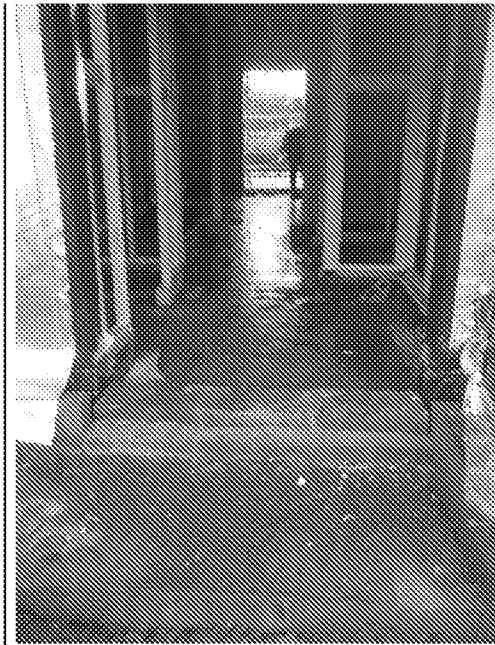
Plot 20 prior to install. Concrete slab in good condition.

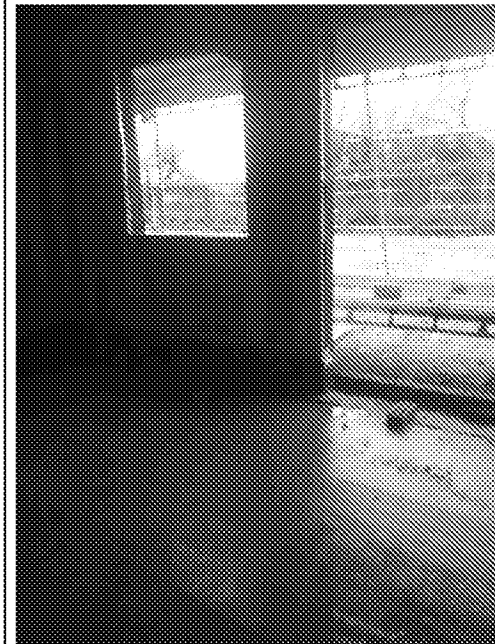
Plot 21 prior to install concrete slab in good condition.

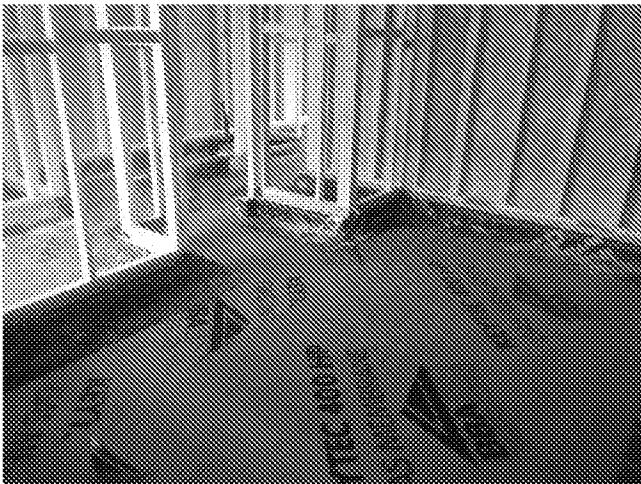
Plot 20 - front of property all good.

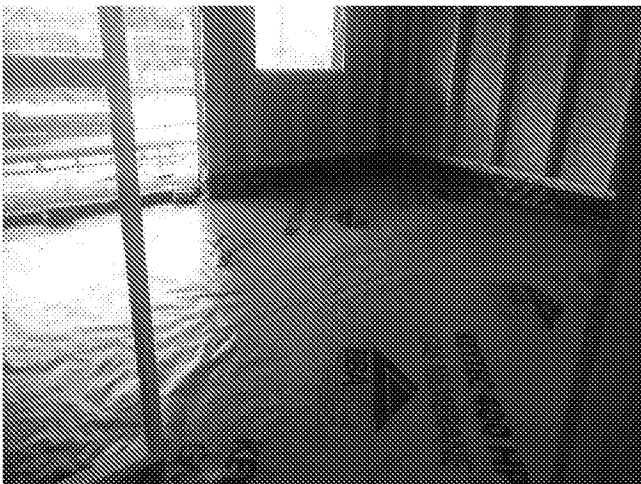
Plot 20 - rear of property all good.

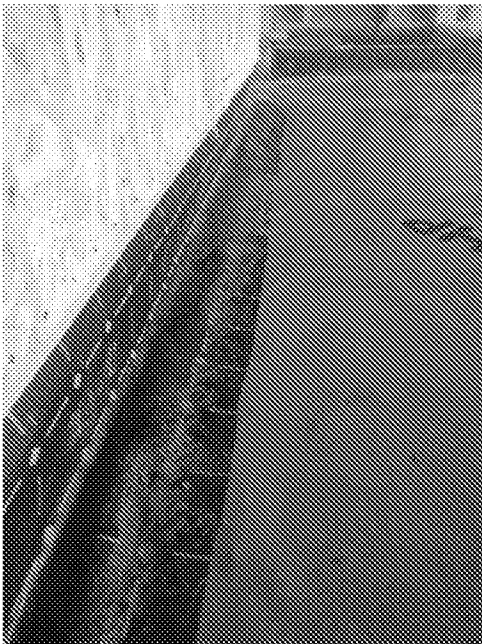
Plot 20 - perimeter seals all good.

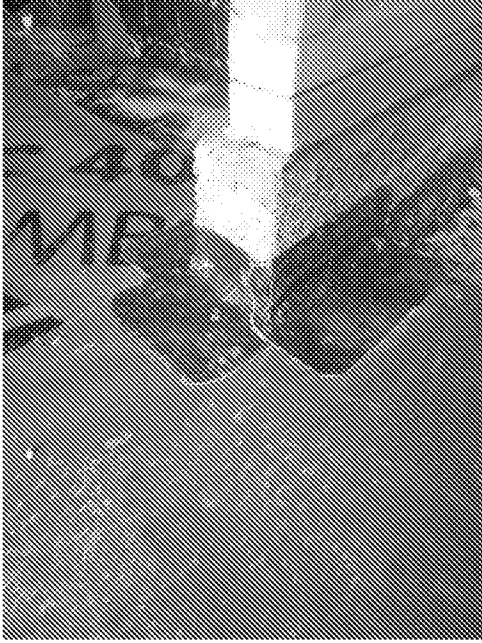
Plot 20 - tape well sealed

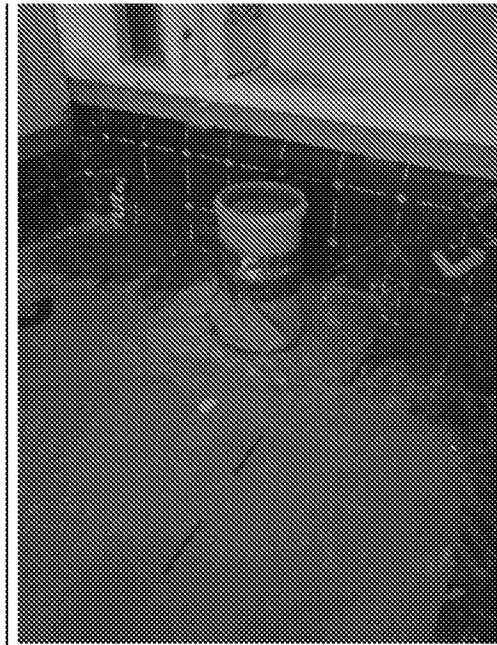
Plot 21 - foul outlet sealed WC

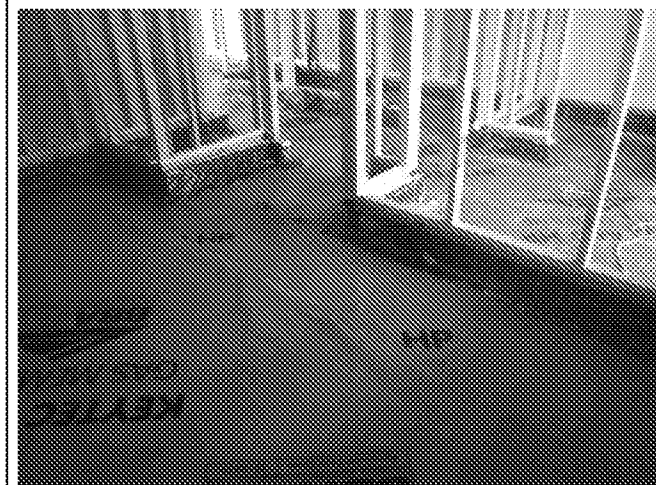
Plot 21 - front of property all good.

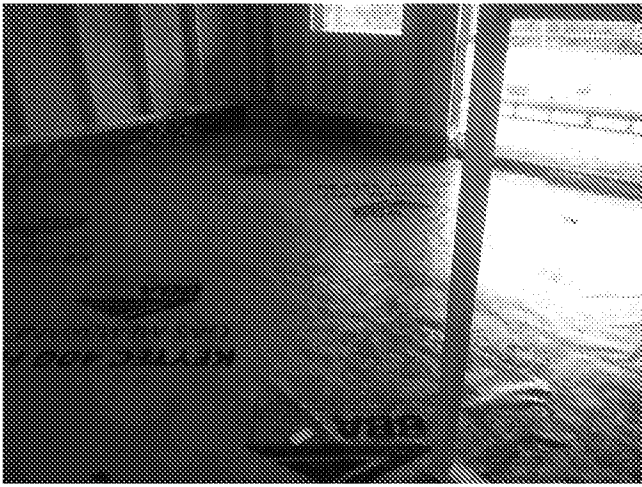
| | <p>Plot 21 - rear of property all good.</p> |

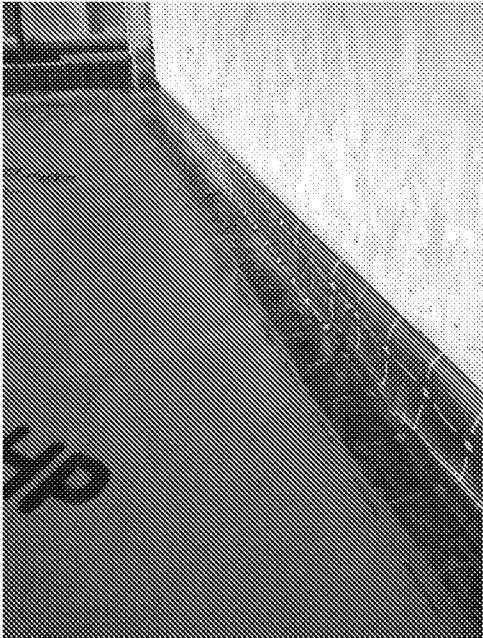
| | <p>Plot 21 - perimeter well sealed.</p> |

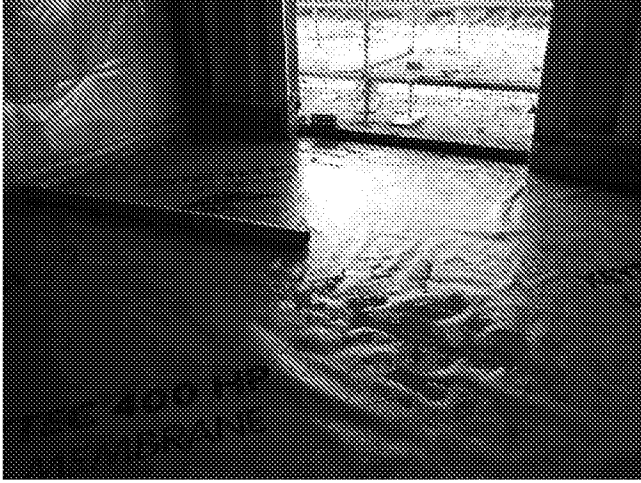
Plot 22 overview
