| Project Name | Cornfield Close |
| Project No. | GE18103 |
| Client | Thakeham Homes |

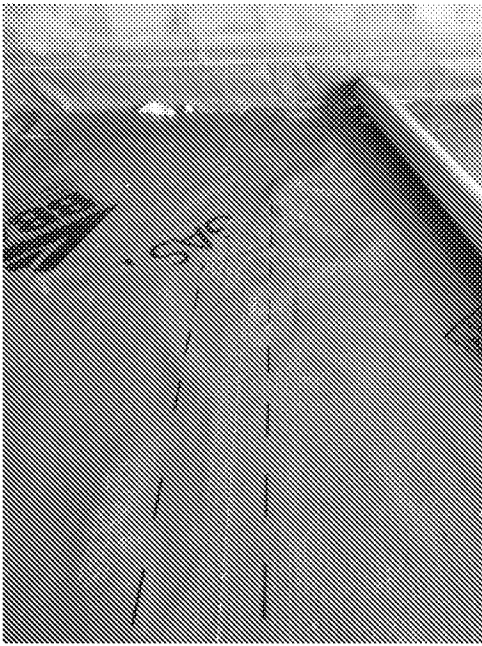
Plot 22 membrane joins

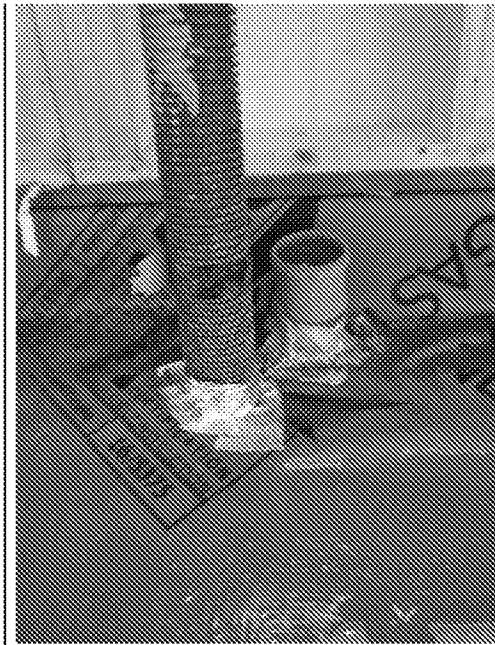
Plot 22 services

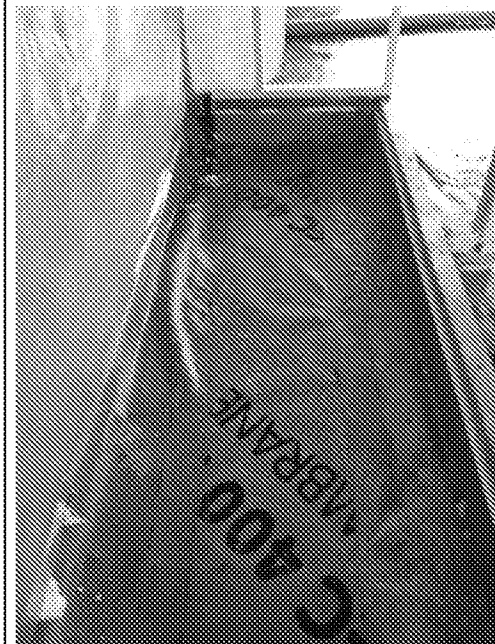
Plot 22 understair detail

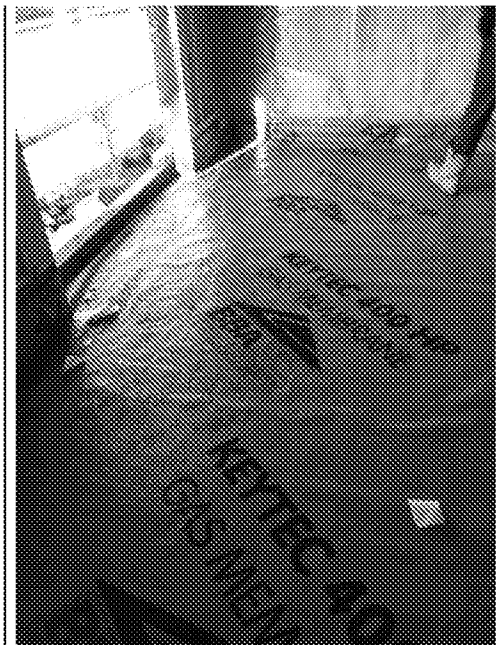
Plot 23 overview

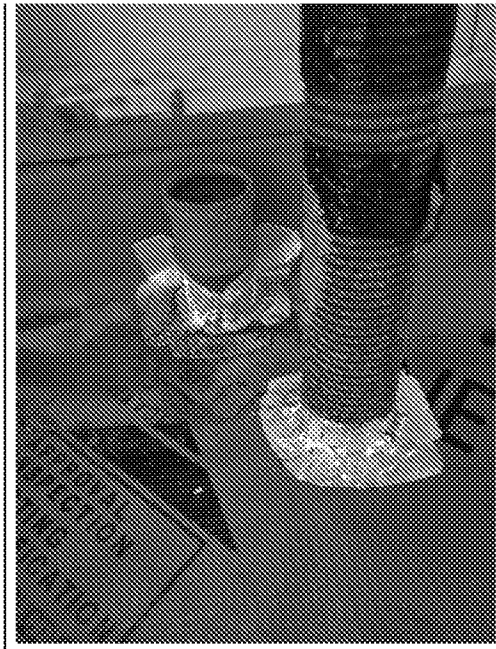
Plot 23 services

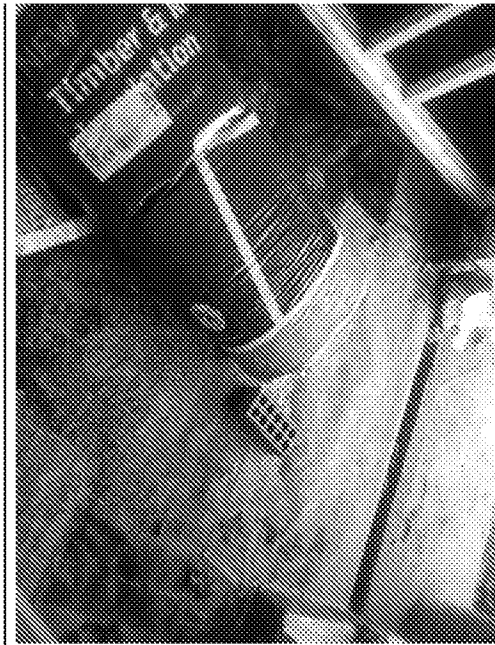
Plot 49 entrance. Undergoing insulation.

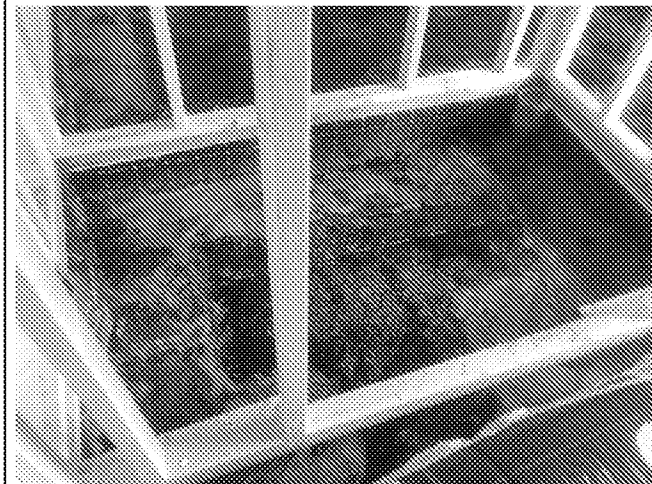
Plot 49 floor and service seal.

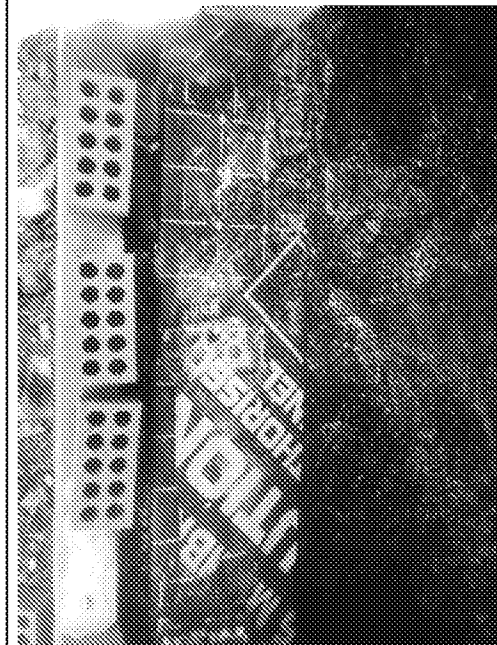
Plot 49 Threshold.

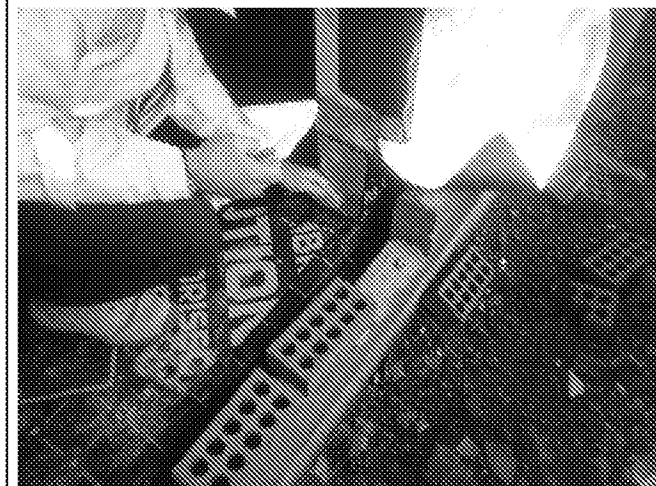
Plot 49 patching.

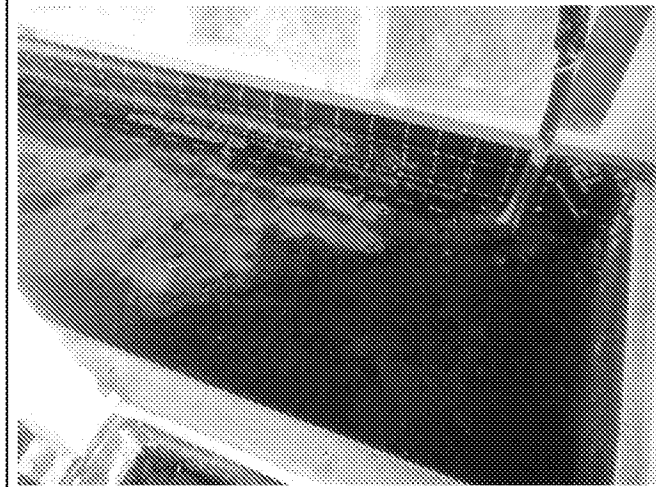
Plot 48 under stairs and service seal.

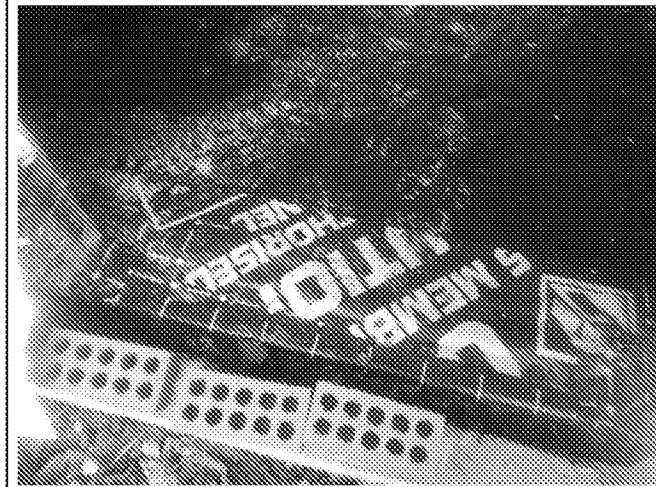
Plot 48 threshold.

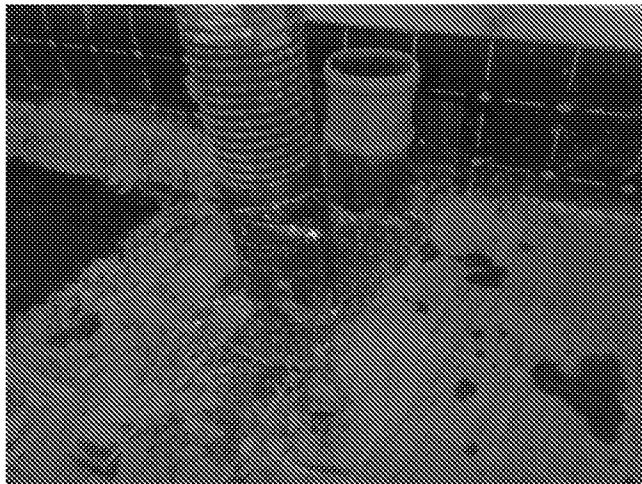
Plot 47 service seals.

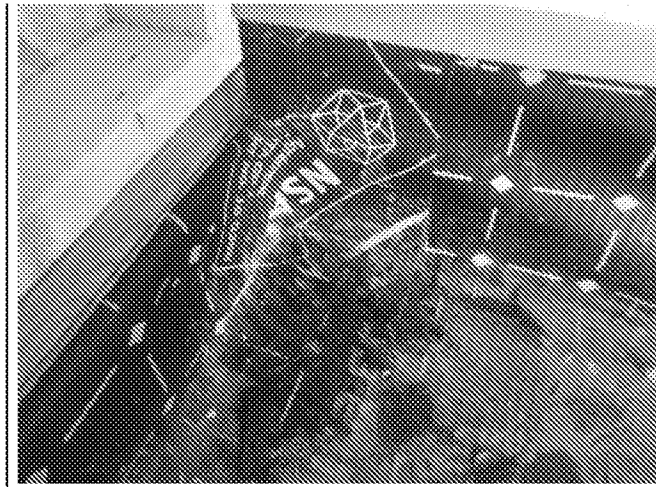
Plot 47 corner detail.

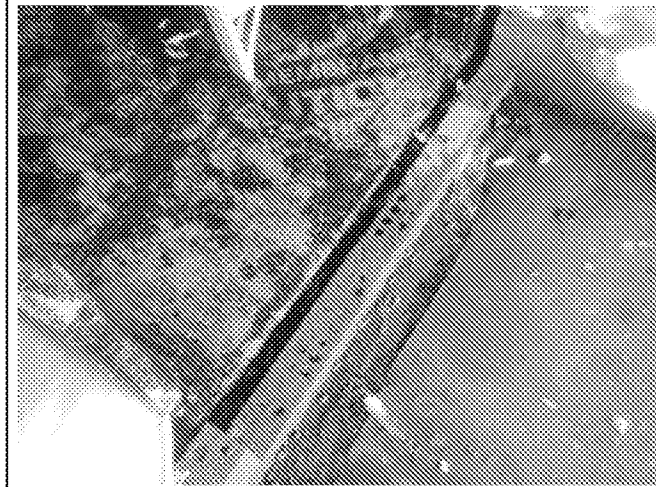
Plot 47 Threshold

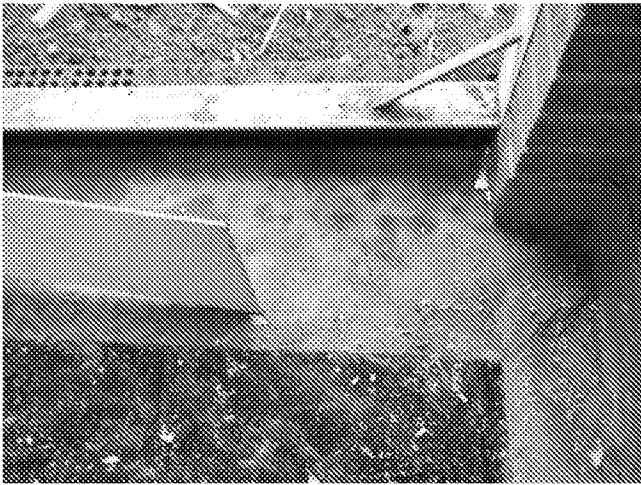
Laped patio.

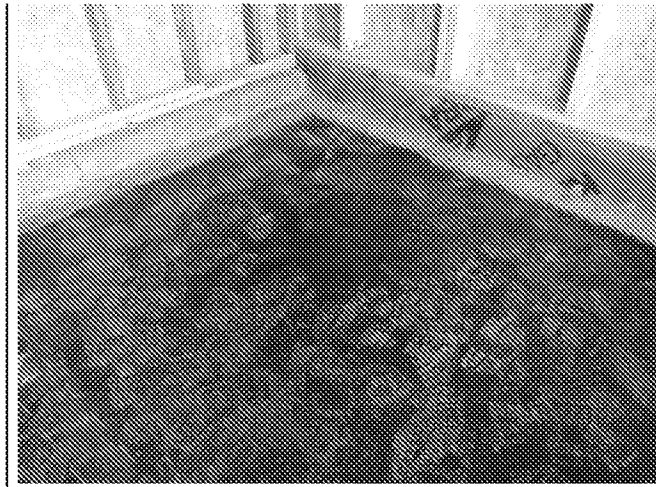
Plot 50 overview

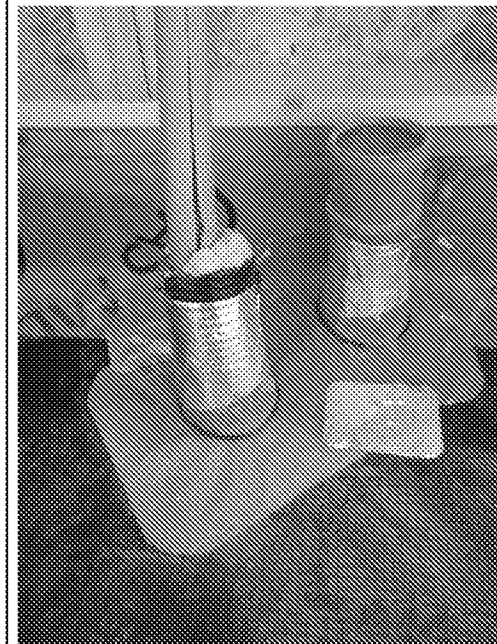
Plot 50 services

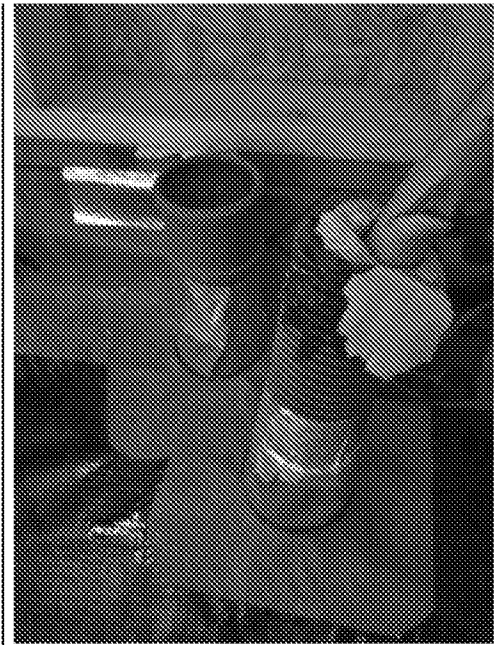
Plot 51 services

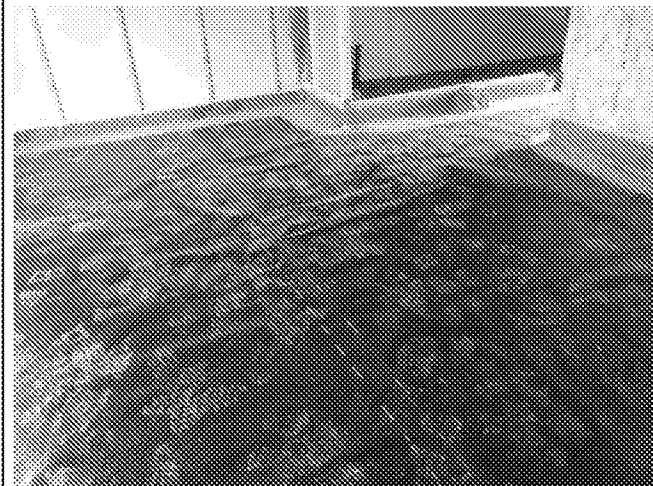
Plot 51 overview

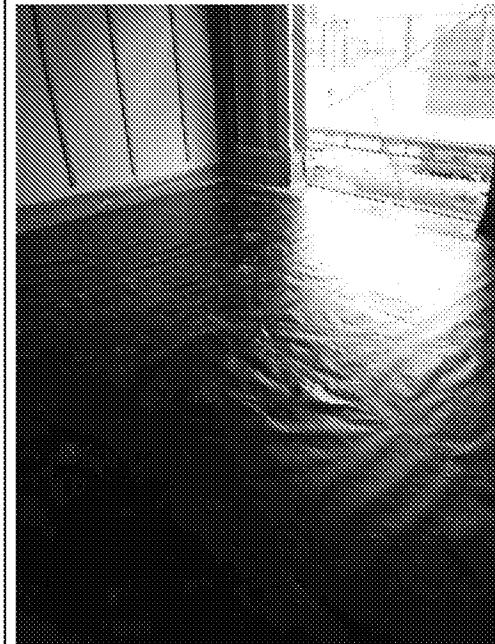
Plot 52 overview

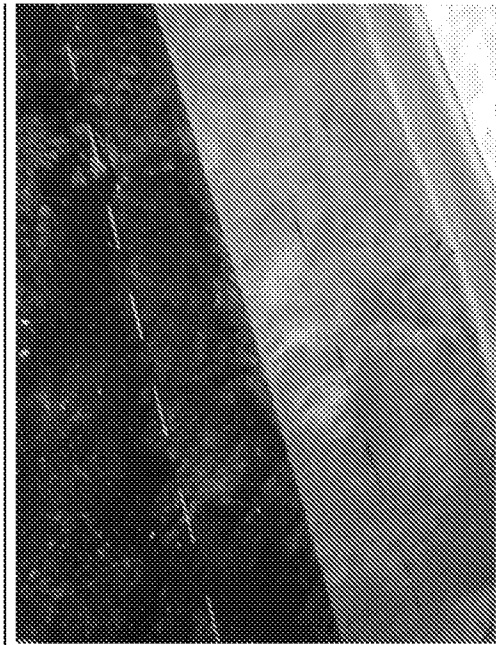
Plot 53 joins

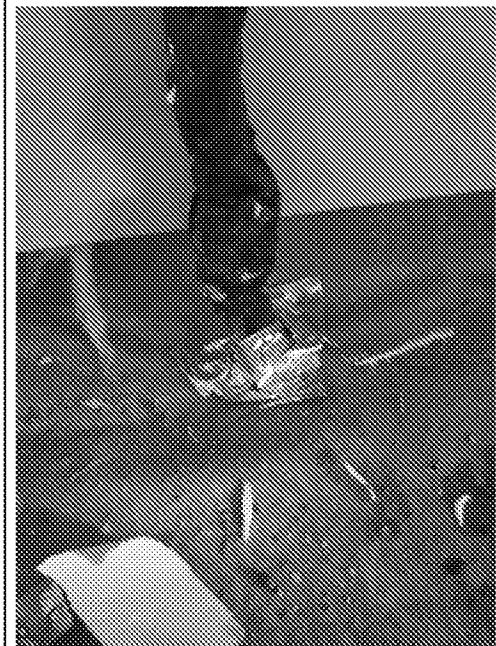
Plot 53 service seal

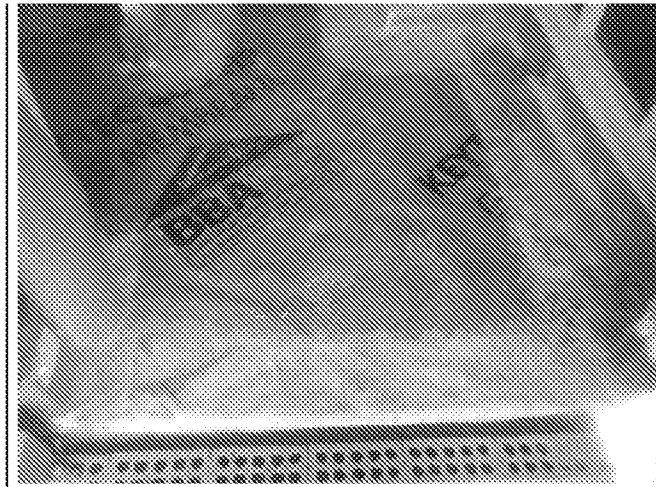
Plot 54 entrance

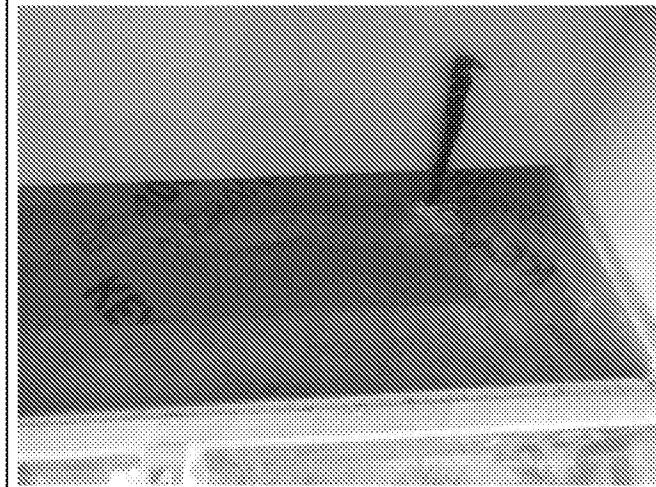
Plot 54 under stairs

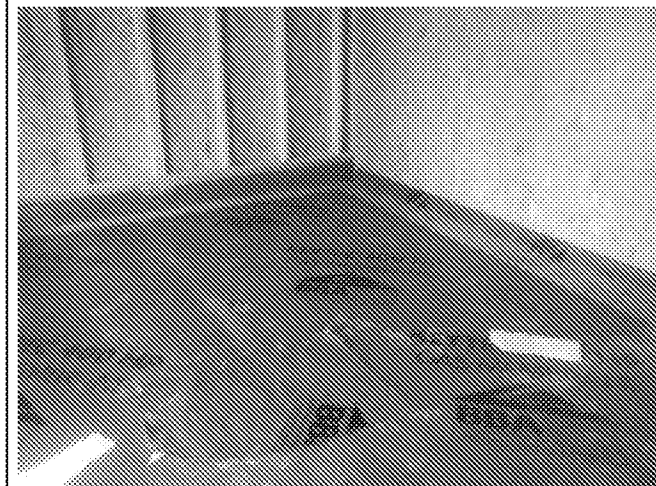
Plot 54 floor

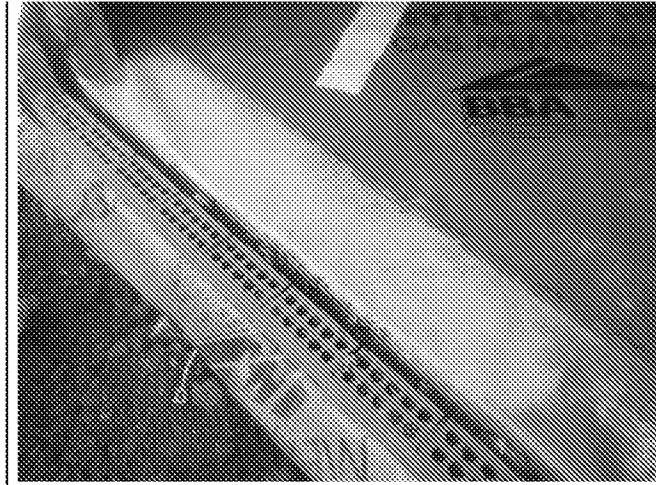
Plot 54 threshold

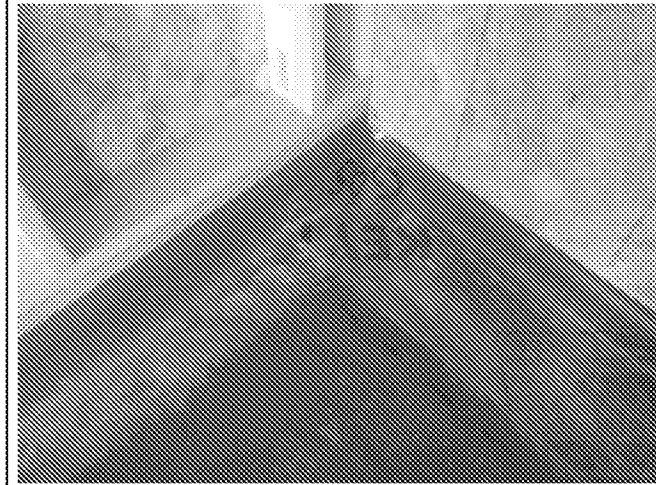
Plot 54 corner detail

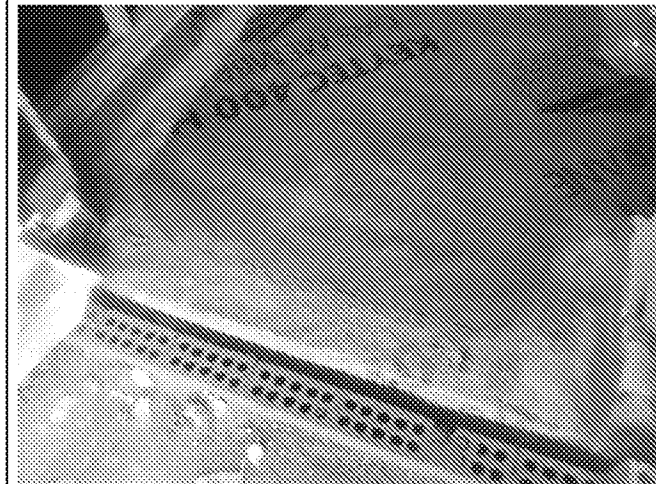
Plot 55 entrance

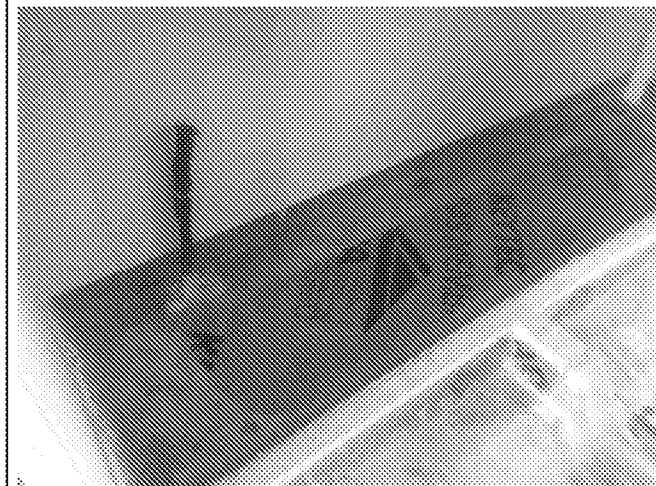
Plot 55 under stairs

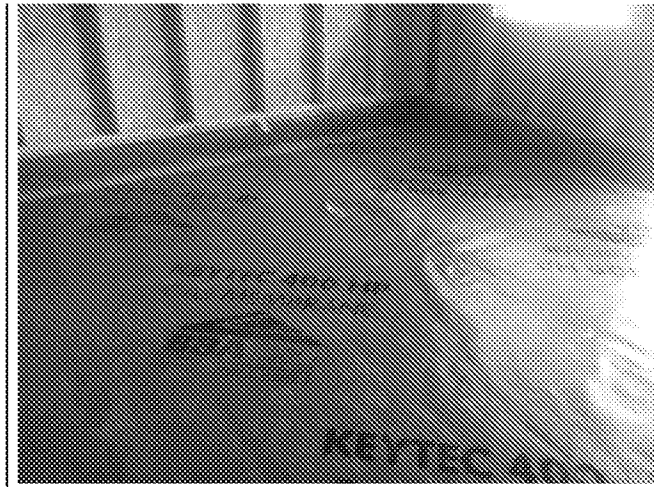
Plot 55 floor

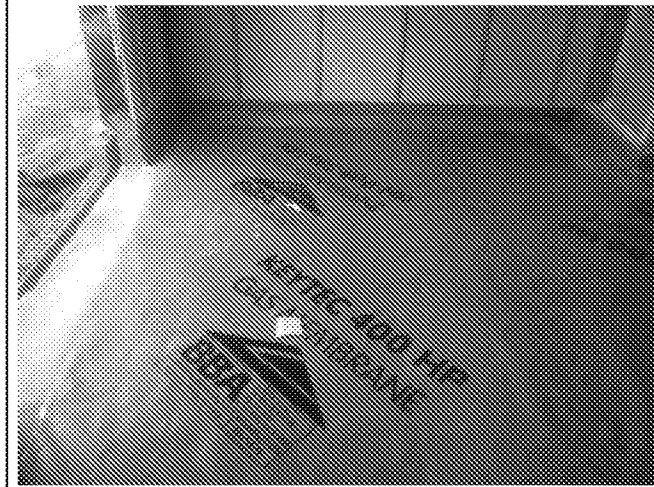
Plot 55 floor and threshold

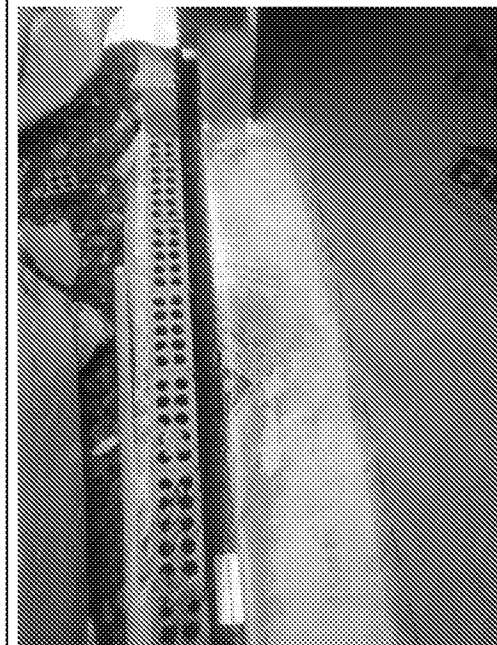
Plot 55 threshold

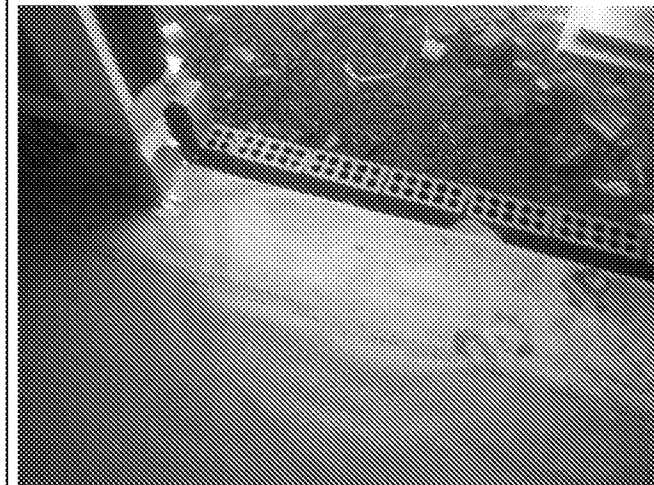
Plot 56 threshold

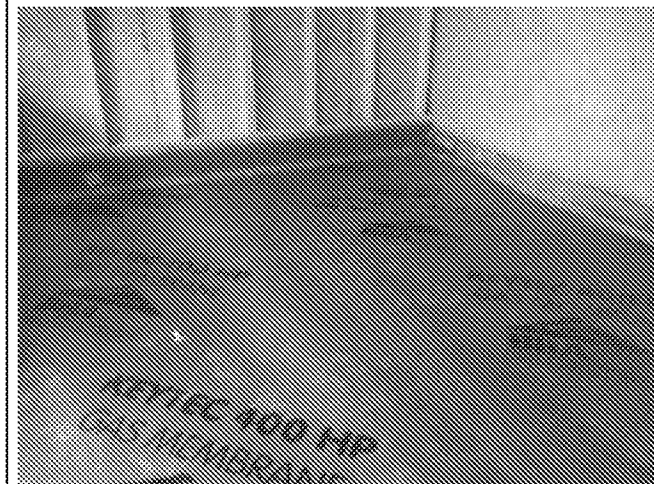
Plot 56 floor

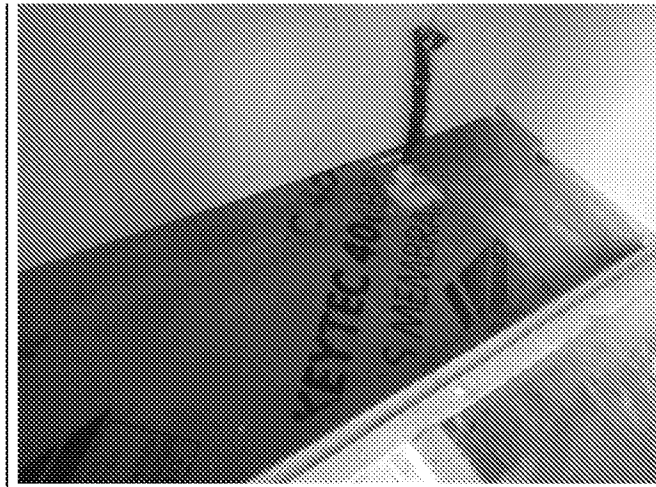
Plot 56 under stairs

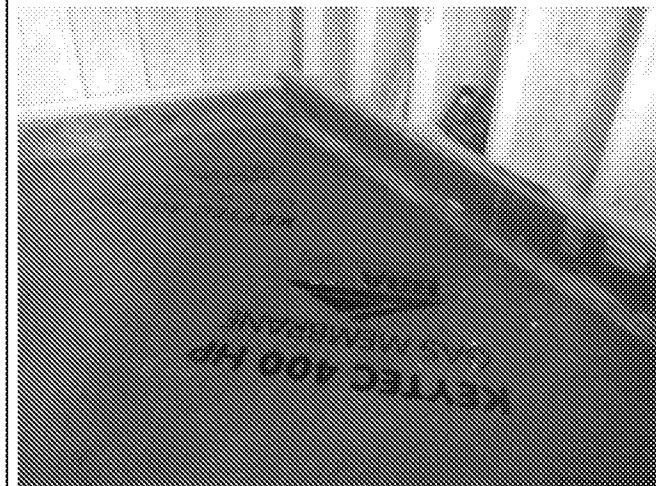
Plot 56 floor

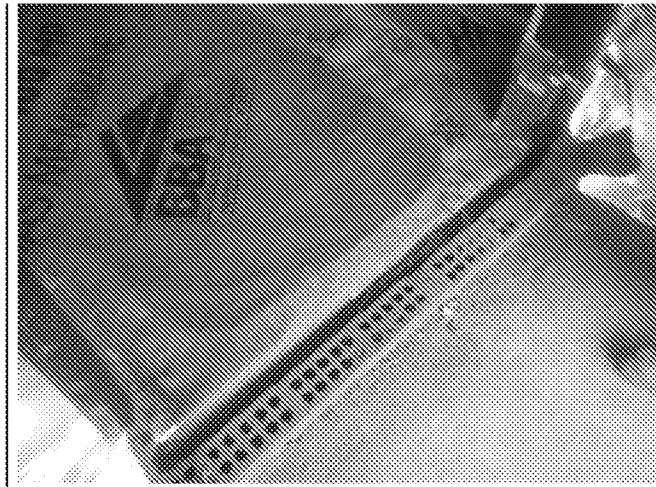
Plot 56 threshold

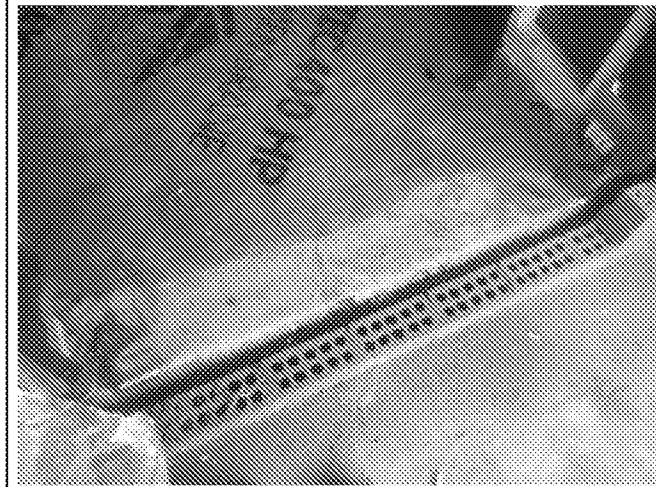
Plot 57 threshold

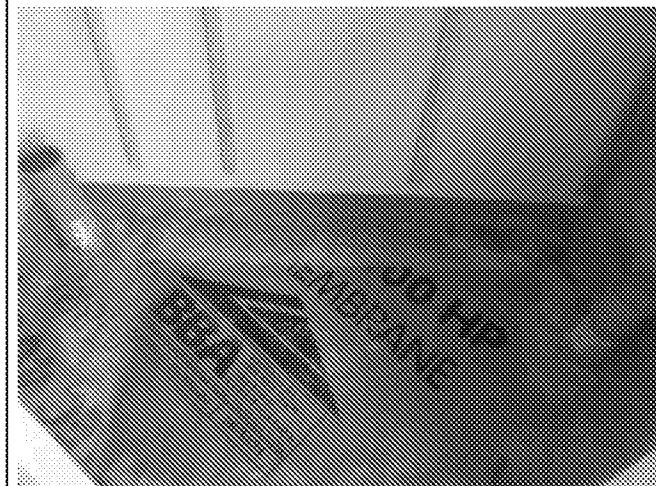
Plot 57 service seals

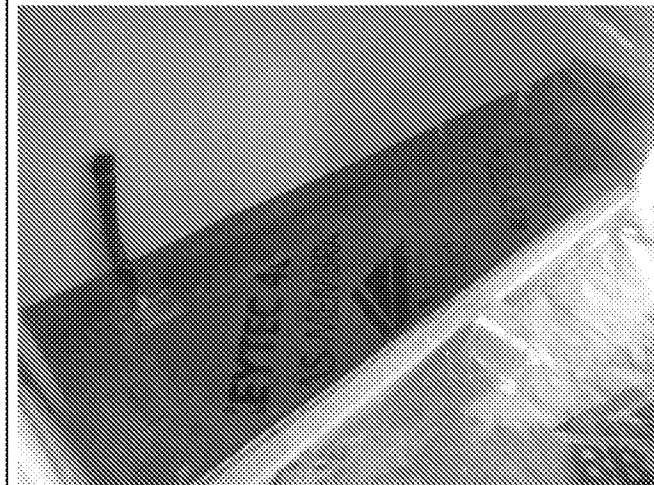
Plot 57 under stairs

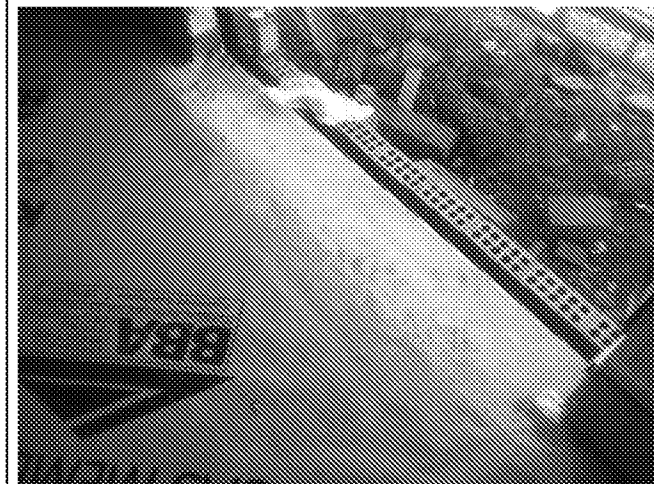
Plot 57 threshold

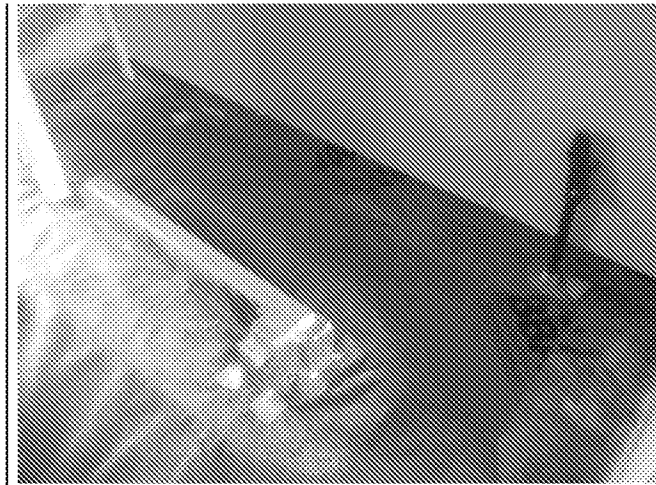
Plot 58 under stairs

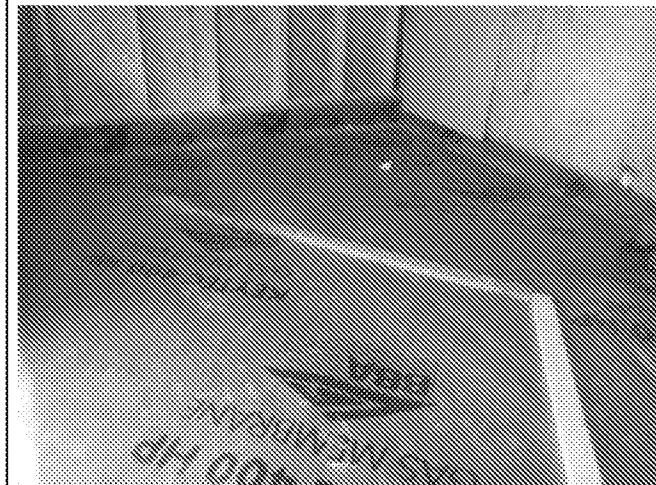
Plot 58 floor

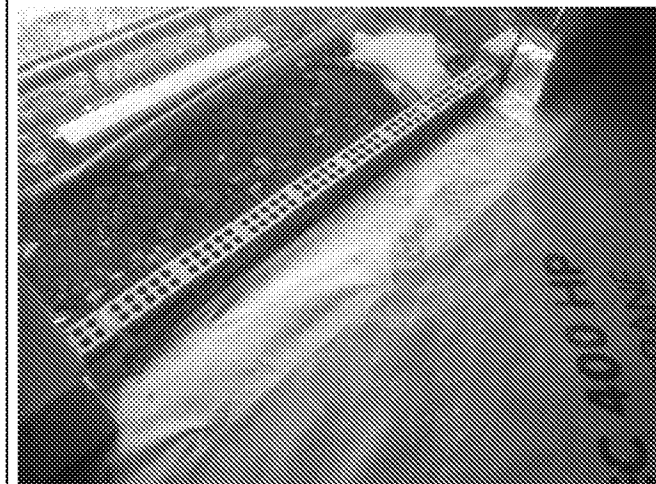
Plot 58 Threshold

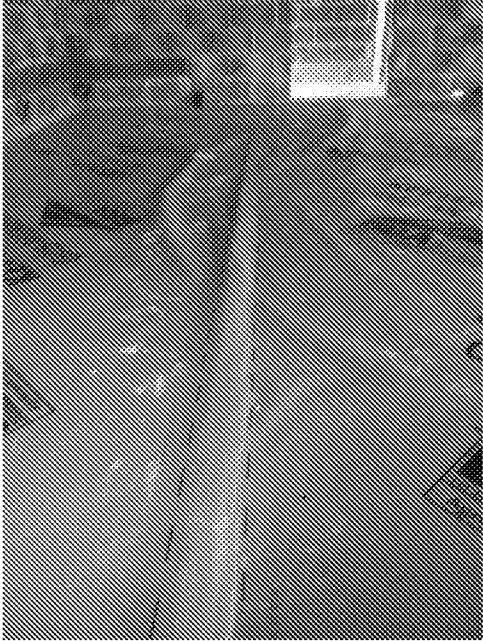
| 1.6 Laps, welds and joints seals | <p>All heat sealed joints.</p> <p>Block B - A large number of patch repairs are required</p> <p>Block A - seal around stairs is not sufficient</p> |

| Photograph | Photograph Title |
|---|---|
| | Block B membrane joins |
