**VERIFICATION REPORT**  
**for PLOTS 50-59 (SOIL COVER SYSTEMS) &**  
**ALL PLOTS (GROUND GAS) AT**  
**CORNFIELD CLOSE, LITTLEHAMPTON,**  
**WEST SUSSEX, BN17 6LD**  
**on behalf of**  
**THAKEHAM CLIENT LTD**

| <b>Date:</b> | <b>27/08/2021</b> |
| <b>Reference:</b> | <b>GE18103/VR/PLOTS 50-59 (Soil) &amp; All Plots (Gas)/AUG21</b> |

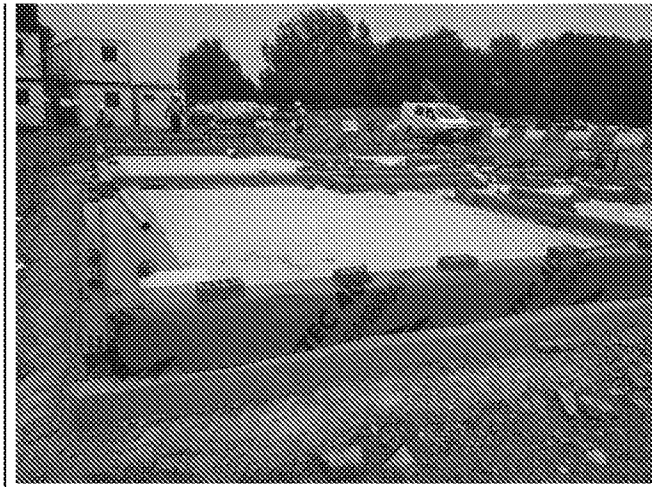
Area - incomplete

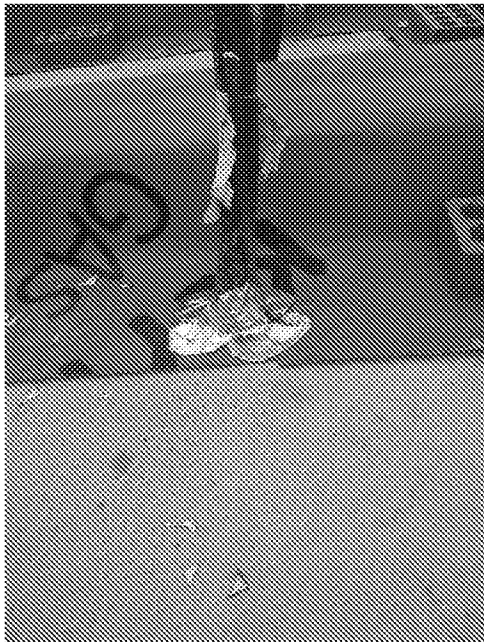
Service

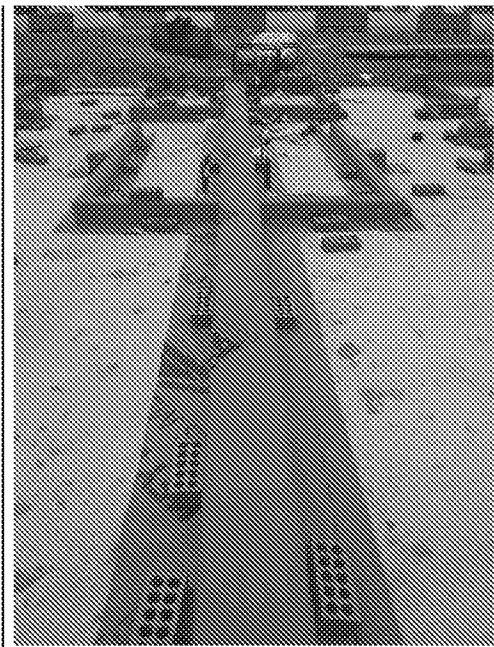
Inner walls - centre

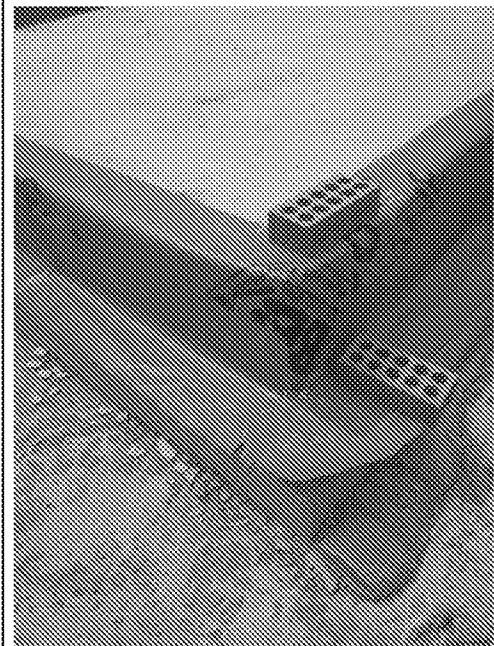
Outer wall corner north east

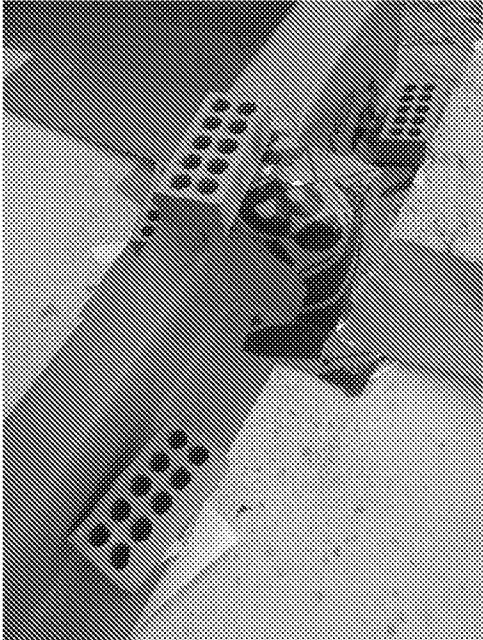
| | Inner walls south (front of property) |

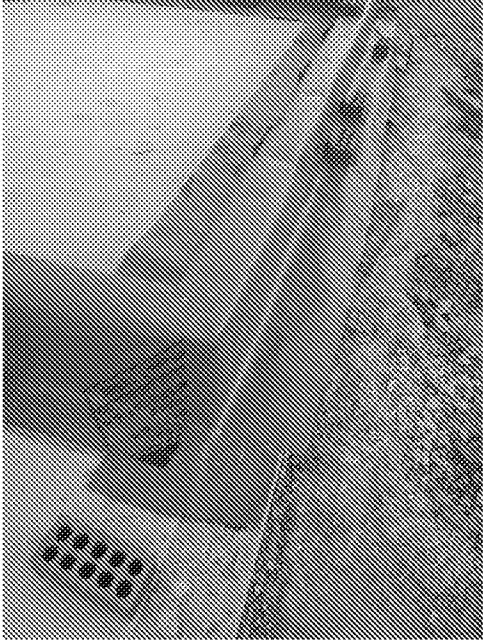
| | Outer corner |

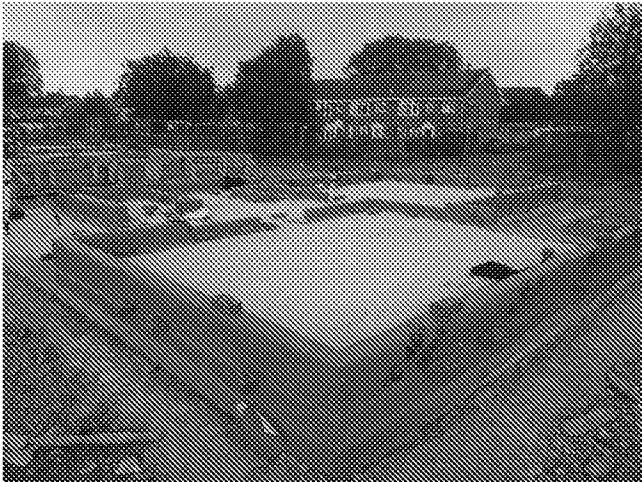
| | Area |

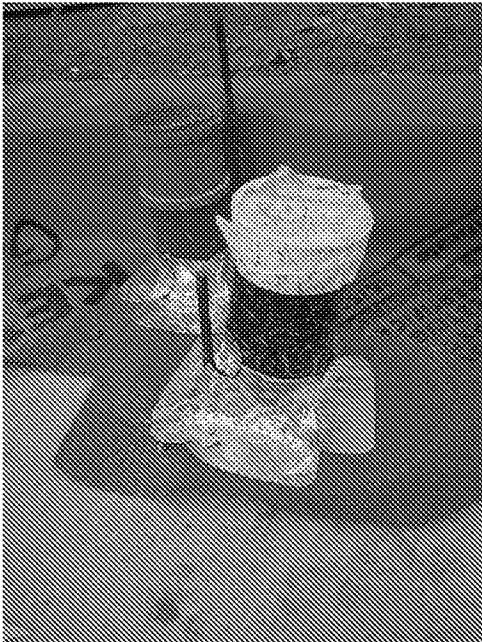
Foil tape around service duct

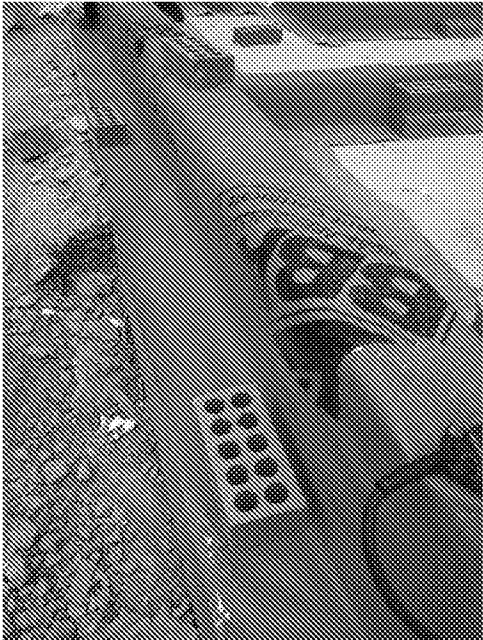
| | Outer layer seal |

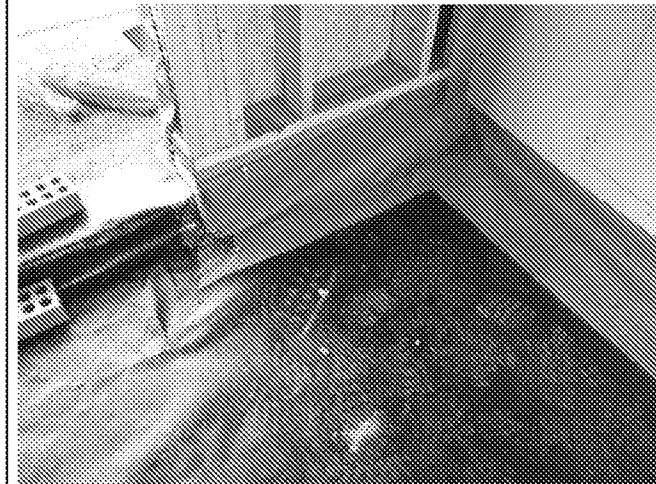
Plot 5 -Threshold corner detail

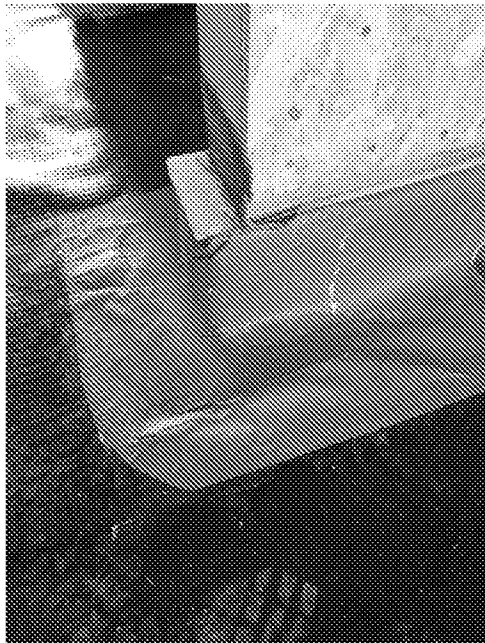
Plot 5 - Corner detail

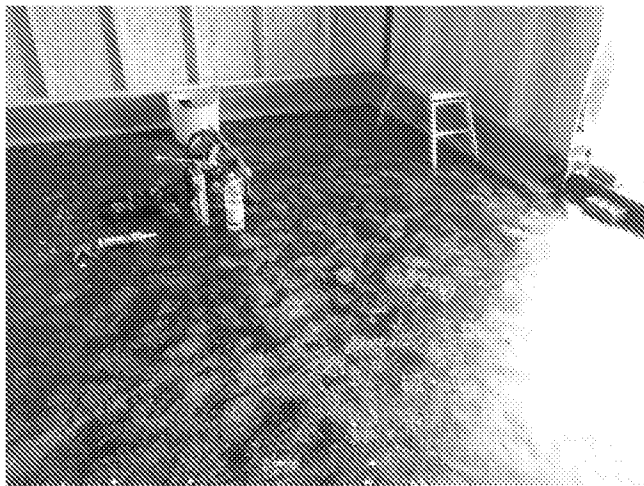
Plot 5 - floor

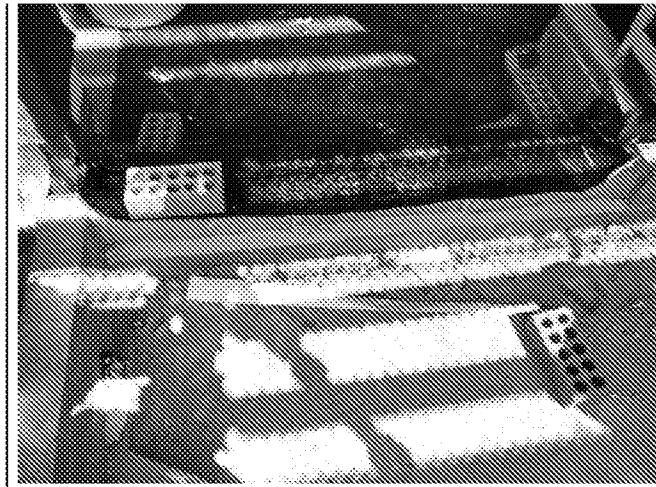
Plot 5 - threshod

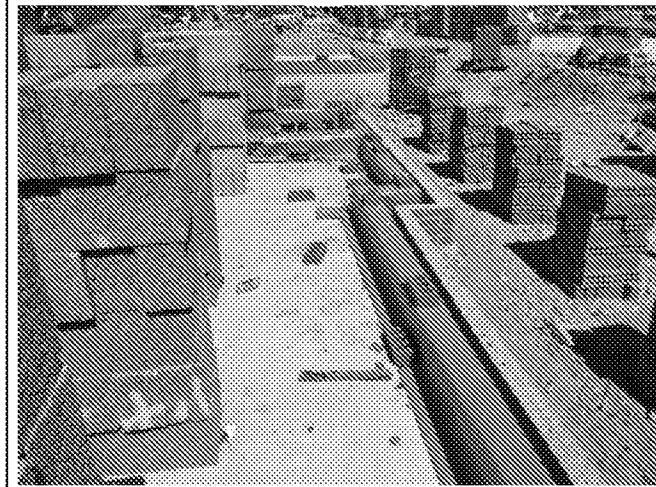
Block B - perimeter

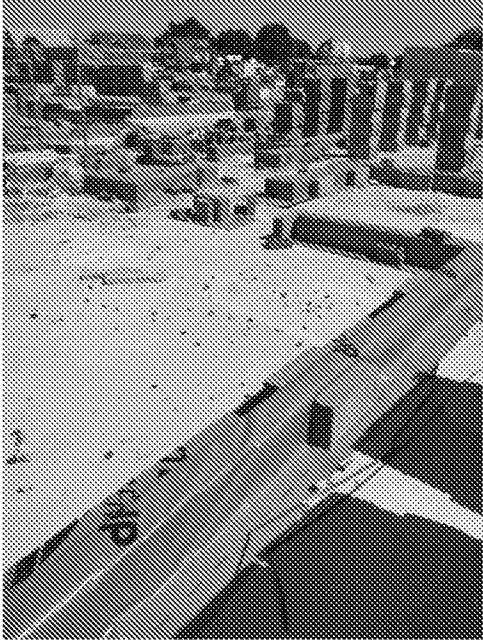
| | Block B - membrane |

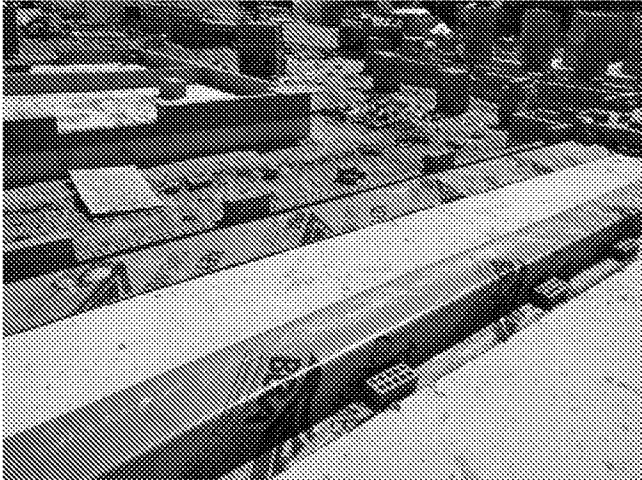
| | Block B - Threshold |

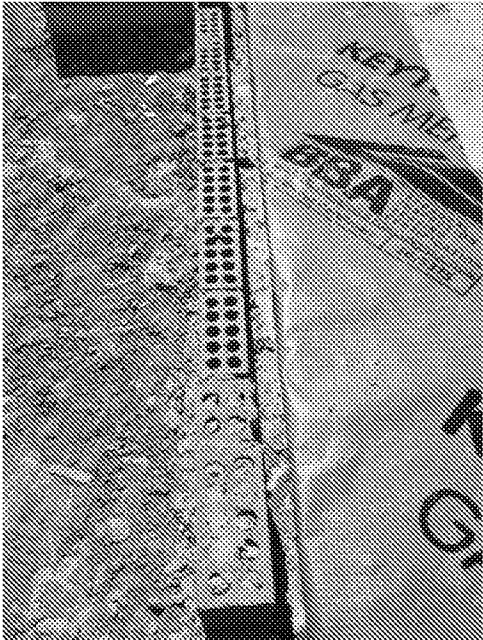
| | Block B - Threshold |

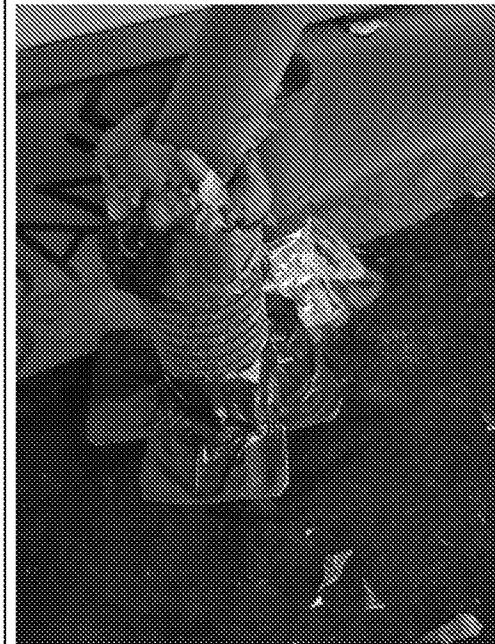
Plot 6 services

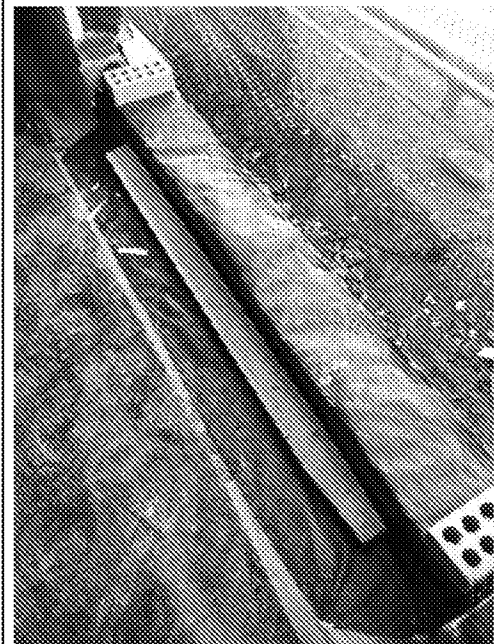
Plot 6 threshold

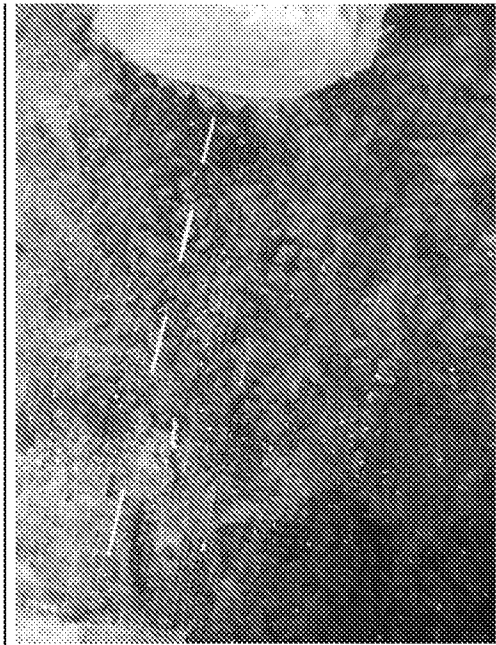
Plot 7 joins

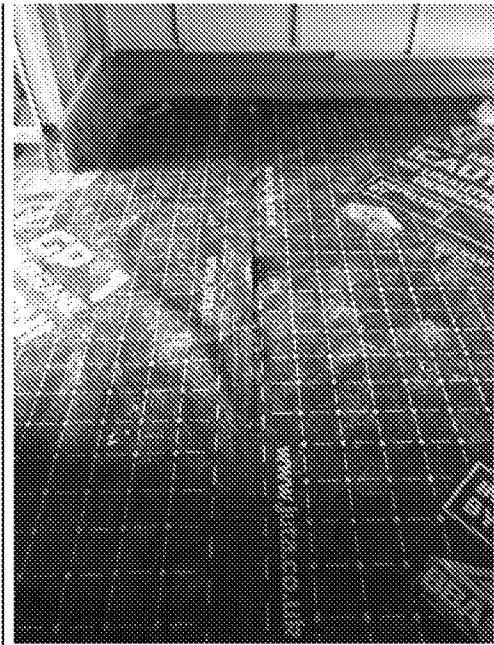
Plot 8 join

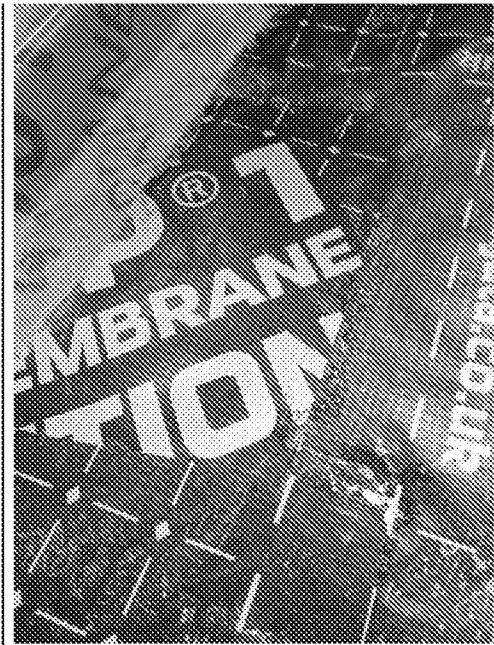
Pot 10 membrane joins

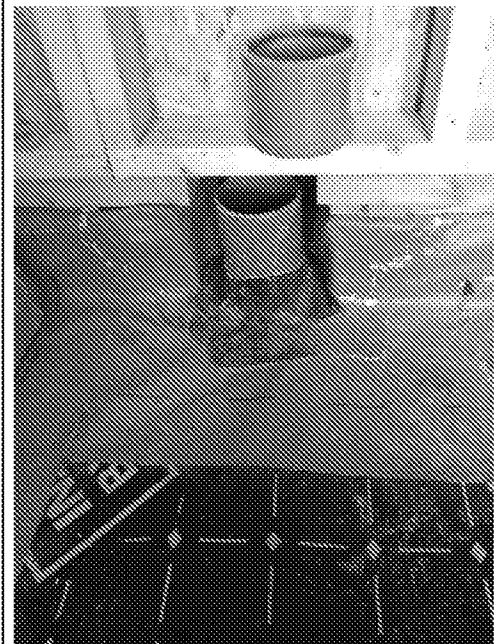
Plot 10 services

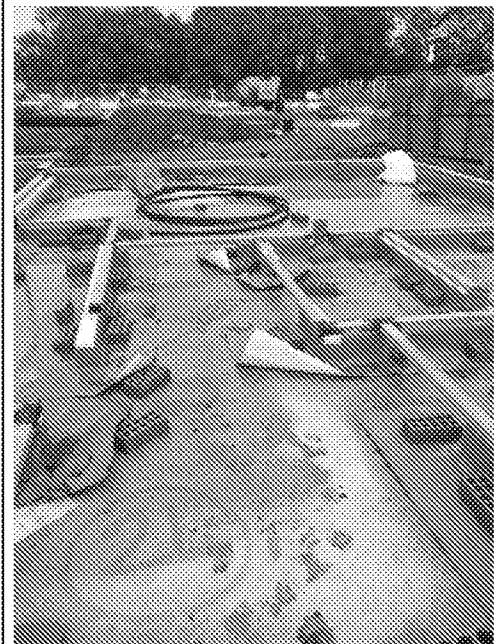
Plot 24 reinspection

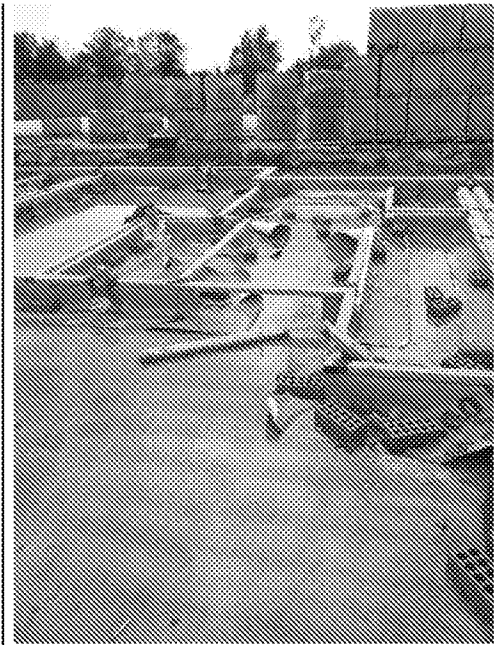
Plot 25 reinspection

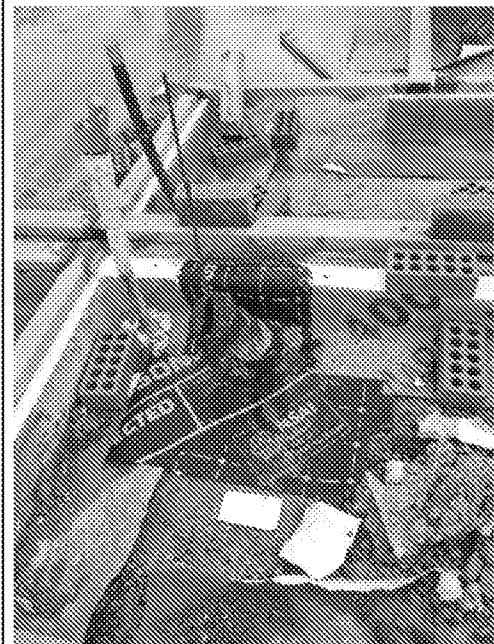
Plot 26 service

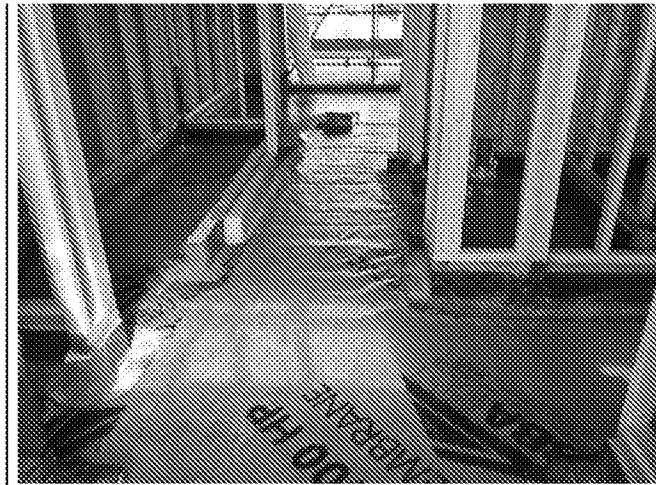
Plot 12 - View across floor

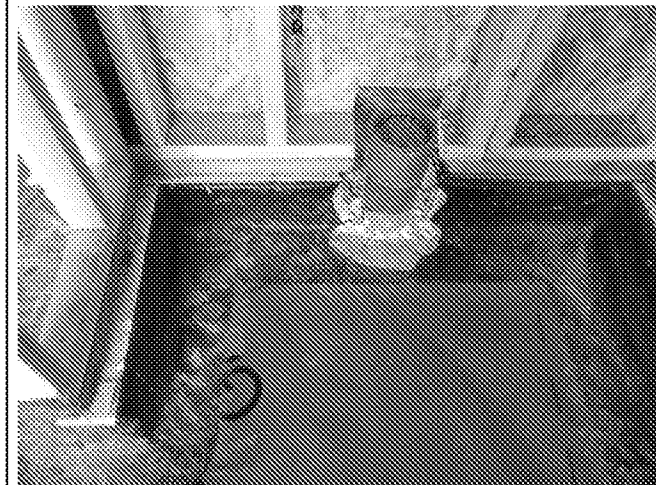
Plot 12 - service seal

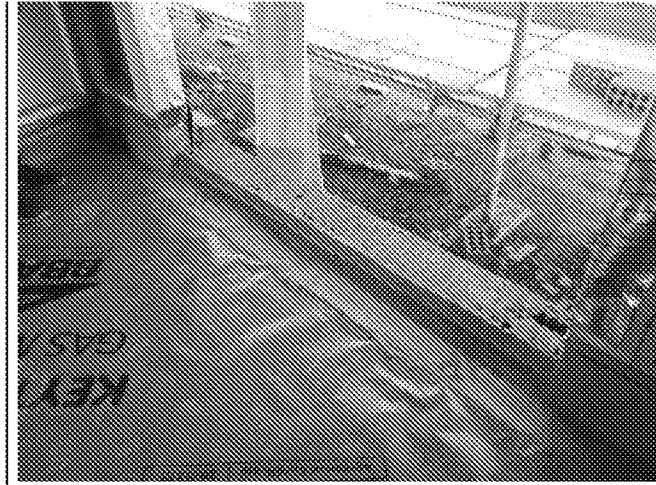
Plot 12 - Threshold

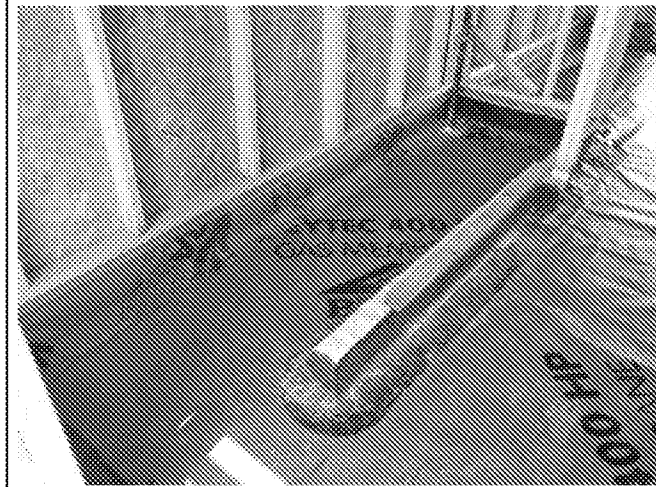
Plot 13 - Under stairs

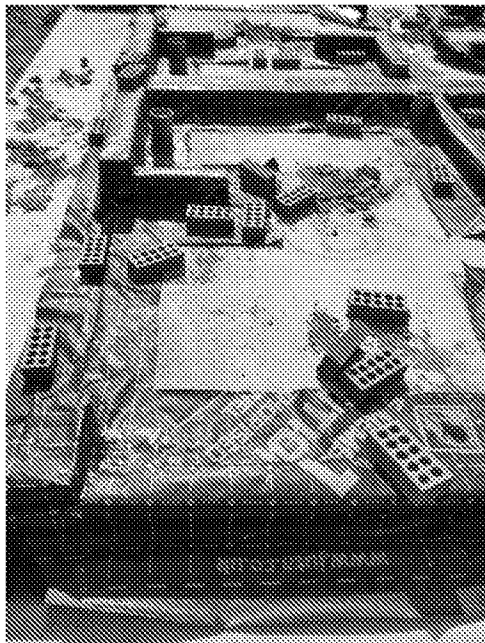
Plot 20-21(Phase 4) - Wind damage

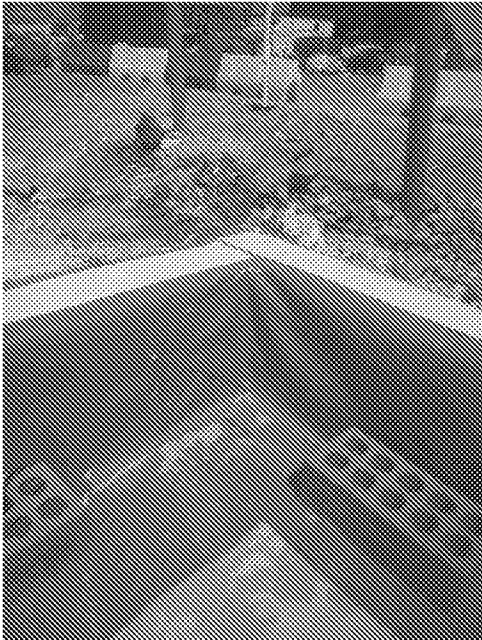
Plots 40-41. Corner detail.

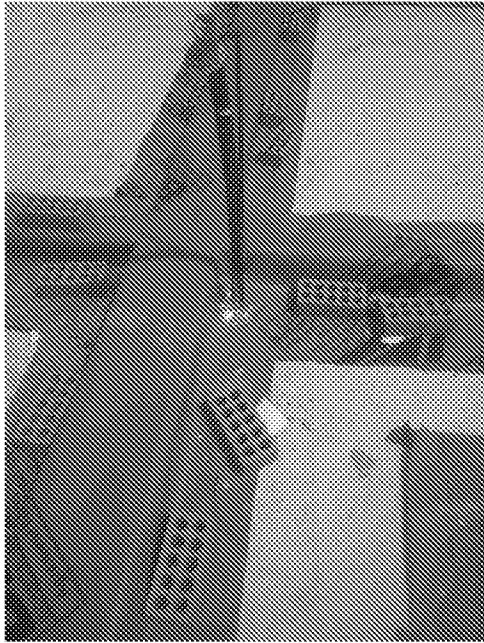
Plots 24-27. Service seal. Road pin will be cut out.

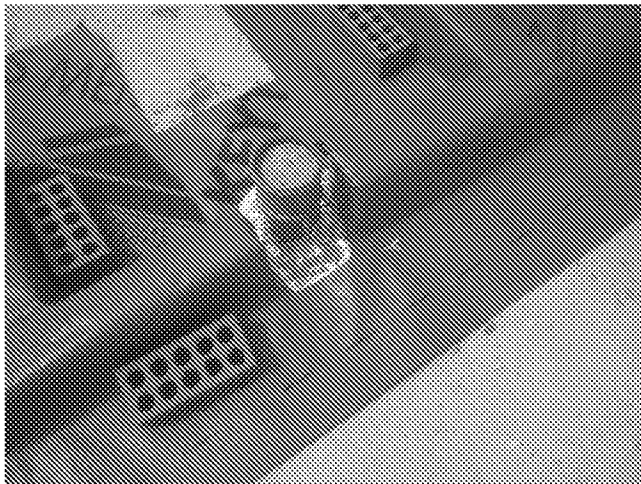
Plots 24-27. Service seal.

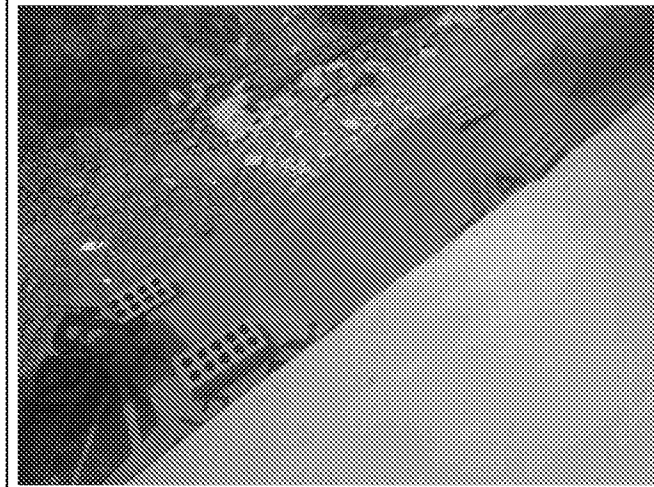
Plots 22-23. Threshold detail.

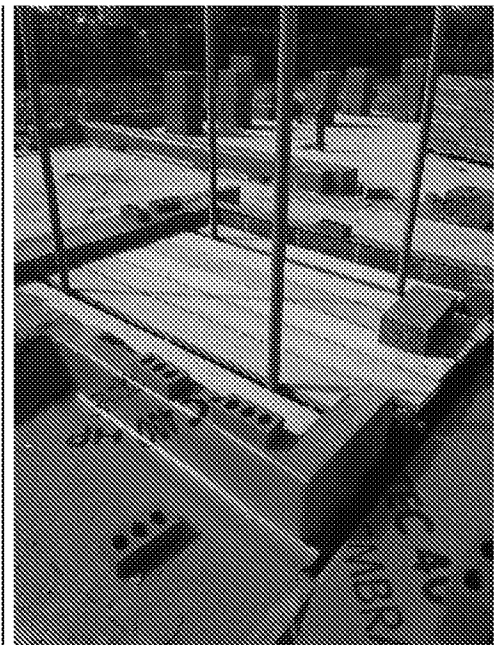
Block B Overview

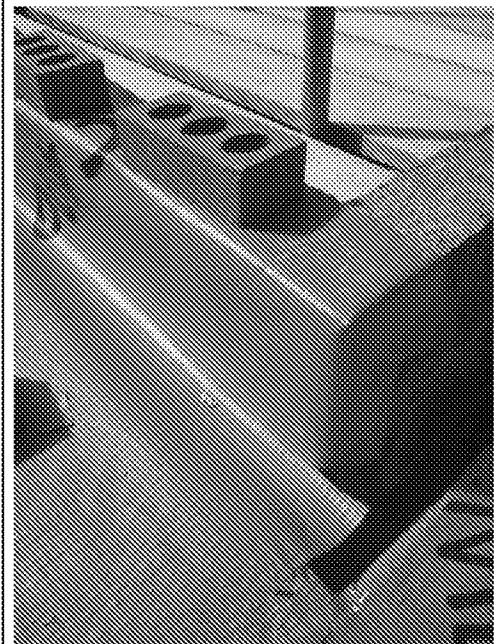
Block B Block work

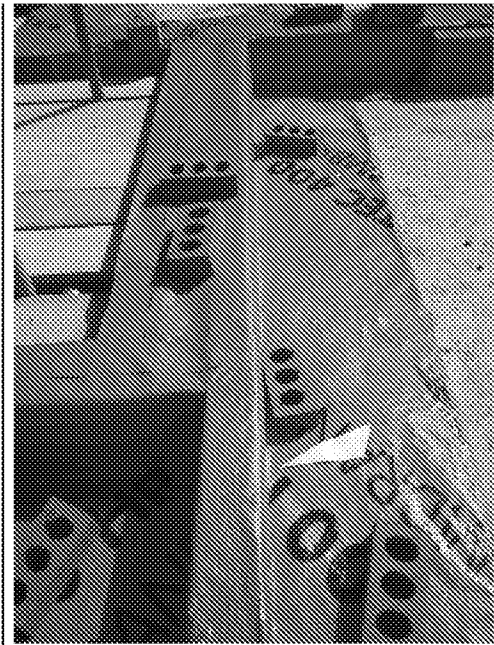
Block B Rear of pit

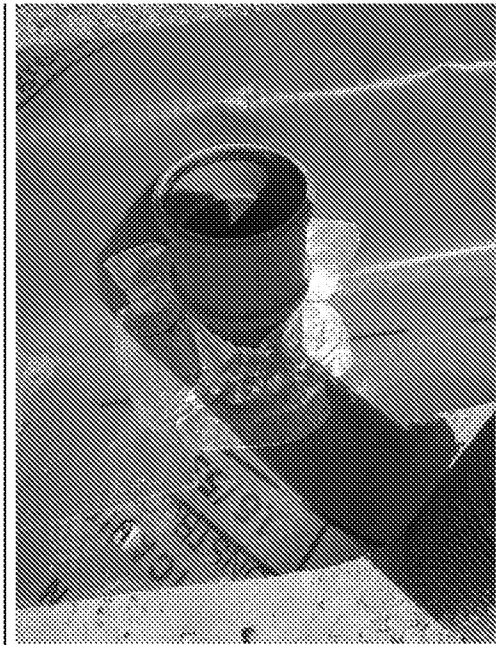
Plot 23 services

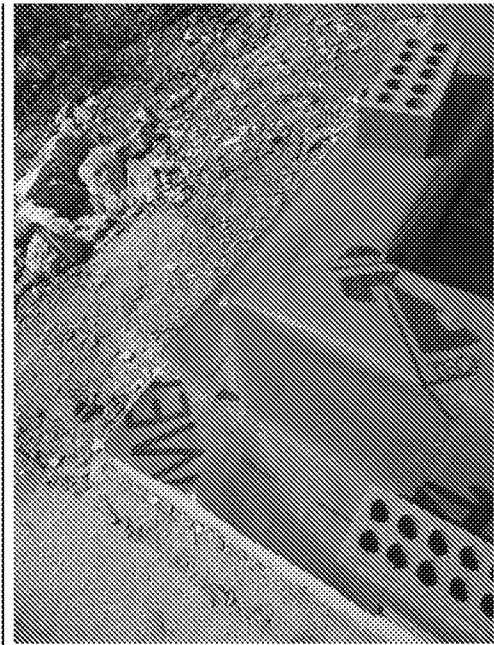
Plot 23 corner

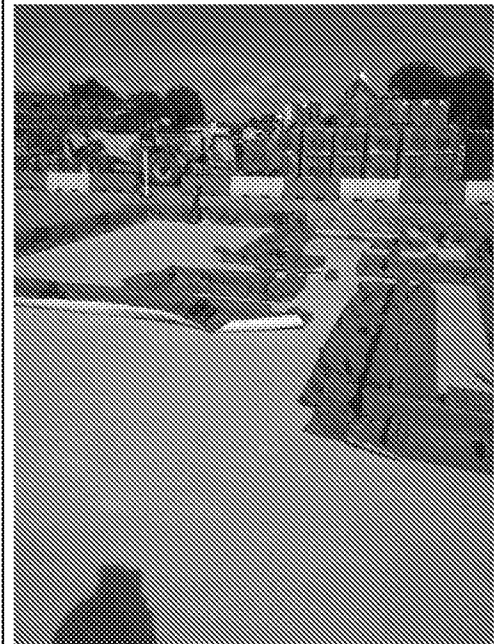
Plot 22 overview

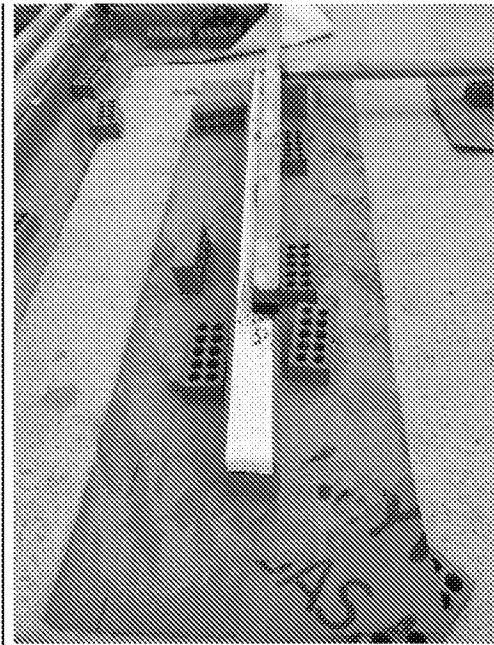
Plot 24 tape for timber frame

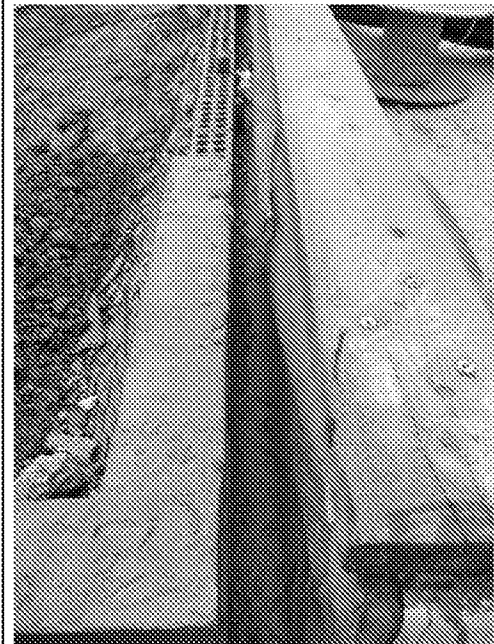
Plot 24 cavity

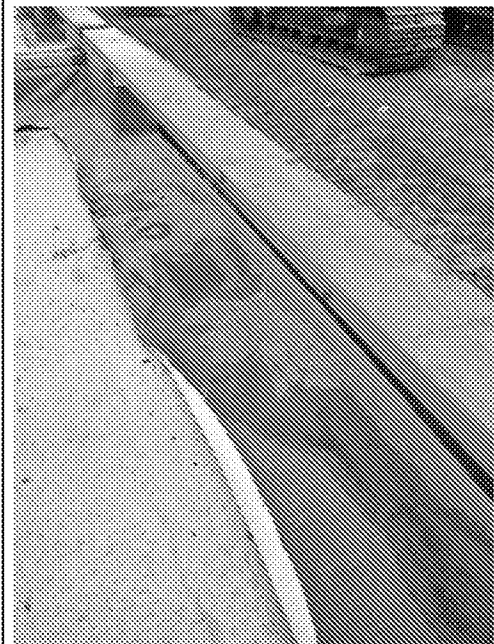
Plot 25 threshold

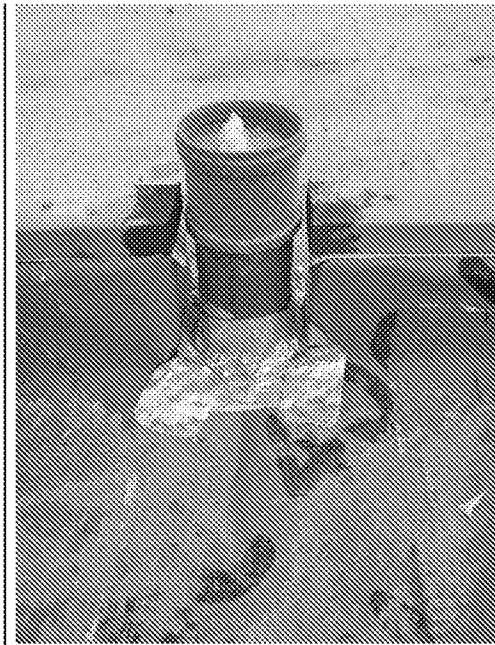
Plot 25 service

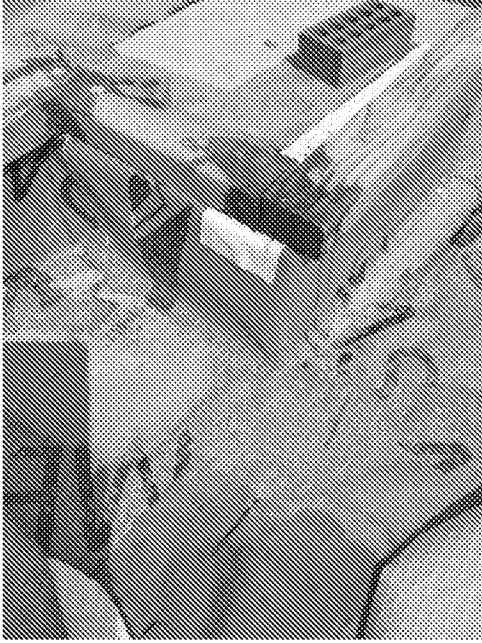
Plot 26 corner

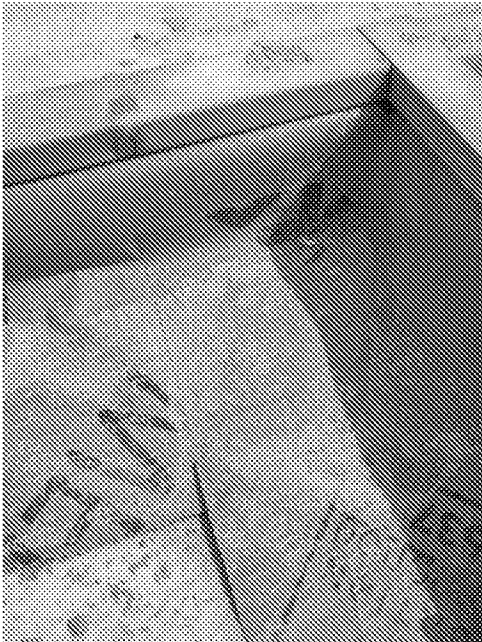
Plot 26 lapping
