| Project Name | Cornfield Close Validation |
| Project No. | GE18103 |
| Client | Thakeham Homes |

*Gas Protection Measures Inspection Report*

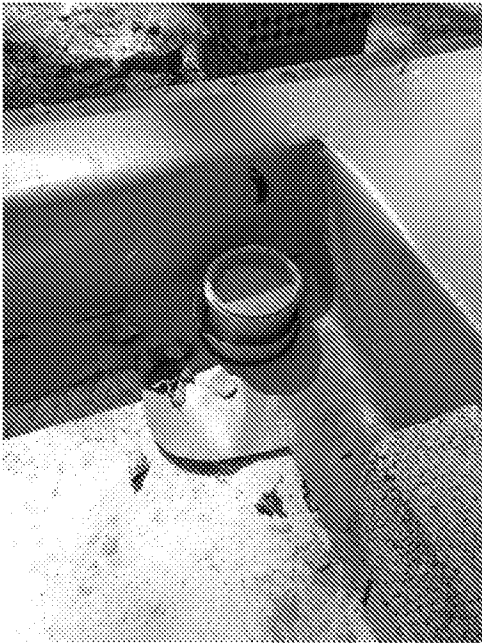
Block B - services not yet sealed

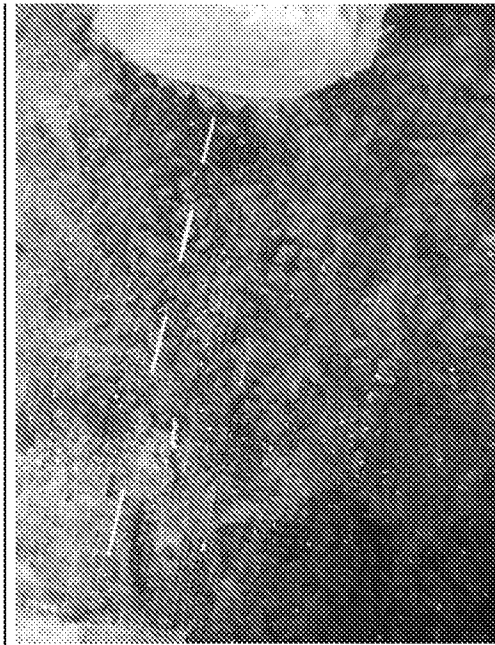
Plot 7 joins

| 1.6 Laps, welds and joints seals | Heat sealed and well sealed |

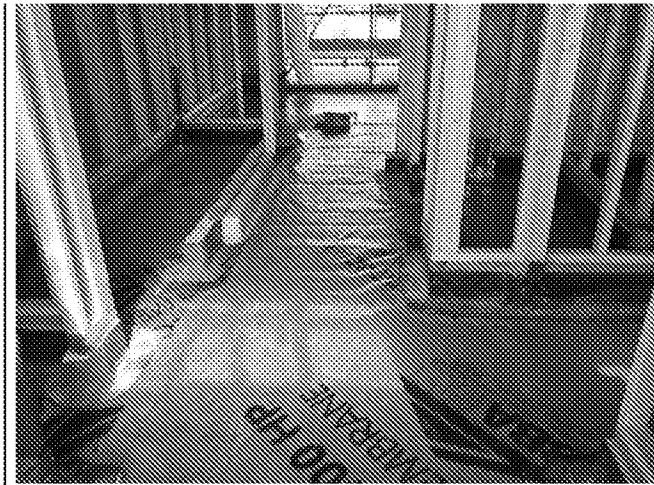
Plot 12 - View across floor

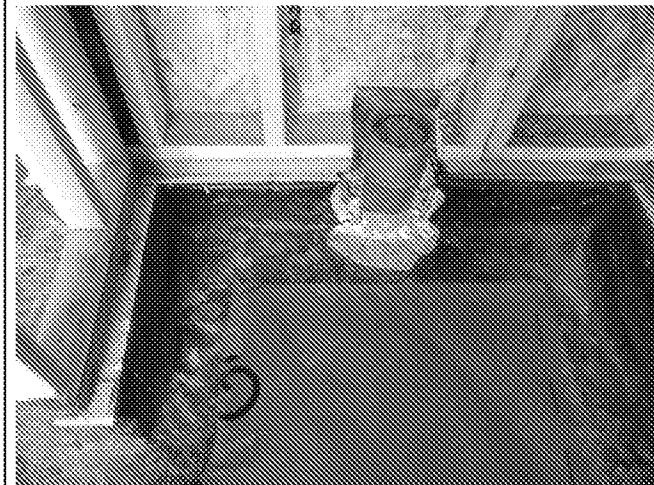
Plot 12 - service seal

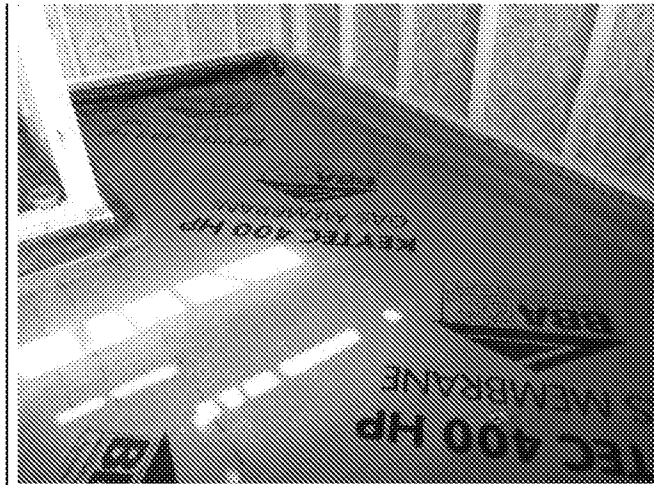
Plot 13 - Floor

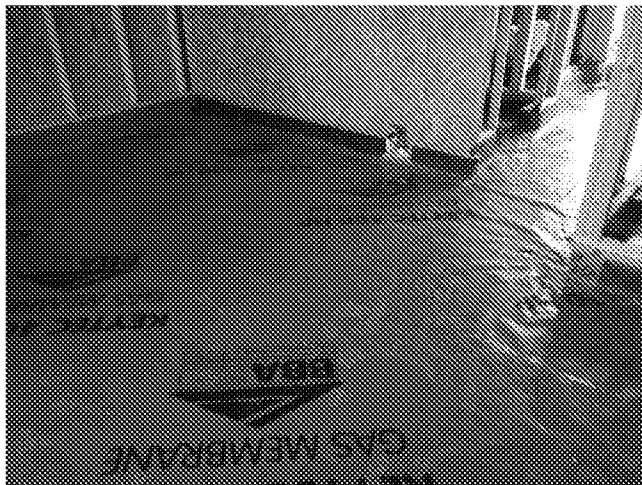
Plot 13 - Floor and service seal

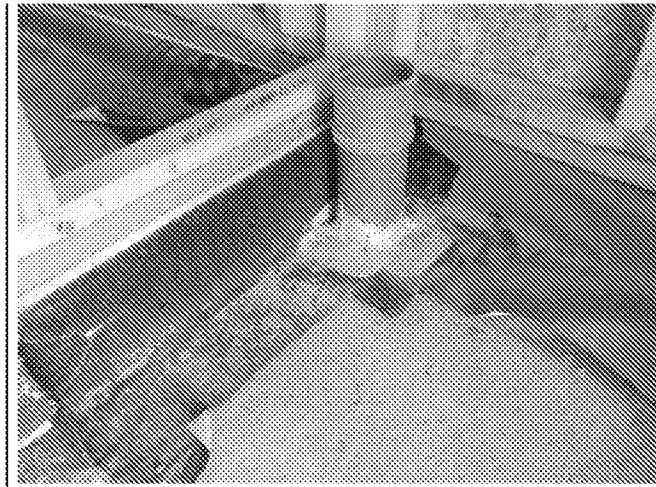
Plot 15 - Services sealed

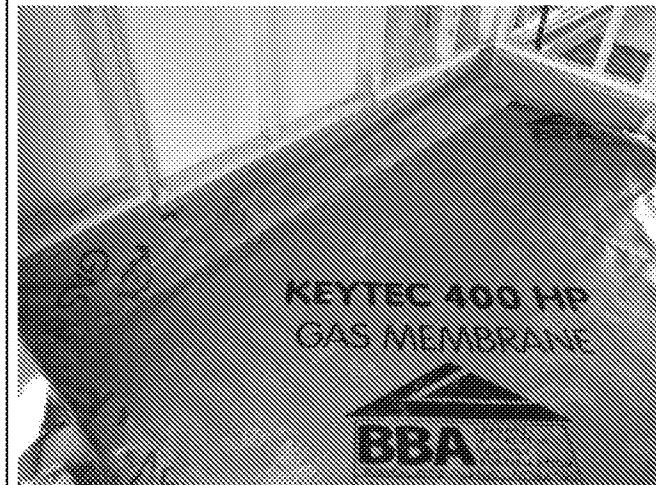
Plot 14 in progress

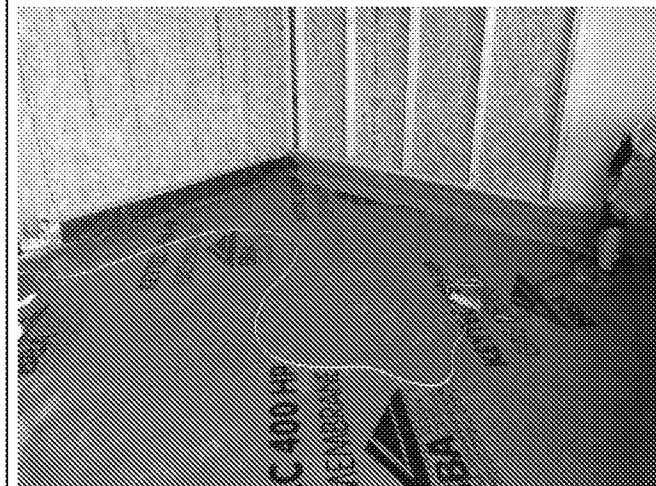
Plot 14 in progress

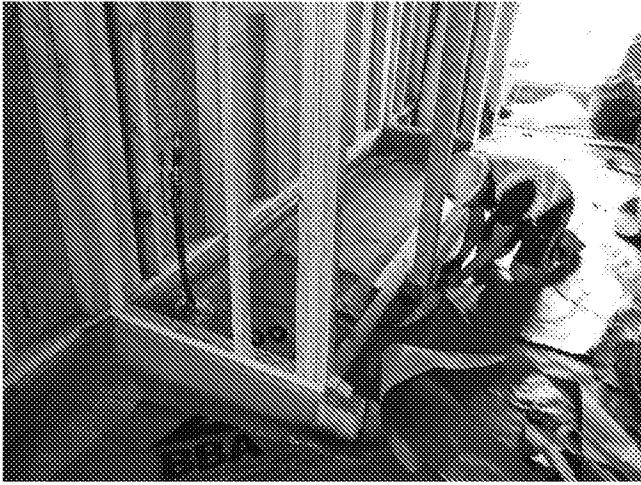
Plot 14 in progress

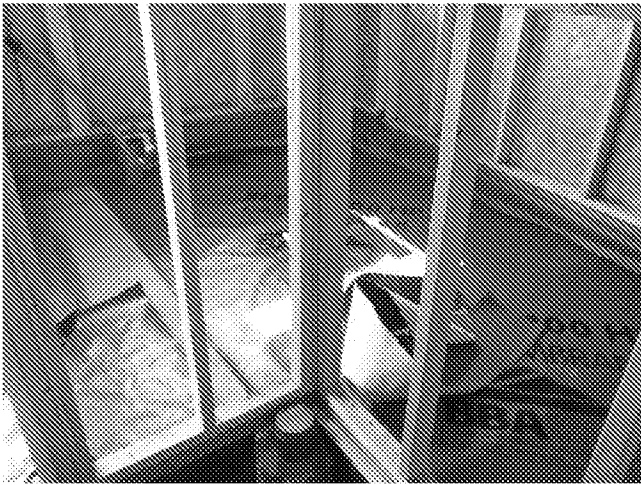
Plot 14 in progress

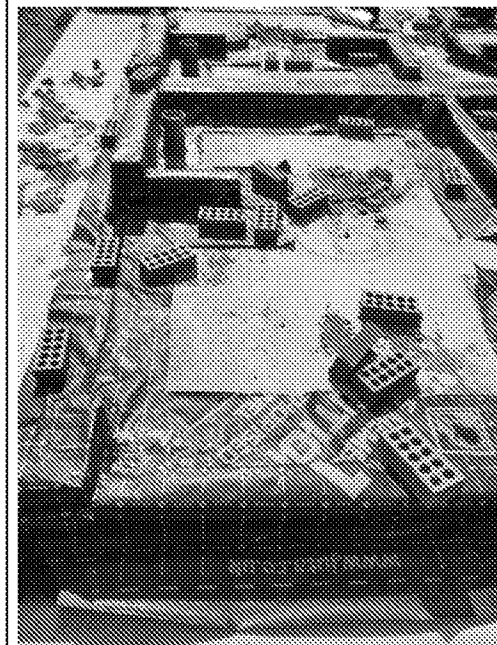
Plot 20-21(Phase 4) - walls and doorway

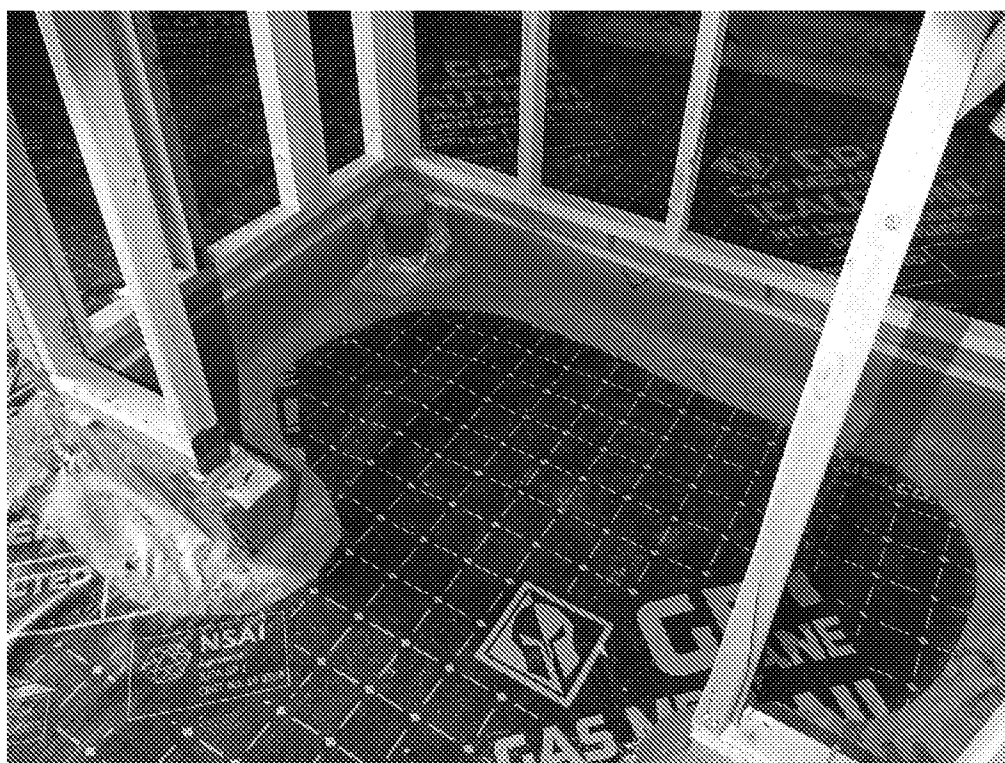
Plate 1 - Infills Plot 11

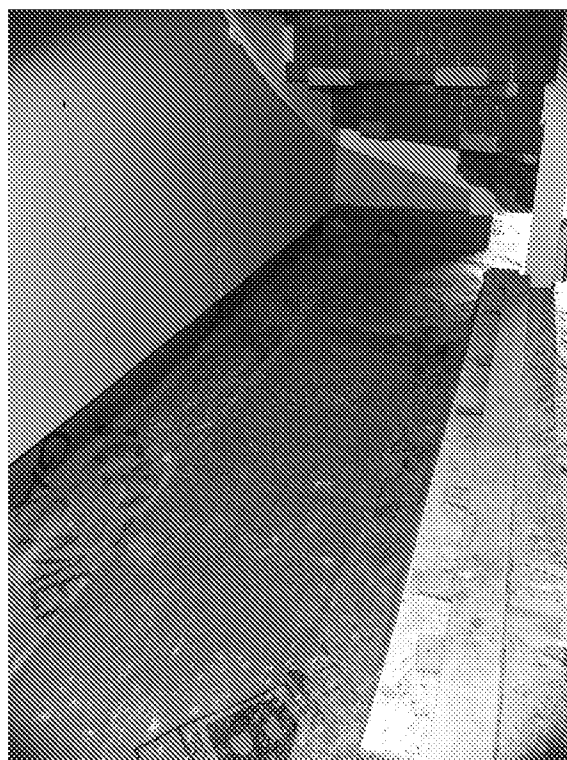
Plate 2 – Infills Plot 11
