Project Name: Stakers Farm Barns, Yapton, BN10 0PU

QED Ref: 19-211

Date of Issue: 26 July 2019

Date of Site Visit: 27 June 2019

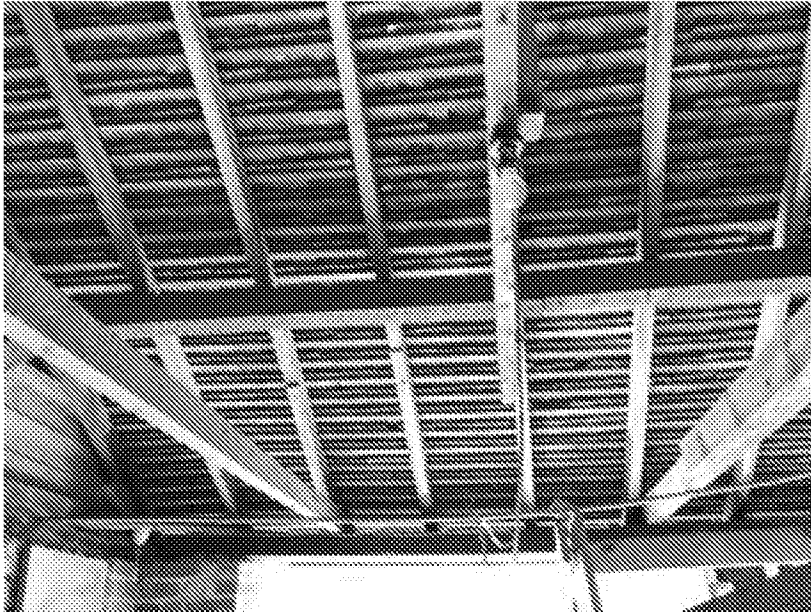
Building 3 – Timber roof trusses formed from rafters, ties, collars and purlins

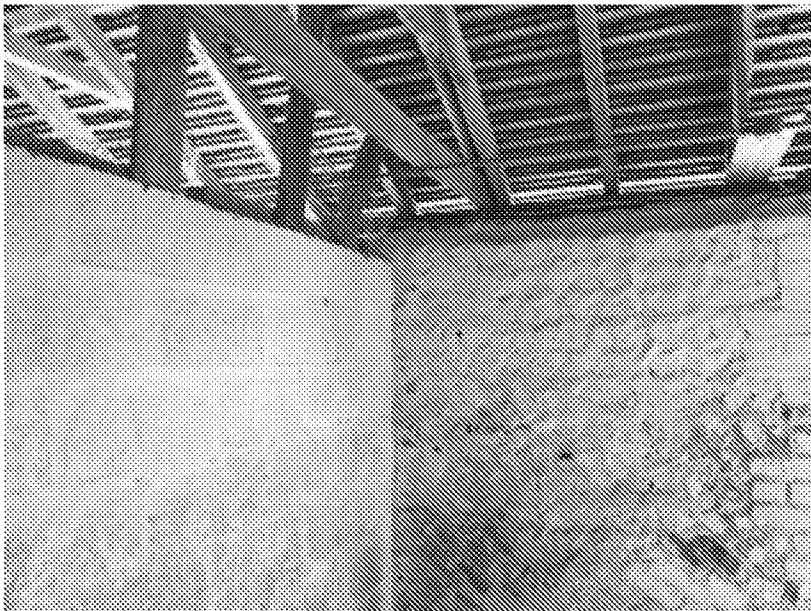
Building 3 – Timber roof trusses formed from rafters, ties, collars and purlins and room division wall
