Project Name: Stakers Farm Barns, Yapton, BN10 0PU

QED Ref: 19-211

Date of Issue: 26 July 2019

Date of Site Visit: 27 June 2019

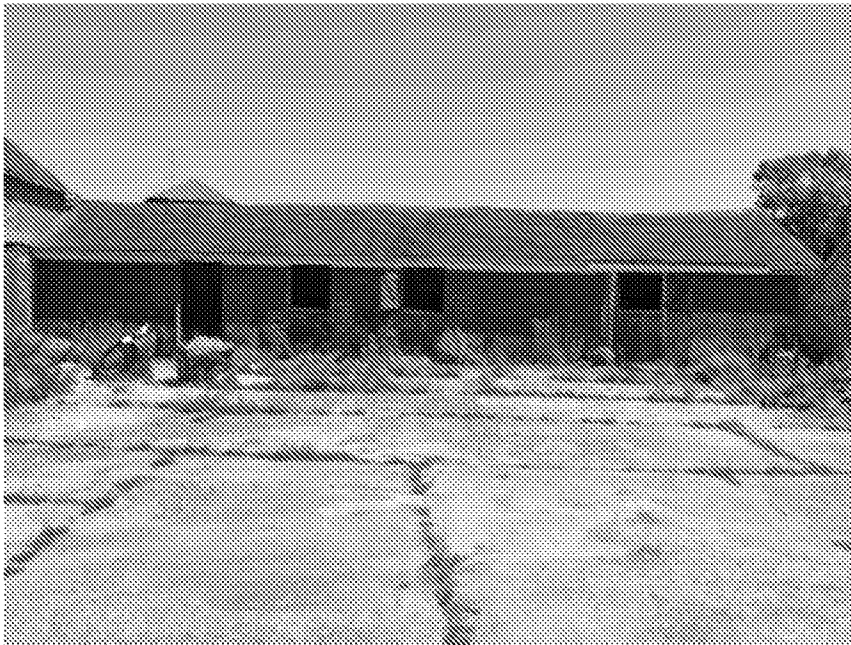
The roof has clay tiles with clay ridge tiles on a series of timber trusses and rafters. The ridge itself is very uneven which suggests there has been a certain amount of movement in the roof historically. There is a gutter at the eaves of the roof at the front which is partially missing.

Building 1 – Front elevation

**Front Wall** – The front brickwork/flint walls with timber cladding above would need to be demolished and rebuilt, as they are not in very good condition and it is assumed there are no or minimal foundations supporting these walls. The posts supporting the main timber trusses are to be underpinned to be able to provide a good firm foundation. The new wall would need to be built off a new foundation that would be constructed between the underpin sections for the posts. The new walls would then provide a good solid support for the roof with new Catnic or similar lintels as required for any new windows or doors. The depths of the existing foundation and proposed underpinning or new foundations are all subject to the depth requirement for foundations in line with the NHBC Standards in relation to the soil type, plasticity of the soil and proximity and type of trees.

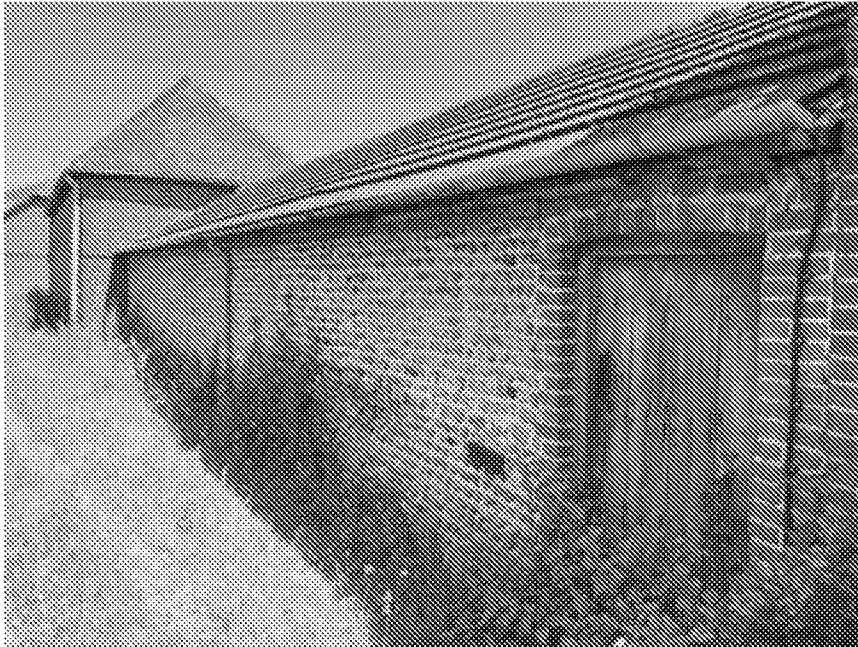
Rear Elevation –The rear elevation was brickwork and flint with one opening adjacent to Building 4. There is eaves guttering along the entire length with one number downpipe in the center of the building.

Building 3 - Rear elevation

Rear Wall – The rear wall has been pushed outwards by the spread of the roof, therefore it is recommended this wall be underpinned along its full length to provide a good firm foundation. Any new openings within this wall would need to be supported with Catnic or similar lintels. The rear wall is to be fixed back to the internal and side walls running perpendicular to the rear wall with Helifix ties or similar to provide a lateral restraint at each junction. Where possible it would also be prudent to carry out some local stitch repairs between walls. The depths of the existing foundation and proposed underpinning or new foundations are all subject the

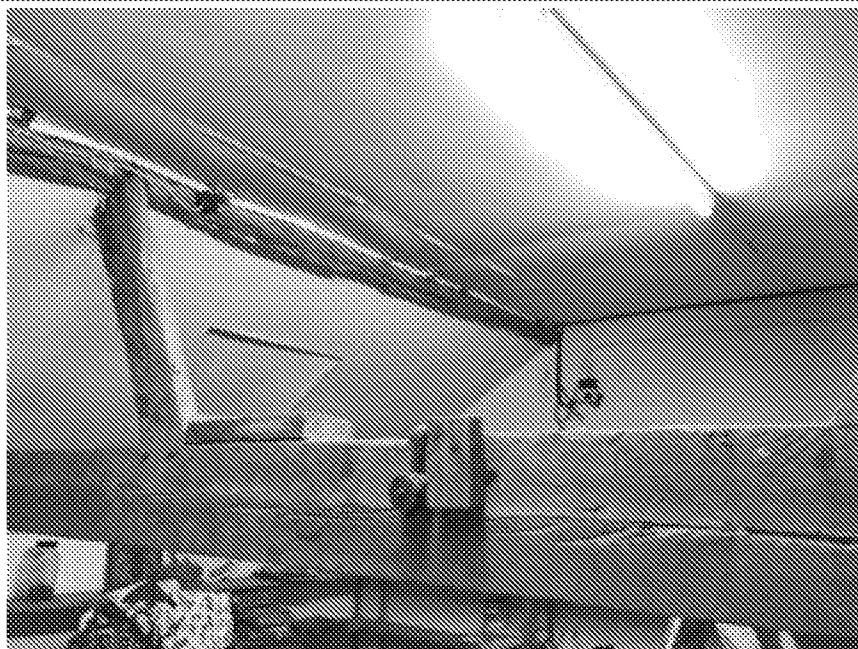
Building 4 – Trusses partially exposed at first floor level

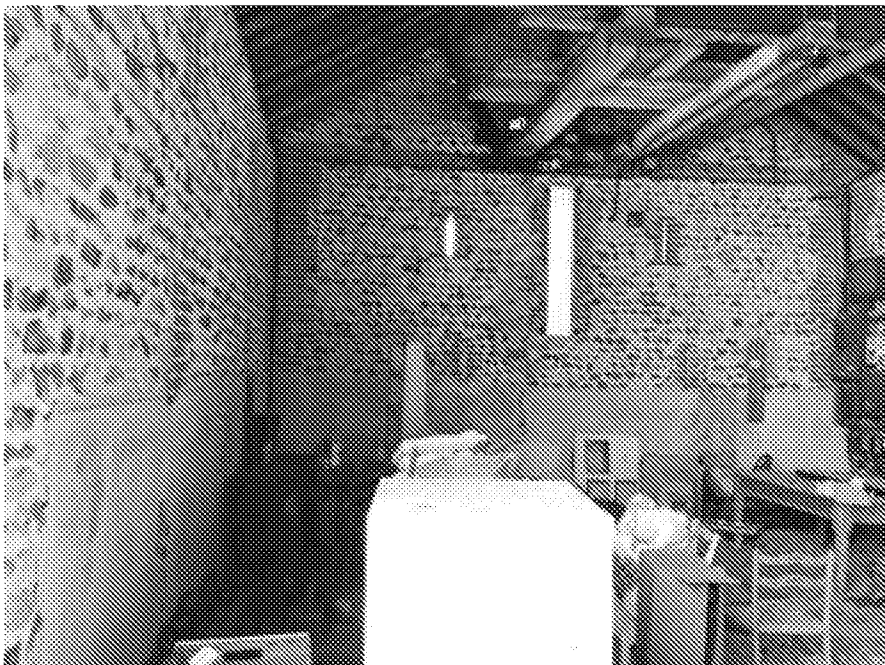
Building 4 – General view of high external walls

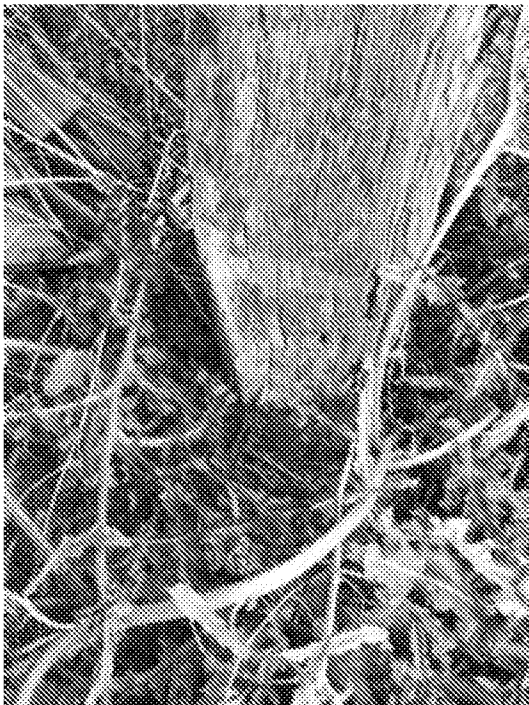
Building 5 – Rotten base of post to room 16 on top of concrete plinth, supporting roof truss

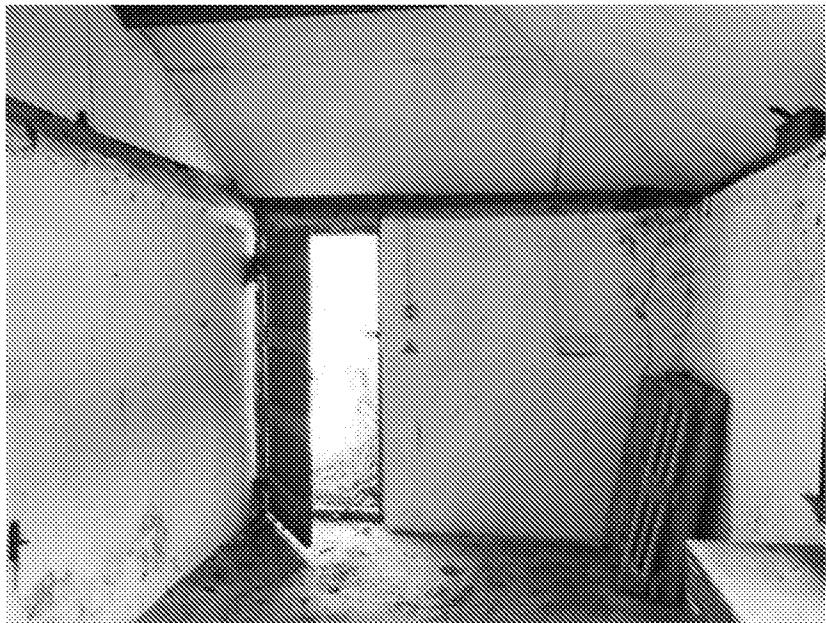
Building 5 – Wall not visible, elements of the timber roof visible only

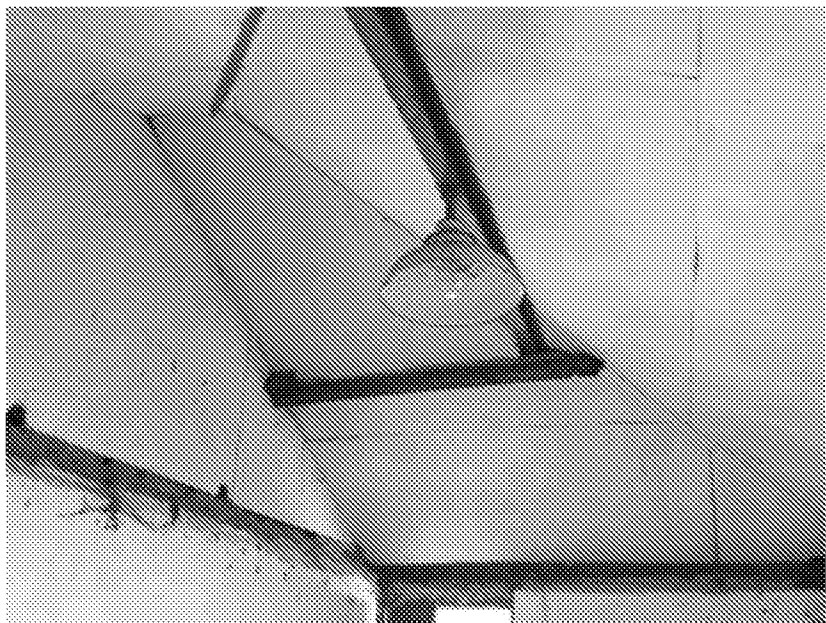
Building 5 – Full roof not visible only a purlins and wall plates
